Mill Brook, Windsor, Vermont

Mill Brook Drainages

Target Maps

DEC Stormwater Infrastructure Mapping Project

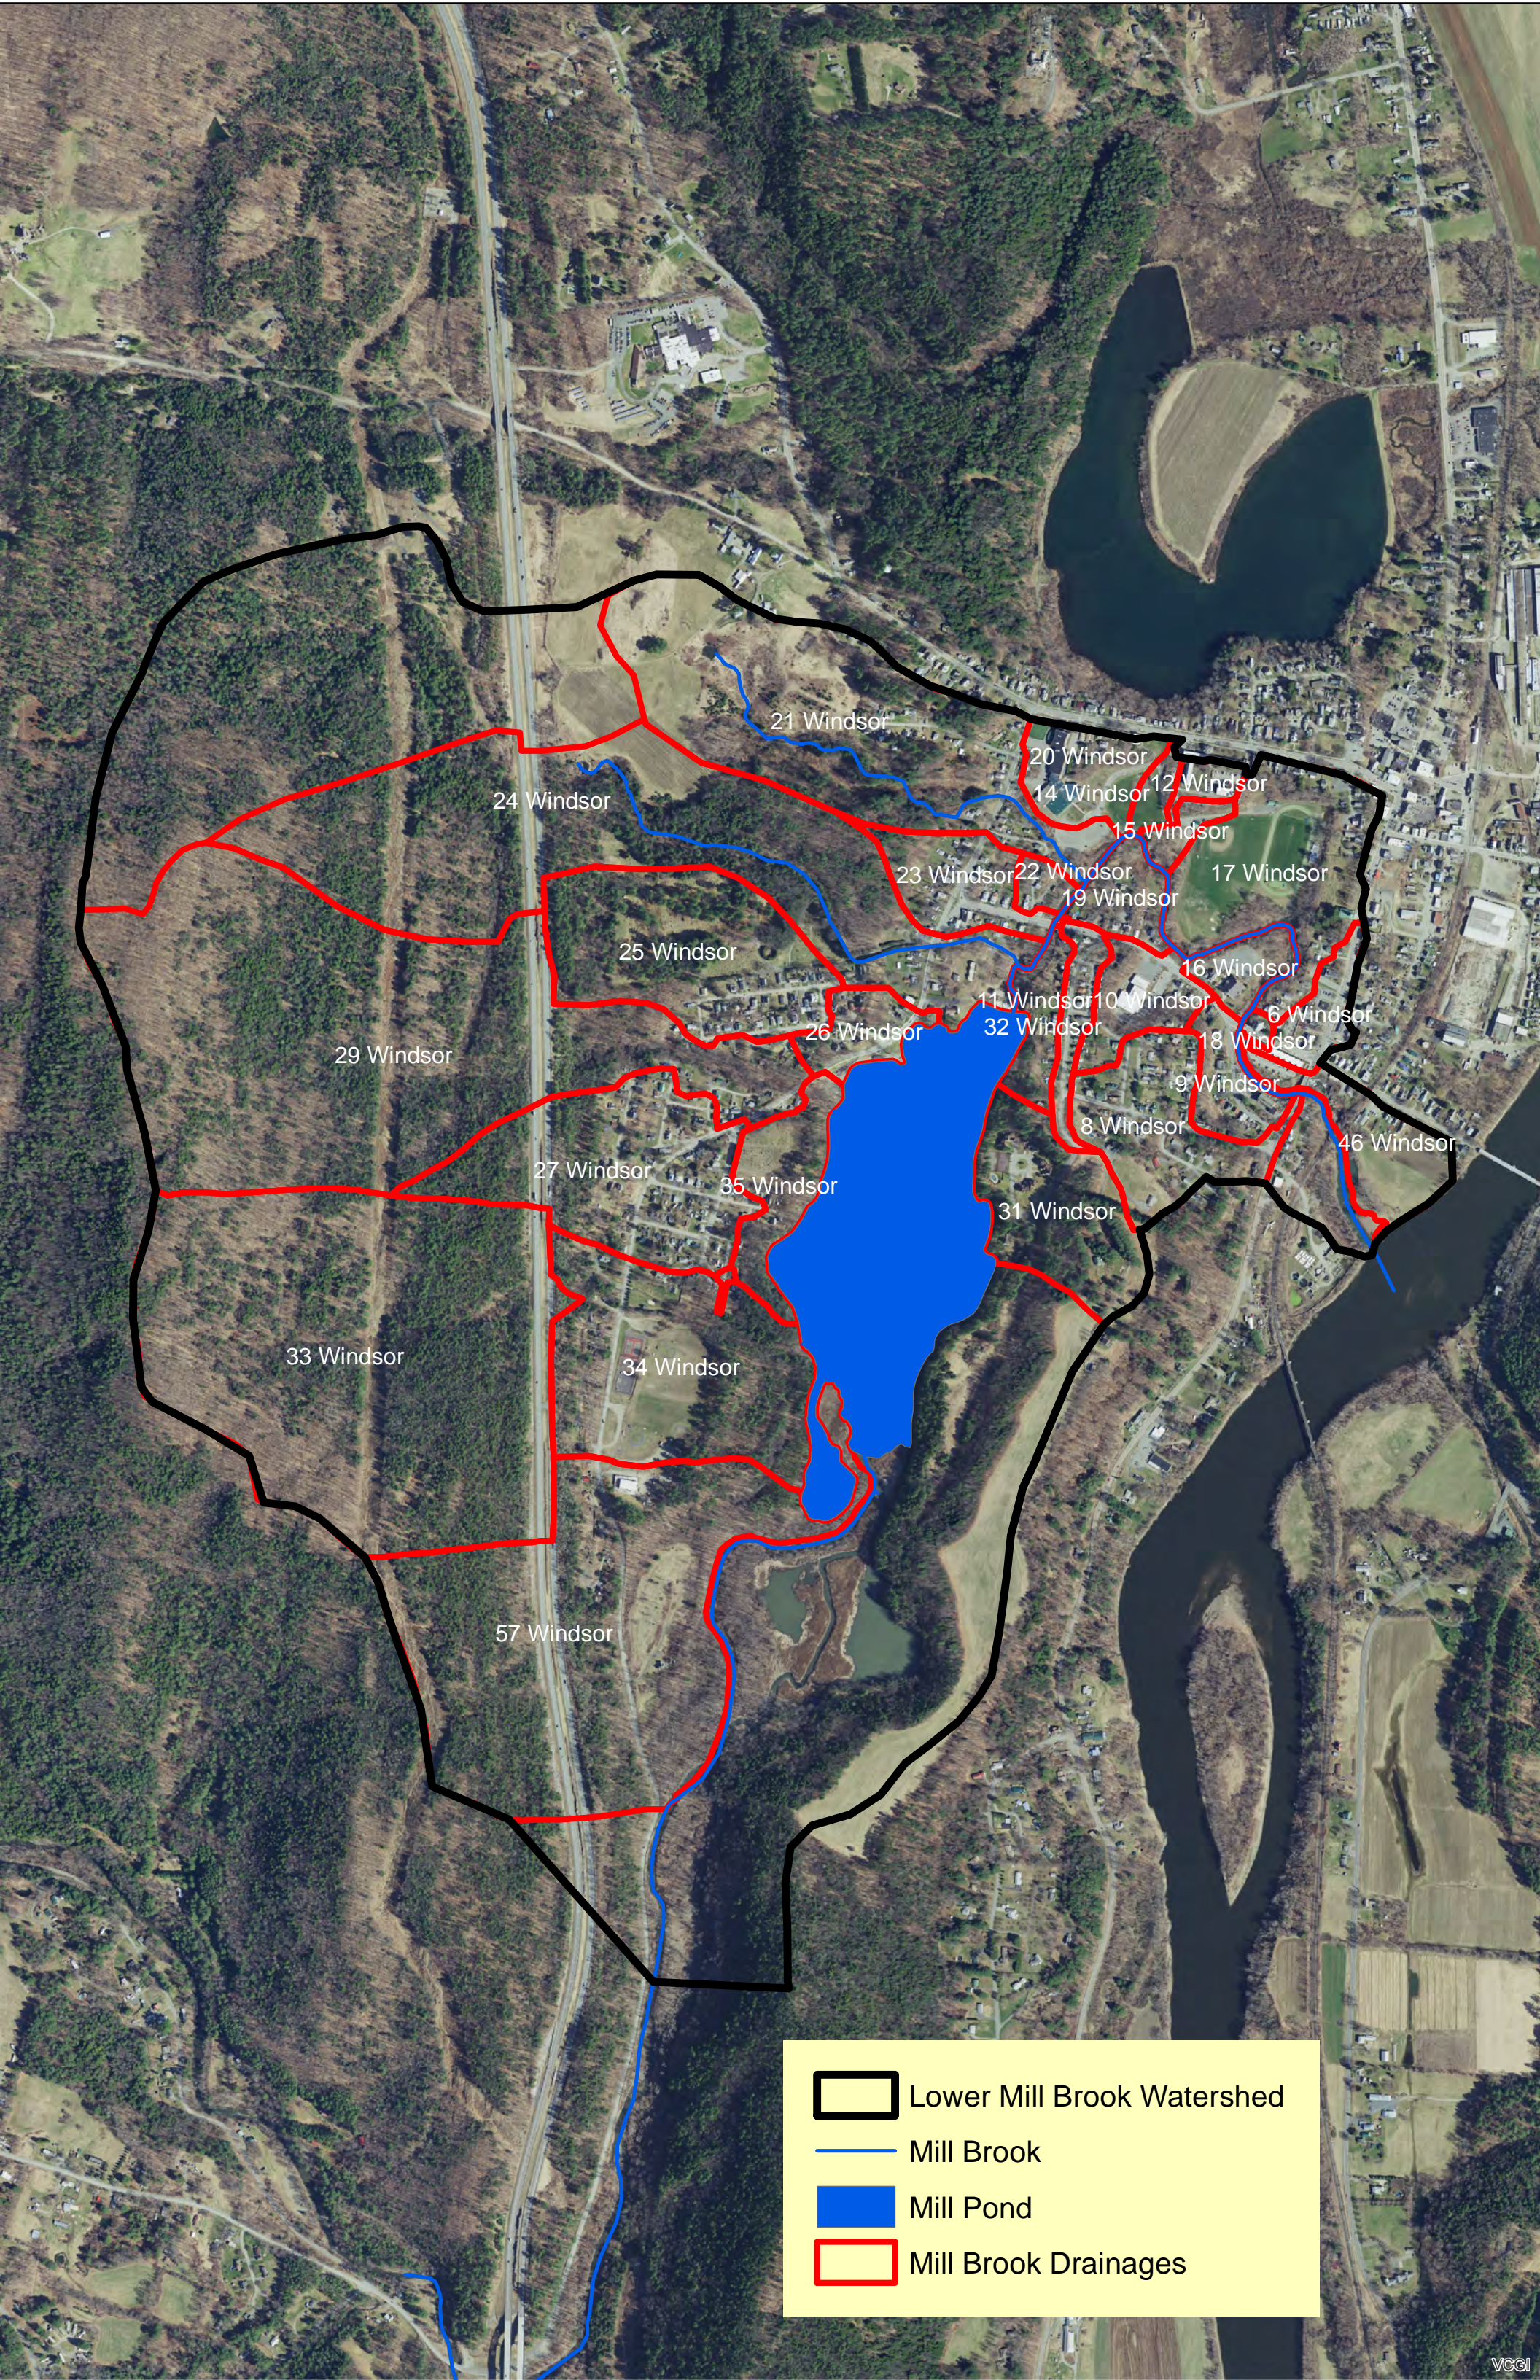
Mill Brook in Windsor, Vermont has been found to be stressed by stormwater runoff as measured by the biology of the stream. The stream will be measured in 2021-2022 for macroinvertebrates and fish. There are at least 28 significant discharges to the brook from the developed lands of Windsor Village. The largest discharge to the stream is drainage area #29 which drains a large section of the central watershed. The recommended course of action for stormwater impacted streams is to install a treatment structure that controls the water quality volume. A map showing the location of the discharges and a possible retrofit location is provided. A cost estimate (excluding land costs) is provided.

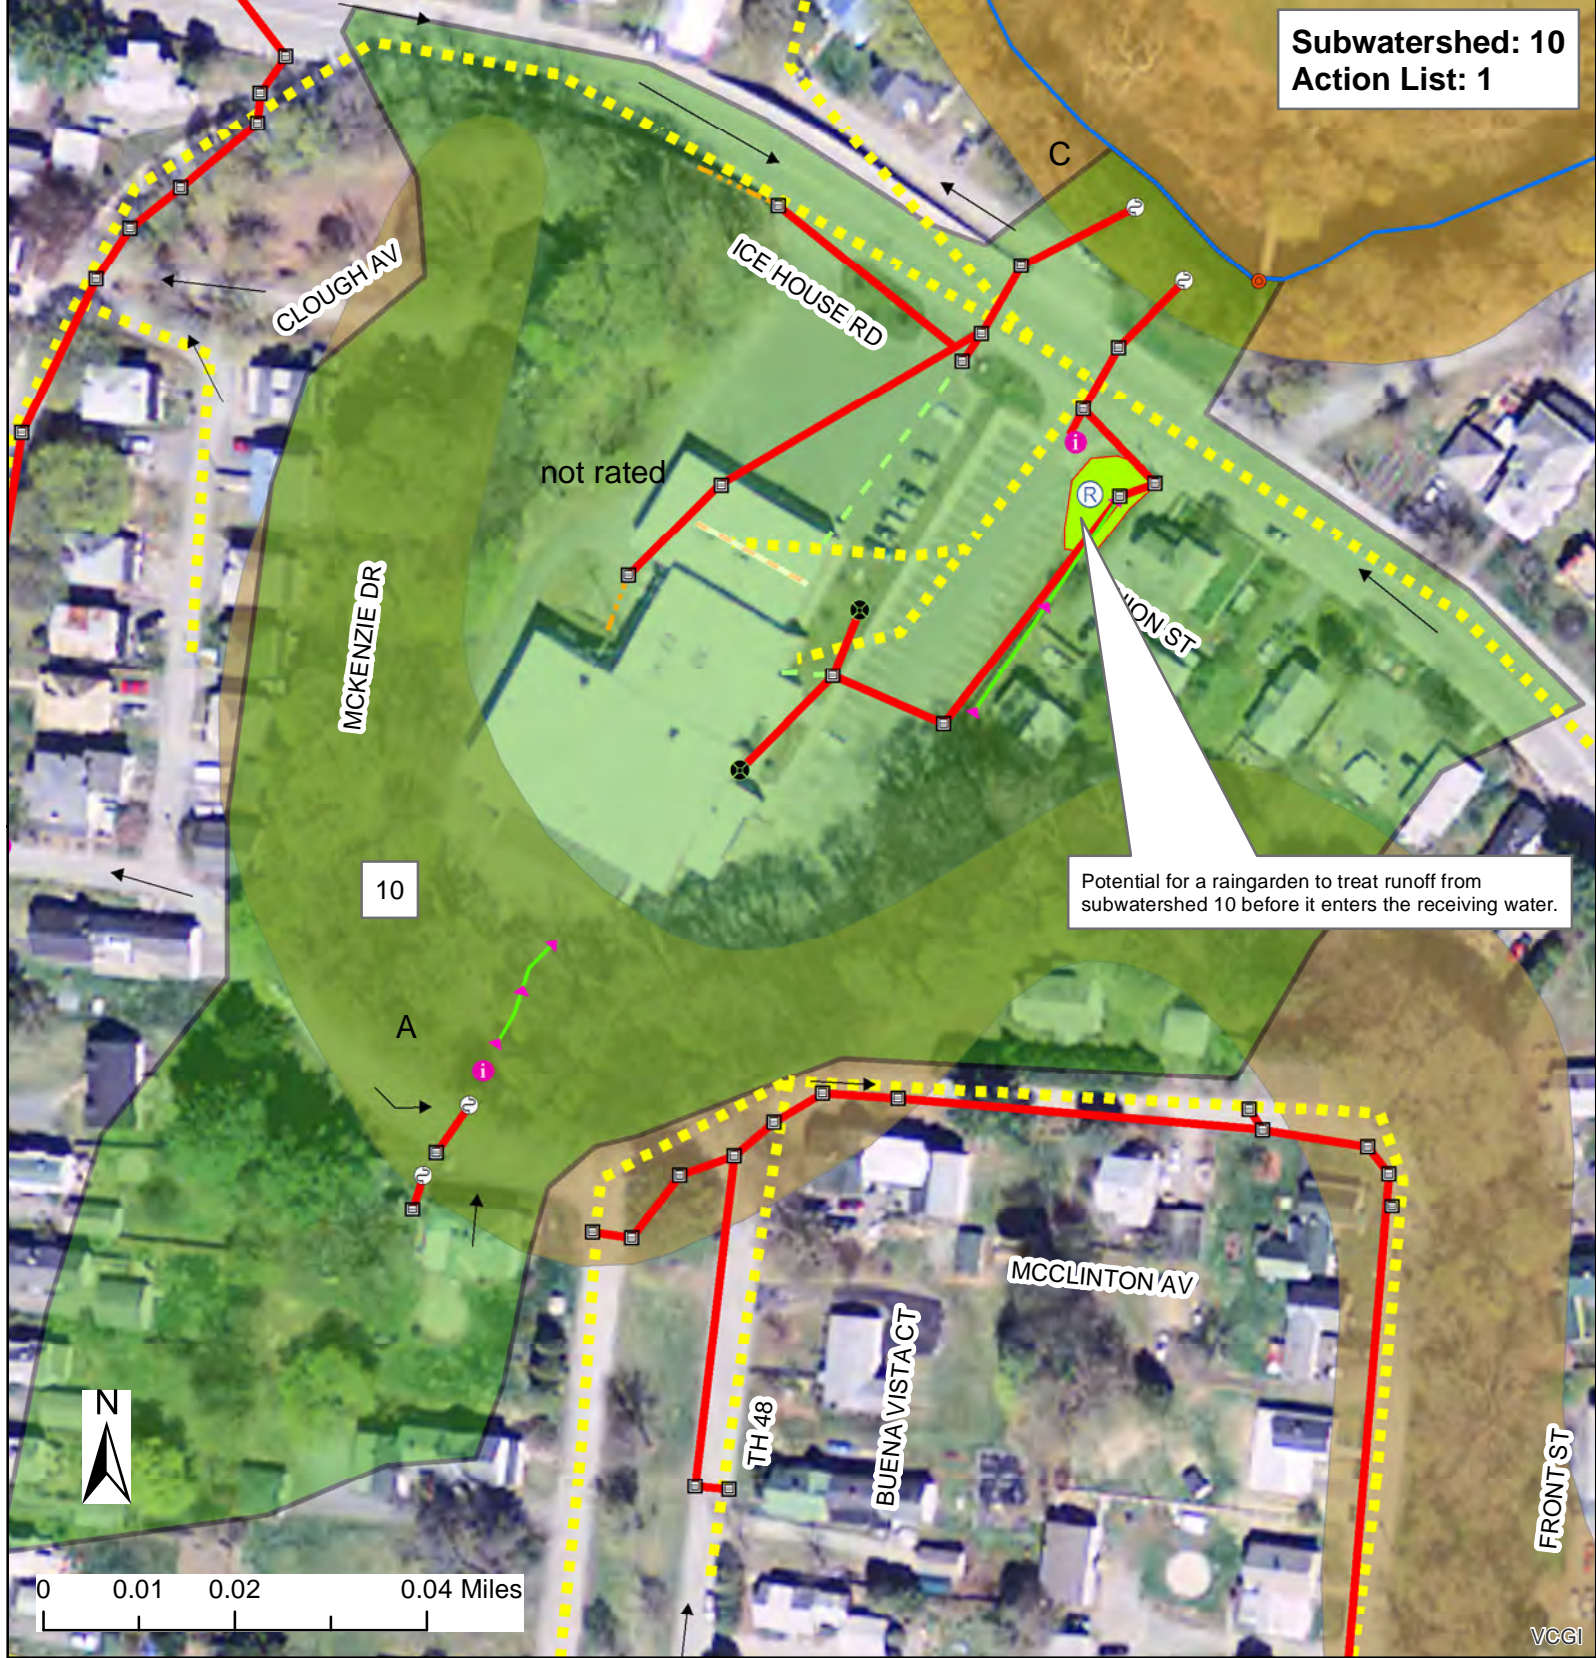
*Showing Priority Action List
Drainage Areas*

And Potential Retrofit Locations

This map shows high priority subwatersheds which are ranked by connectedness, percent of impervious cover, field observations, and potential retrofit measures and locations.

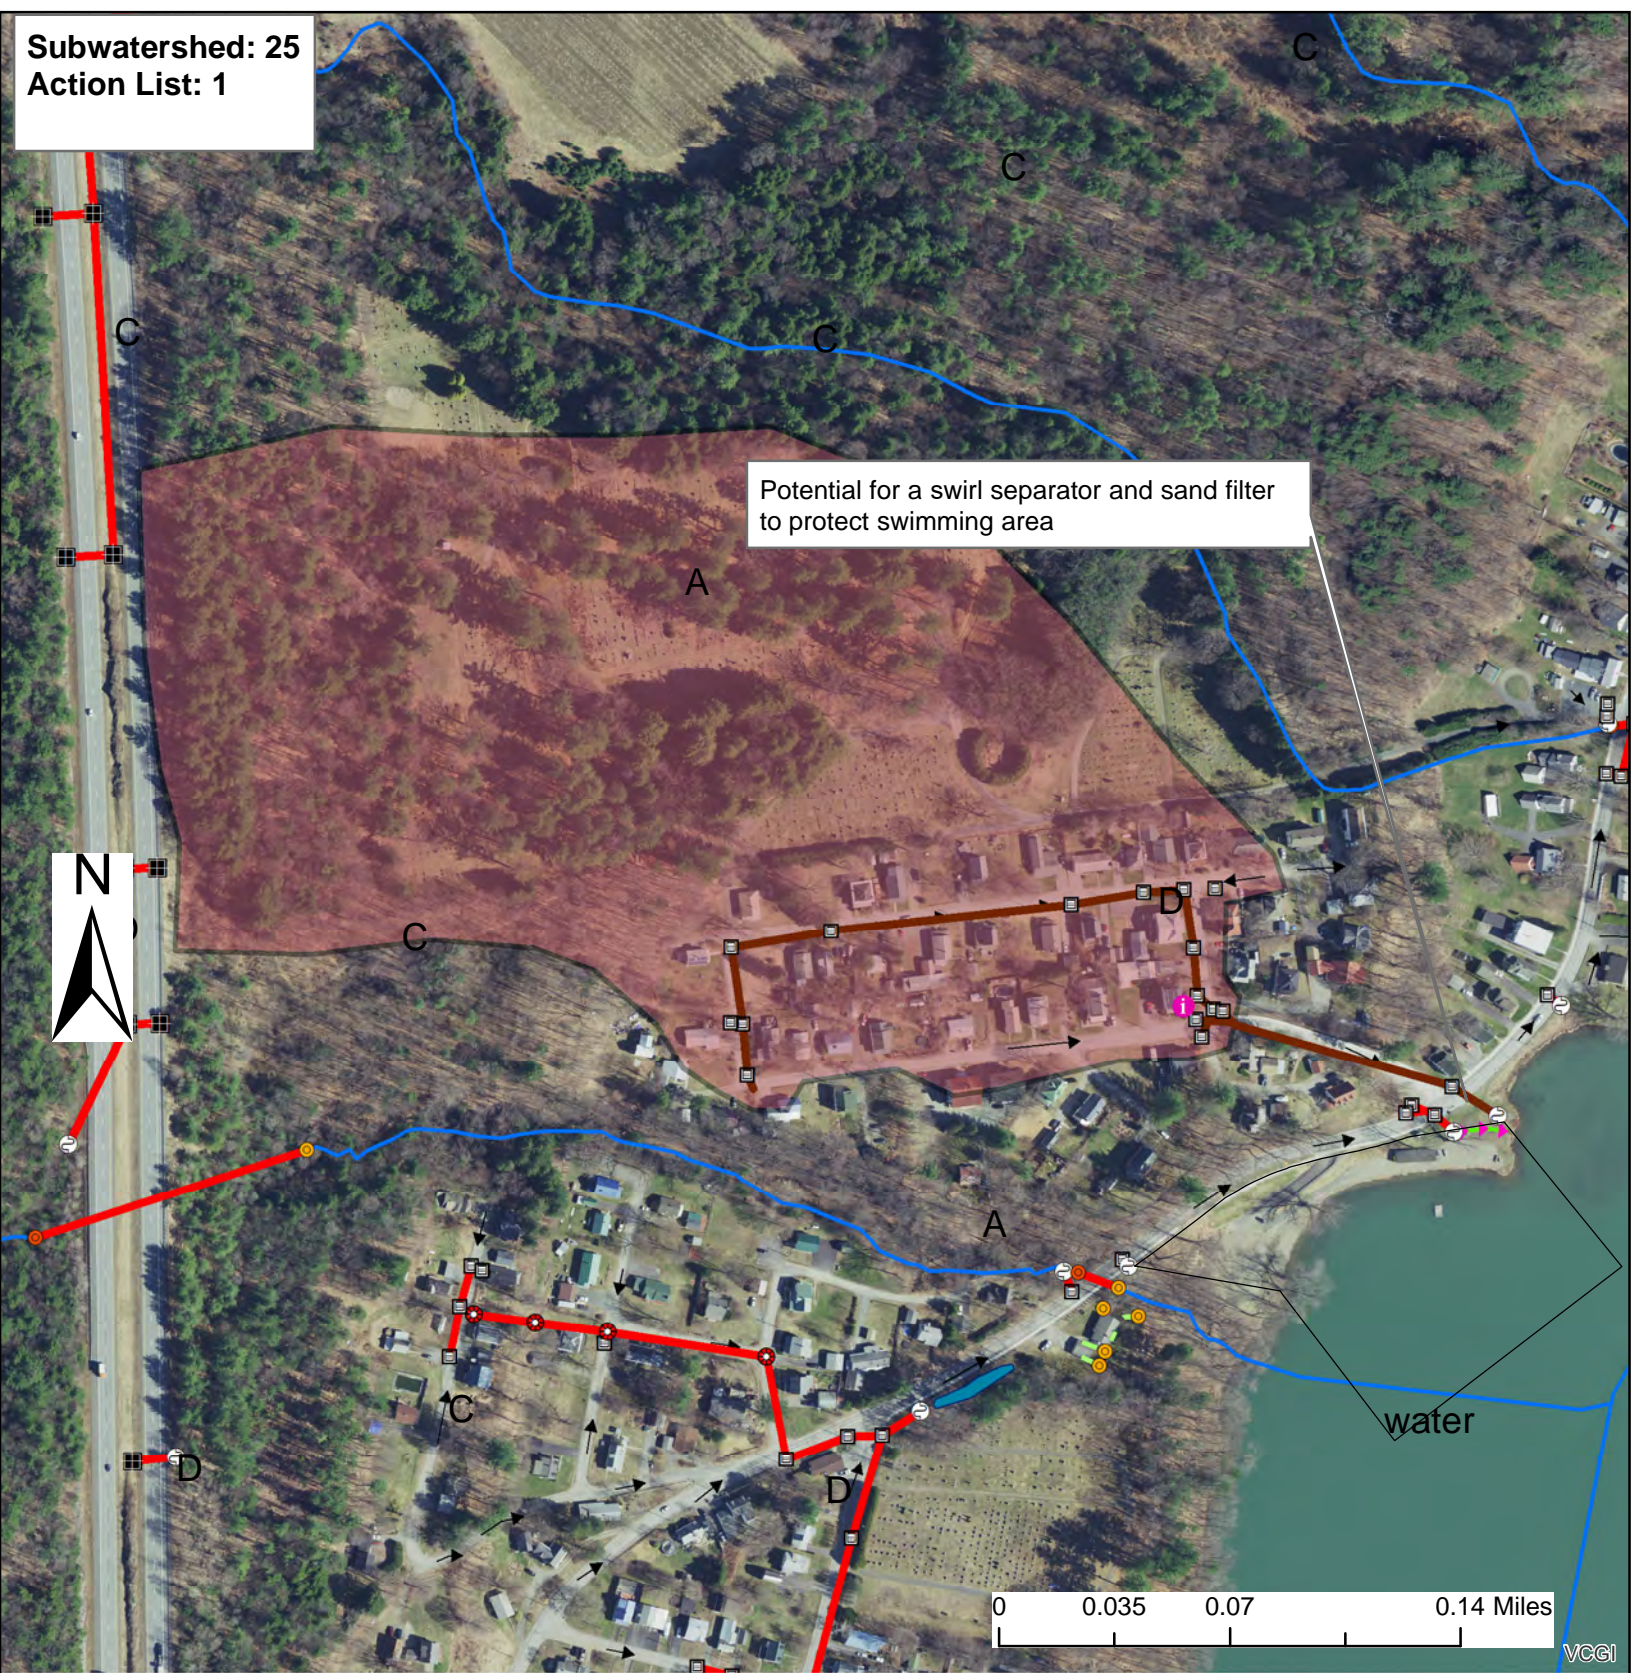
Subwatershed: 25
Action List: 1

Lower Mill Brook Windsor, VT

| Watershed Number | Action List # | Proposed Action | Proposed or Existing Stormwater Treatment Practice | Permit Number | Watershed Area (Acres) | Current BMP Sediment Reduction Credit | Sediment Load with Current Reductions (lbs.) | Priority Action Sediment Reduction Credit | Sediment Load with Priority Action (lbs.) | Nitrogen Load with Current Reductions (lbs.) | Priority Action Nitrogen Reduction Credit | Nitrogen Load with Priority Action (lbs.) | Water Quality Volume (ft ³) | Estimated Basin Construction Cost | Estimated Other BMP Construction Cost | Cost of Sediment Removal Per Pound (based on annual sediment load) | Cost of Nitrogen Removal Per Pound (based on annual nitrogen load) | Assistance Program | # LID-Roof Raingardens to Treat Water Quality Volume |
|---|---|---|---|---|---|---|---|---|---|---|---|---|---|---|---|---|---|---|---|
| 25 Windsor | 1 | Swirl separator and sand filter to protect swimming area | VS-SF/CB | | 33.26 | 0% | 4237 | 85% | 636 | 35.3 | 60% | 14.1 | 10442.4 | \$950,262 | | \$264 | \$44,855 | CWIP,SRF,LISF | 120 |
