# Groundwater Reclassification Petition

Burgess Brothers Superfund Site  
Bennington, Vermont

VtDEC Groundwater Coordinating Committee

February 14, 2002

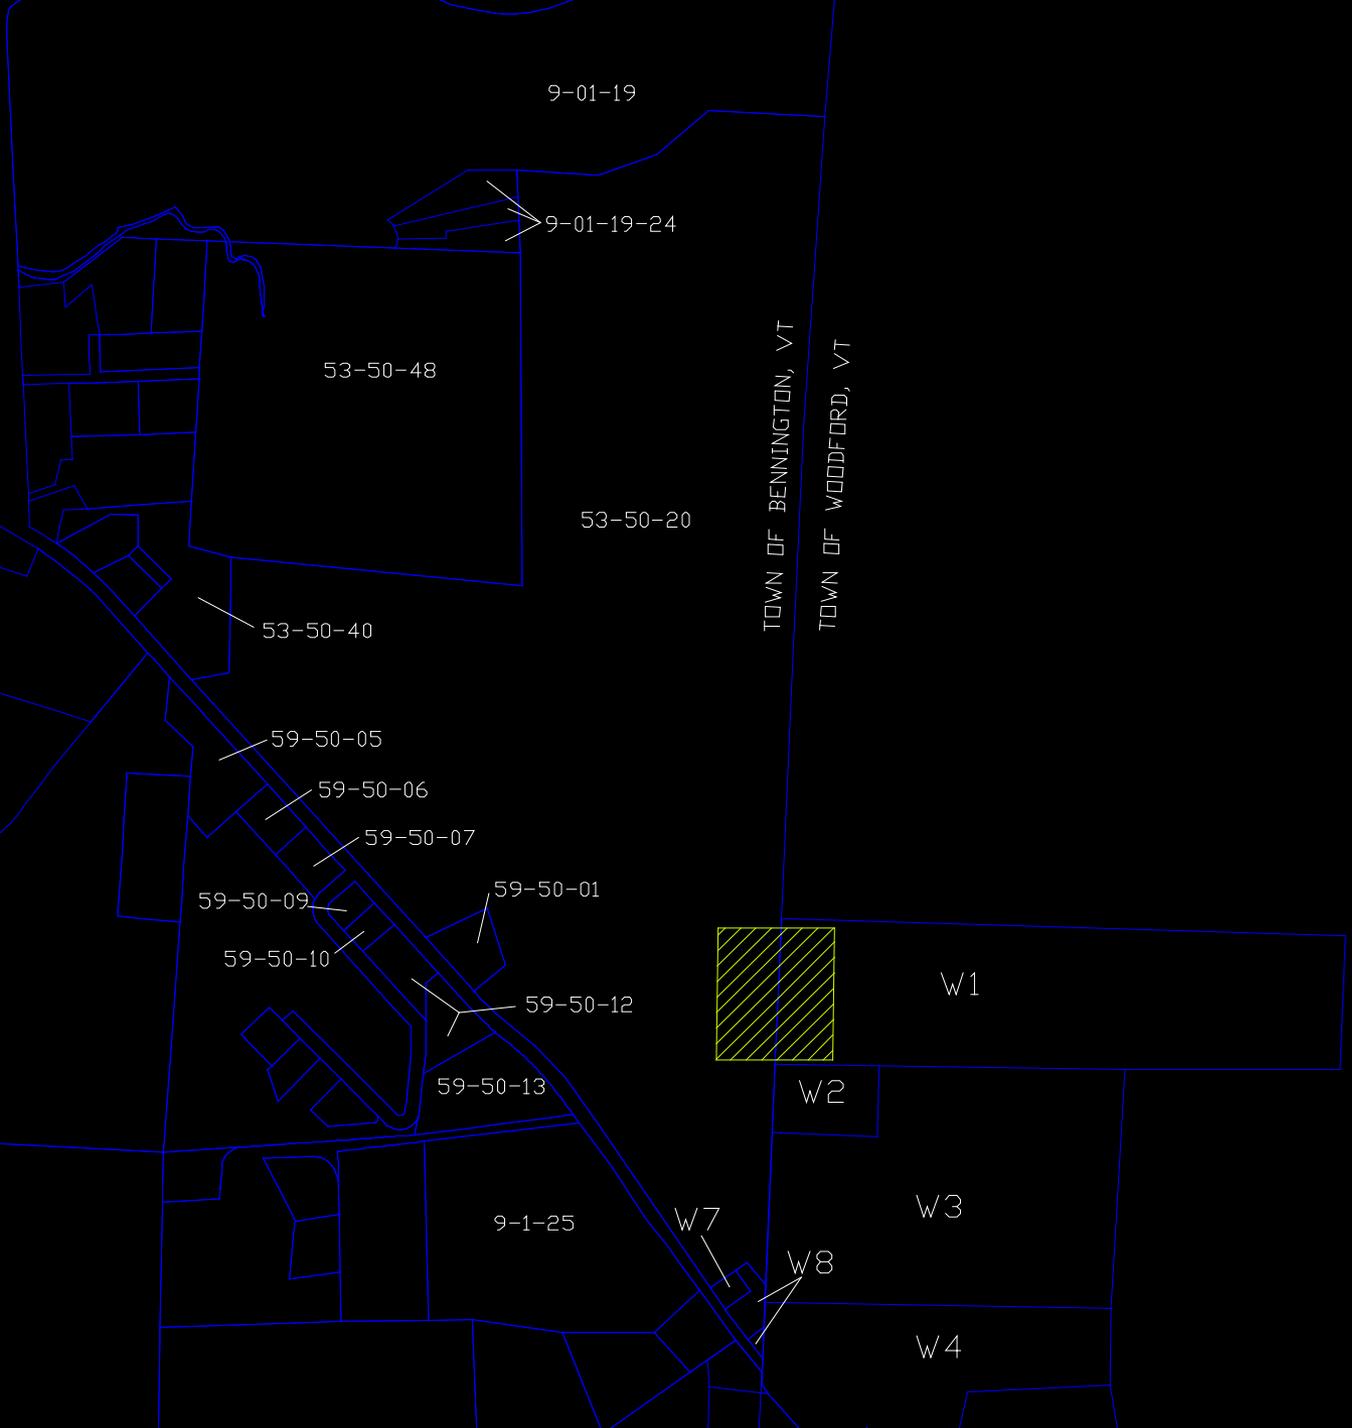
APPROXIMATE LOCATION  
GROUNDWATER RECLASSIFICATION

LOT NUMBER	PARCEL OWNER
9-01-19	JOSEPH MAYER
9-01-19-24	RUTH RUDNICK
53-50-48	STATE OF VT
53-50-40	WOODFORD PACKERS
59-50-05	CLYDE D. HOWE,
59-50-06	LAWRENCE HARRINGT
59-50-07	RALPH DICKINSON,
59-50-09	PATRICK KINNEY,
59-50-10	FRANCIS ROY, 22
59-50-01	PEGGY SAUER-GAGND
59-50-12	GLENN SAUER, 1
59-50-13	JEAN BURGESS,
9-1-25	BENJAMIN BACON,
53-50-20 *SITE*	BURGESS BROS / CLYDE
W1 *SITE*	BURGESS BROS / CLYDE
W2	BURGESS BROS / CLYDE
W3	BURGESS BROS / CLYDE
W4	C. BURGESS & I. WAL
W5	BEVERLY & THEODORE P
W6	R. FRANTZ AND NANCY C
W7	BURGESS BROS / CLYDE
W8	TOW

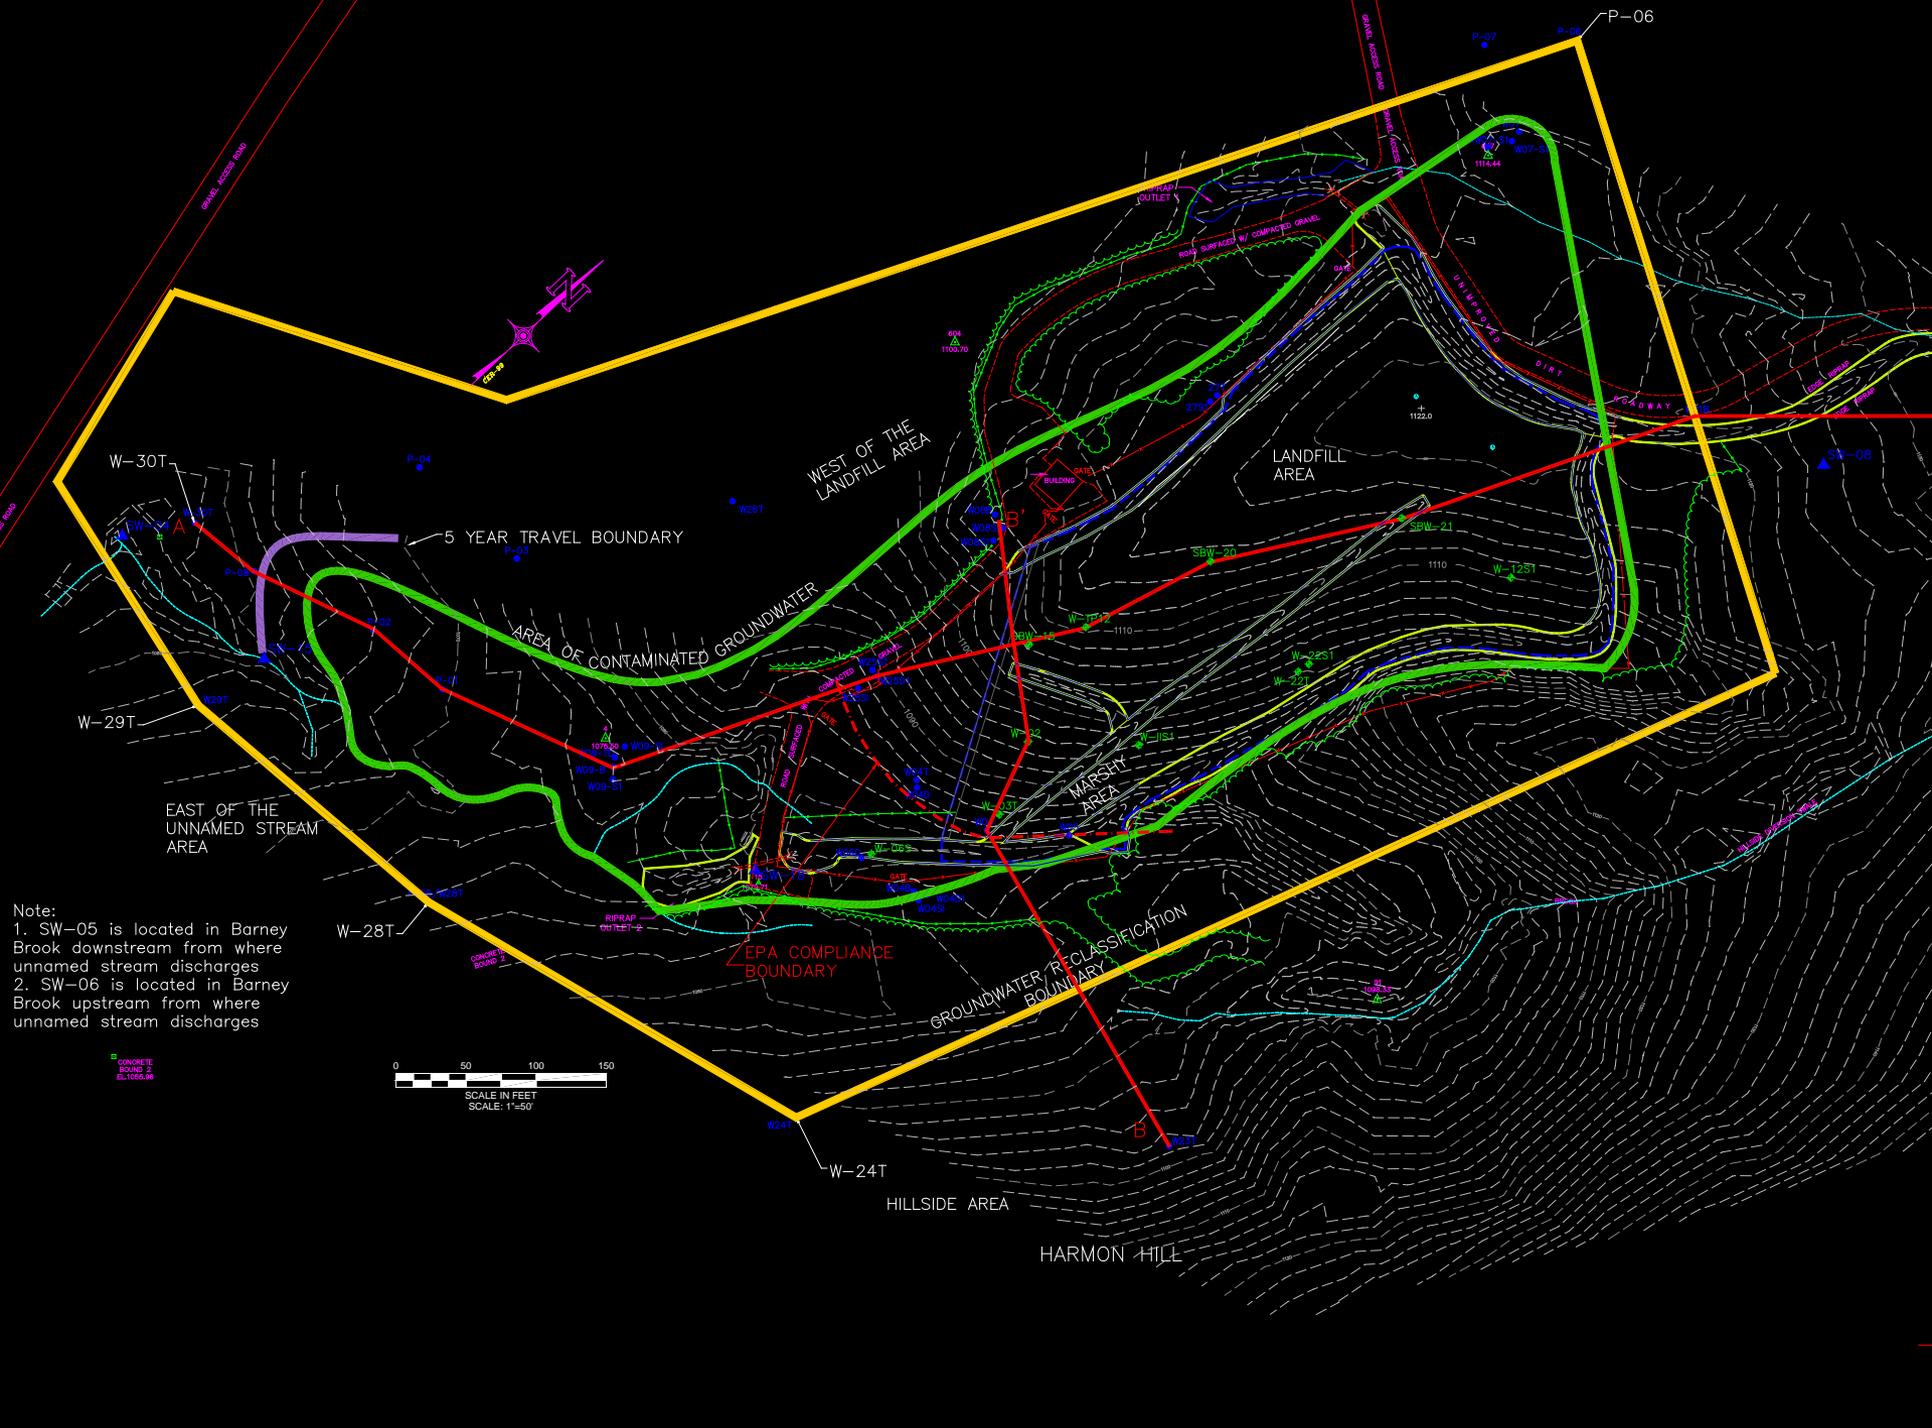
Note:  
 1. SW-05 is located in Barney Brook downstream from where unnamed stream discharges  
 2. SW-06 is located in Barney Brook upstream from where unnamed stream discharges

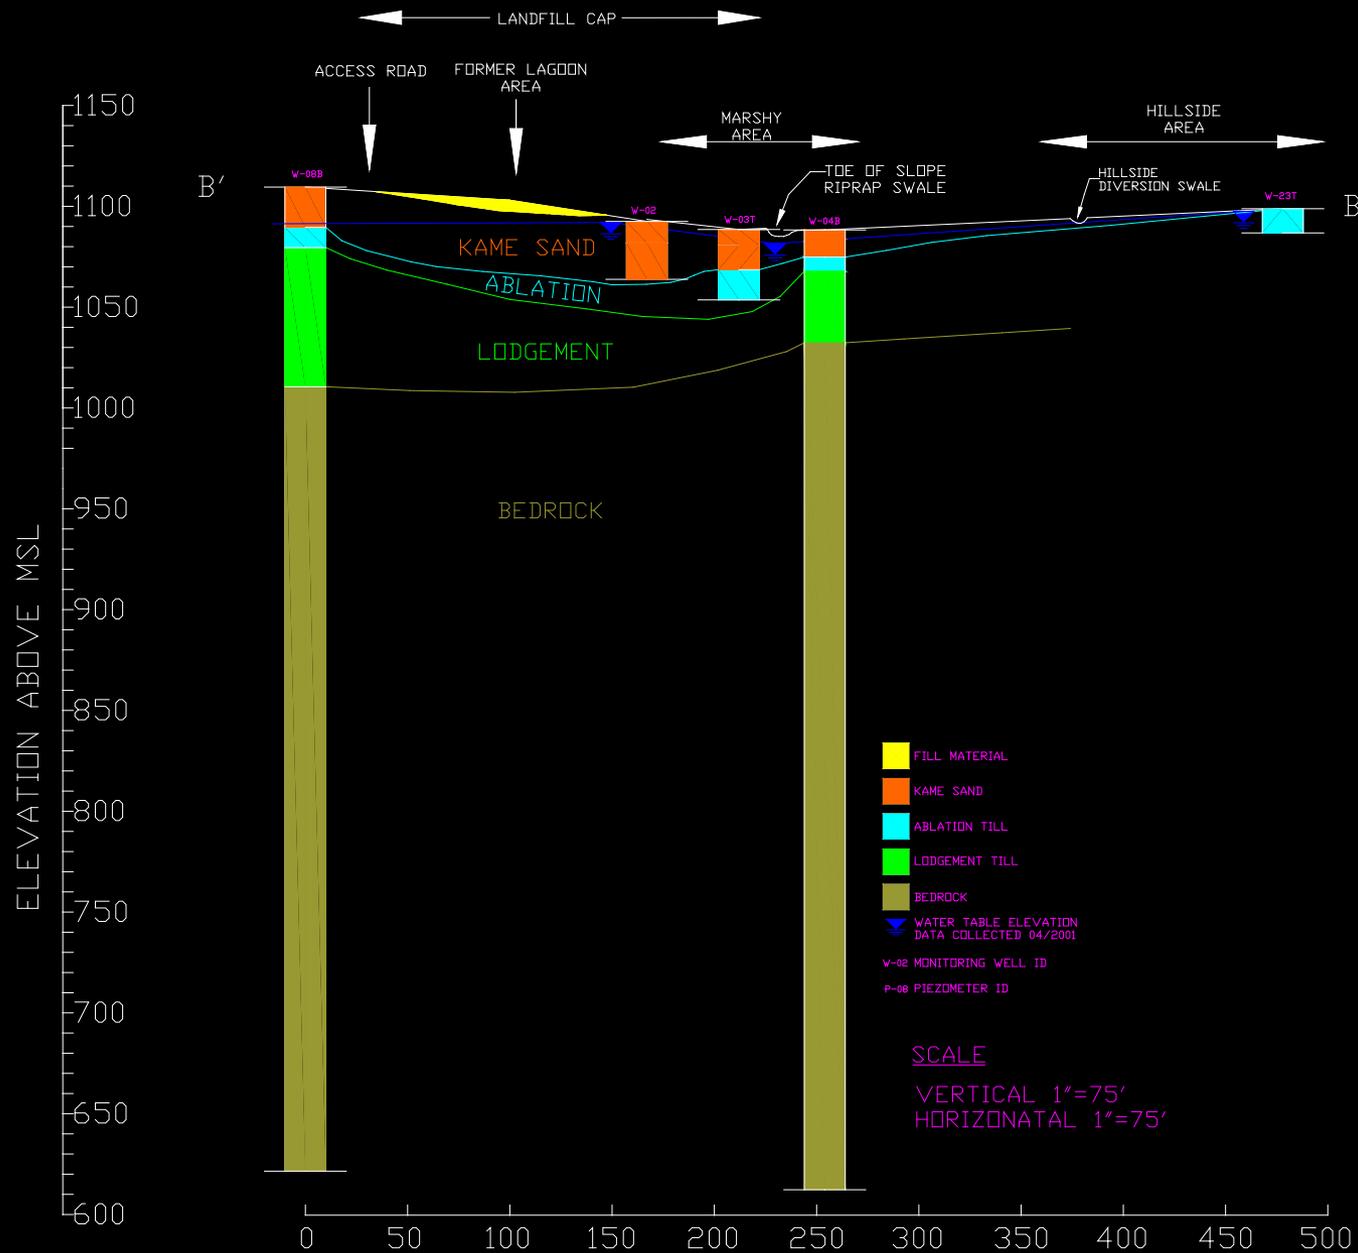
# East – West Cross-section

- Shallow overburden aquifer
  - Kame sand
  - Ablation glacial till
- Lodgemont till
  - Dense, low permeability confining layer
  - Separates shallow and deep aquifer
- Bedrock aquifer

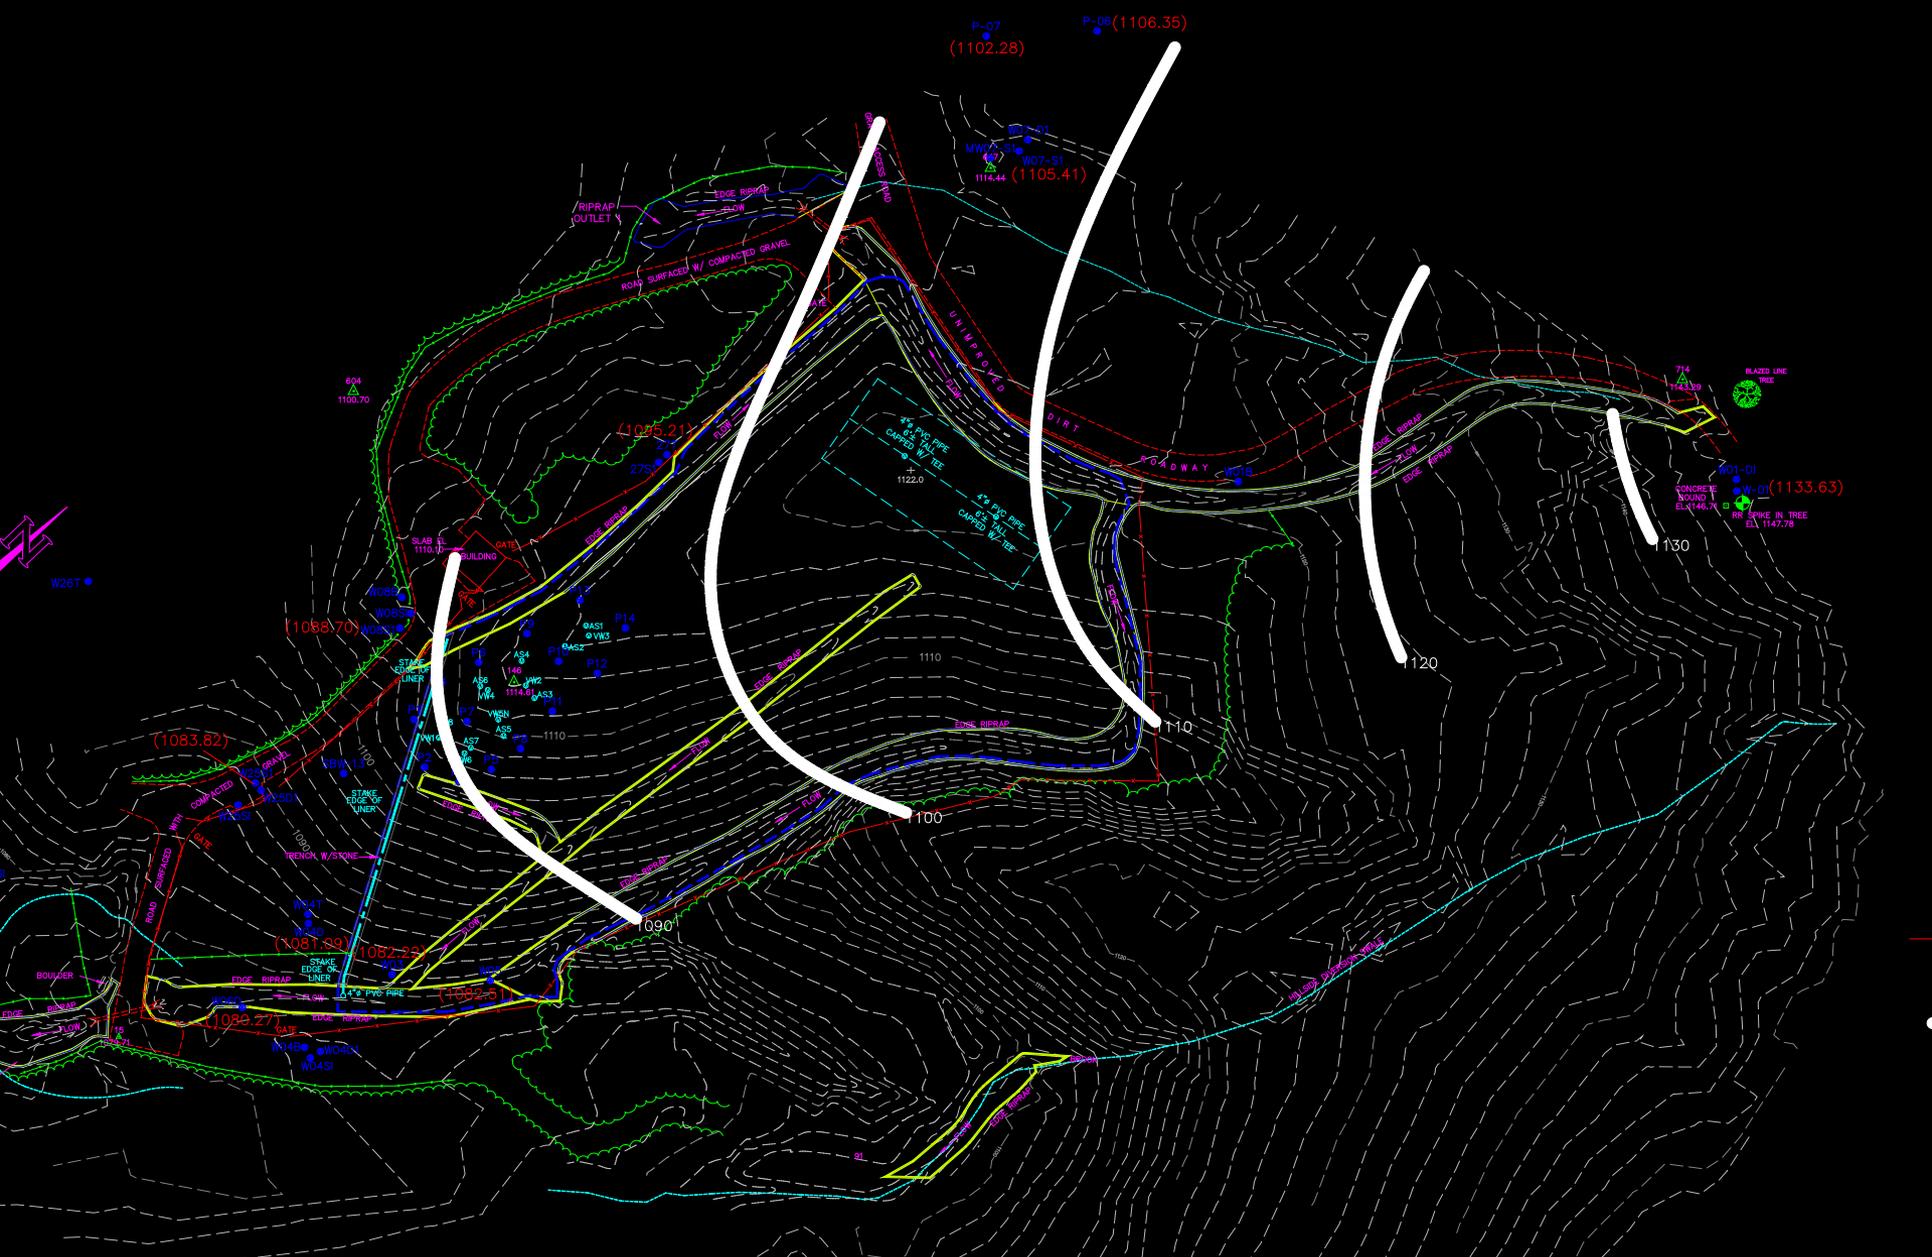
# Groundwater Flow – Kame Sand

- Groundwater flow

- Horizontal

- Follows site topography

- North-south slope, Harmon Hill to east

- Upward gw flow in kame sands/till in Marshy area

- Discharge to swales and Unnamed Stream

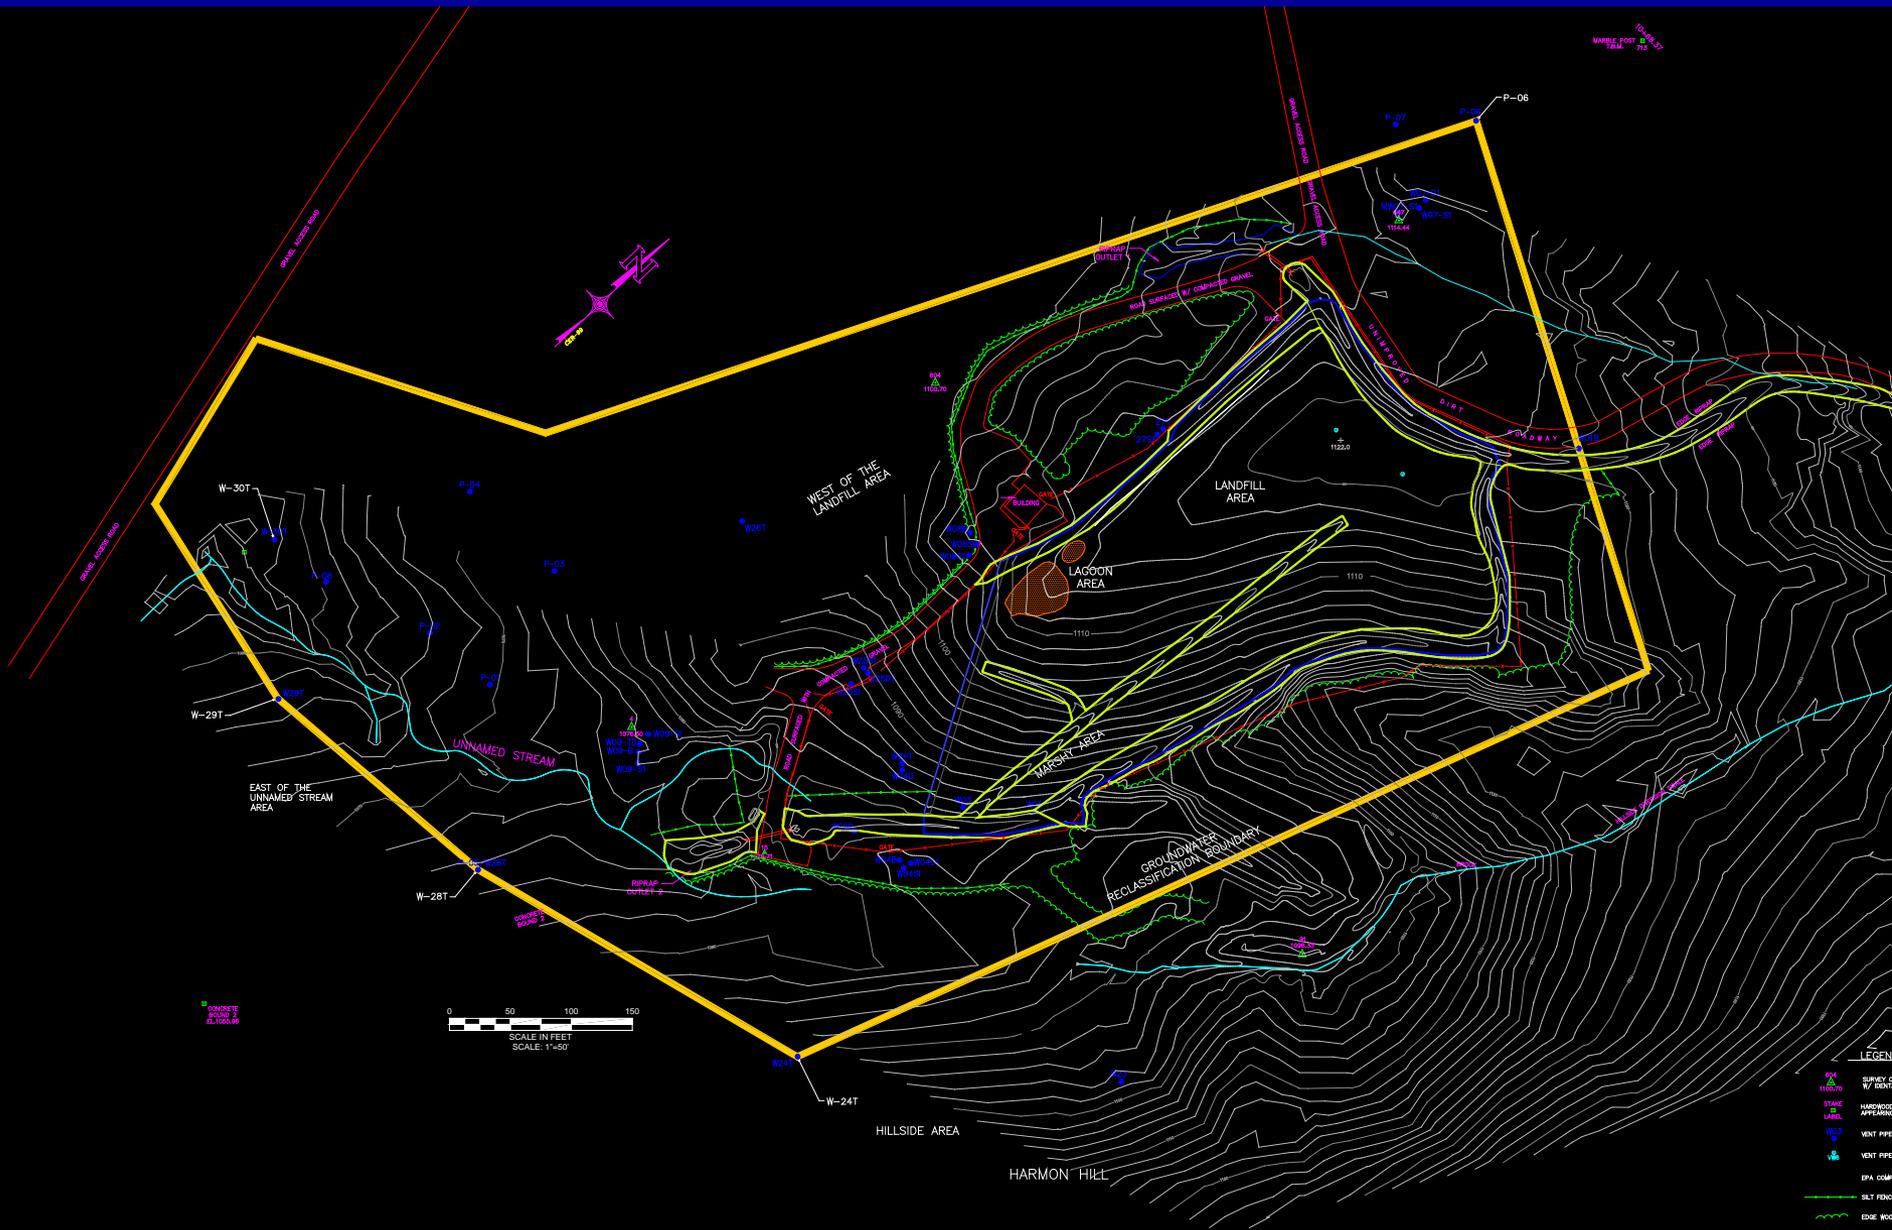
# Groundwater Reclassification Boundary

Area of Contaminated Groundwater

Topographic Barriers to Migration

North – South Slope

Harmon Hill to East

Hydrogeologic Barriers to Migration

GW flow direction (N-S)

Diversion swales and Unnamed Stream

- Upgradient (North): P-06 through W-01B
- Cross-gradient (East & West)
  - Topographically/hydraulically upgradient of Area of Contaminated Groundwater
  - East - on slope rise to Harmon Hill to W-24T
  - West – P0-6 to survey marker near W-26T

- W-24T to W-28T to W-29T

- GW flow captured by Unnamed Stream

- No contaminants detected across from stream

- Adjacent to gravel access road

- 5-yr travel boundary from ACGW = 35'

- Buffer zone = 160' to 200' (min. 22 yr travel time)

- 3 monitoring wells between ACGW and  
Reclassification Boundary (P0-2, P-08, W-30T)

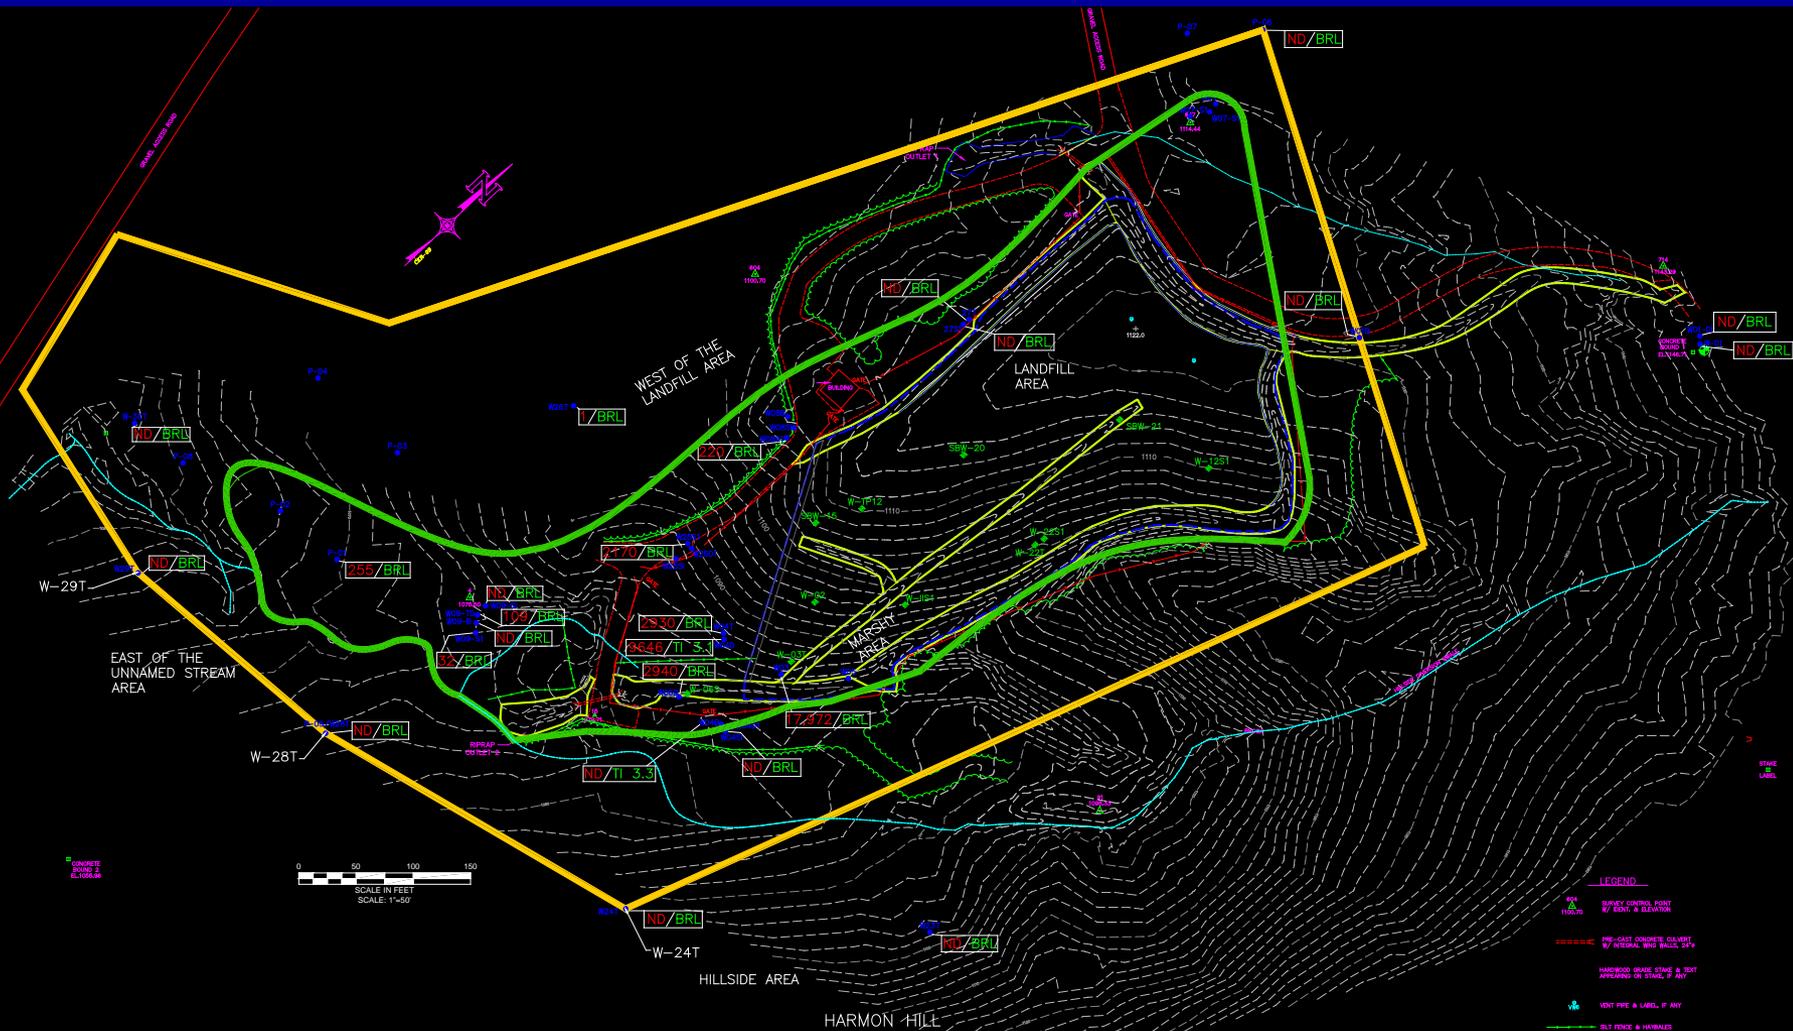
# Groundwater Quality – 1999 and 2001

- Notes:
1. Total VOC results in ug/L are shown in red.
  2. Metals results are shown in ug/L are shown in green.
  3. All VOC results are from April 2001 sampling

Thallium Note:  
Source of Thallium (Tl) is not known. Thallium
