LEVEL II  
ENVIRONMENTAL SITE ASSESSMENT  
for  
RUSSELL AUTO BODY  
91-1013

M & W SOILS ENGINEERING  
MAIN STREET, P.O. BOX 884  
CHARLSTOWN, NH 03603

**LEVEL II  
ENVIRONMENTAL SITE ASSESSMENT  
FOR  
CHET RILLING**

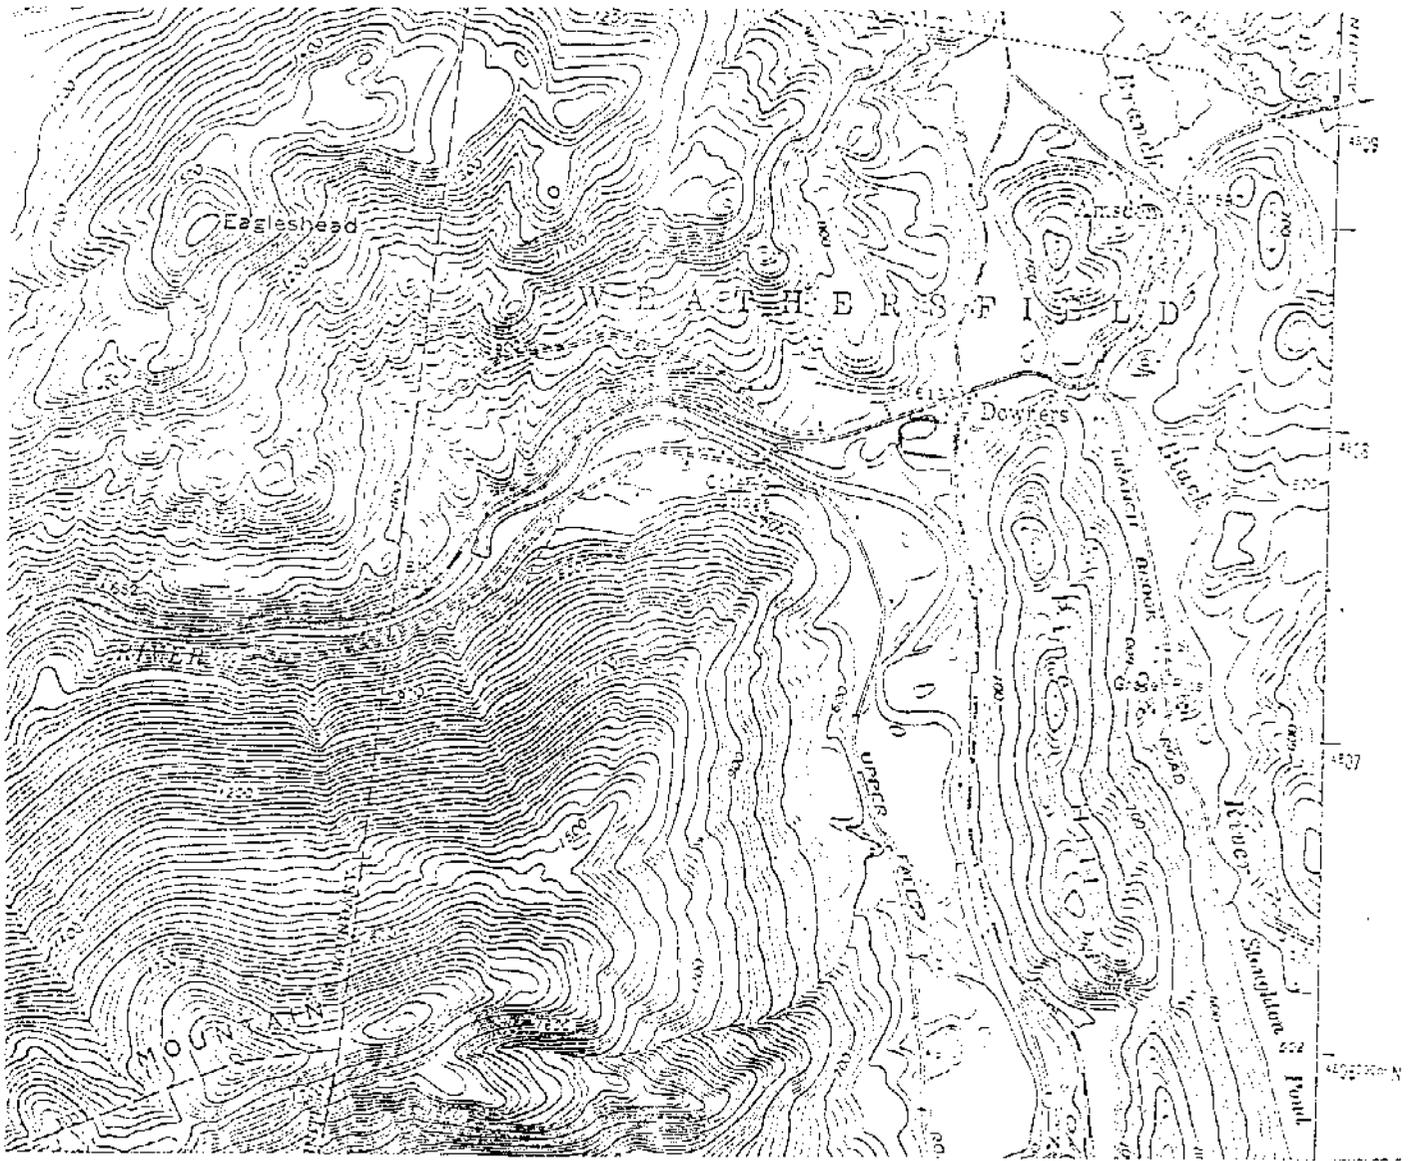
**APPENDIX B  
 SITE TOPOGRAPHY**

SCALE 1:24 000

CONTOUR INTERVAL 20 FEET  
 NATIONAL GEODETIC VERTICAL DATUM OF 1929
