# CENTRAL VERMONT – STORMWATER MASTER PLAN

## CALAIS, EAST MONTPELIER, AND WOODBURY, VERMONT

**FINAL REPORT**  
April 30, 2019

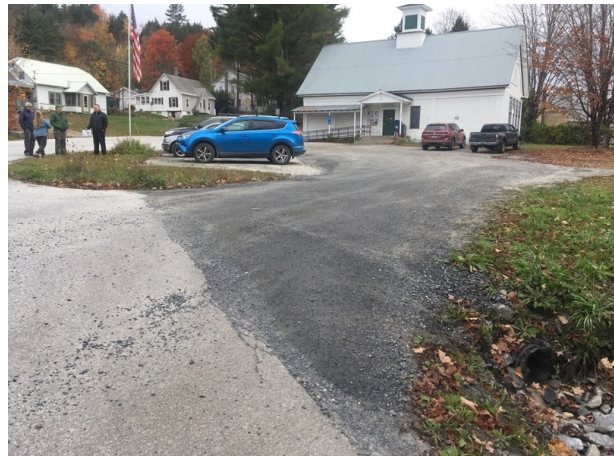
**Figure A9.** The Calais Post Office with greenspace to the left of photo by flagpole.

**Description:** The site includes the Post Office building and associated partially paved parking lot as well as the roadside ditch running south down the western side of Batten Rd. Stormwater is currently collected in a series of culverts that drain to the Kingsbury Branch. The concept for this site includes redirecting drainage from Batten Rd to an underground storage and infiltration chamber system located in the greenspace by the flagpole (see Figure A9). Soils are mapped as being very good at this site (Hydrologic Group A), so an analysis was conducted to evaluate the potential for an infiltration practice. Soils were found to be generally sandy.

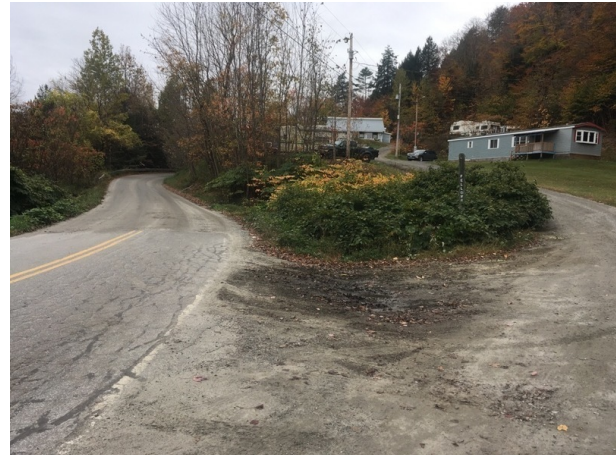
**Figure A10.** Greenspace at intersection of Moscow Woods Rd and Fellows Rd where an infiltration basin would be located.

**Description:** The site includes Moscow Woods Rd and Fellows Rd. Stormwater currently collects at the intersection and is drained by a cross culvert under Moscow Woods Rd to the large eroded gully across the street. The gully eventually drains to the Kingsbury Branch. The concept for this site includes constructing an infiltration basin in the existing greenspace at the intersection of Moscow Woods Rd and Fellows Rd and stabilizing the gully near where it enters Kingsbury Branch (see Figure A10). Soils are mapped as being very good at this site (Hydrologic Group A), so an analysis was conducted to evaluate the potential for an infiltration practice. Soils were found to be generally sandy.

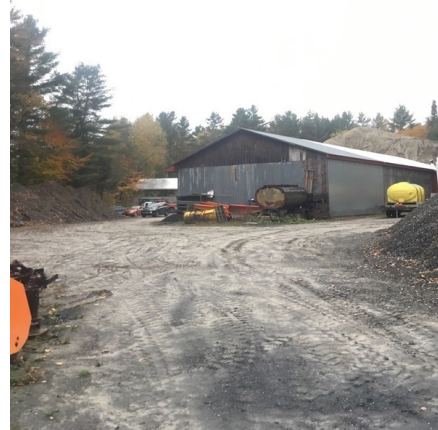
**Figure A12. An infiltration basin is proposed for the Calais Town Garage site.**

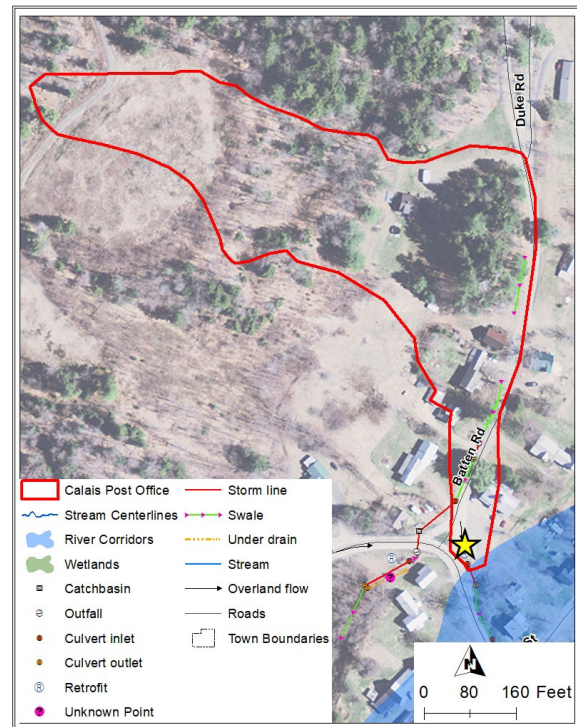
**Figure A14.** The proposed BMP drainage area is shown in red for the Calais Post Office. The recommended BMP location is shown with a star.

The proposed retrofit for this site is to implement a subsurface infiltration chamber system under the greenspace between the Post Office’s parking lot and Moscow Woods Rd (see starred location in Figure A14). The 5.5-acre drainage area for the proposed BMP is shown with a thick red line in the map above (Figure A14). It is recommended that an educational sign is installed in conjunction with this system to educate Post Office patrons and the general public. A new pipe connection is proposed to direct drainage from the ditch along Batten Rd to the system. The system will overflow to the existing ditch along Moscow Woods Rd. There is potential to regrade the parking lot to better direct runoff to system. Construction should be planned so that one entrance to the Post Office parking lot remains open at all times during business hours. See the photos and associated descriptions in Figure A15. The Calais Recreation Association, who own the property where the Post Office is located, have expressed their preliminary willingness to proceed with further design. Additional coordination with the Calais Recreation Association and a formal agreement will need to be obtained during the Final Design phase. Permission has been requested from the United States Post Office and is currently pending.

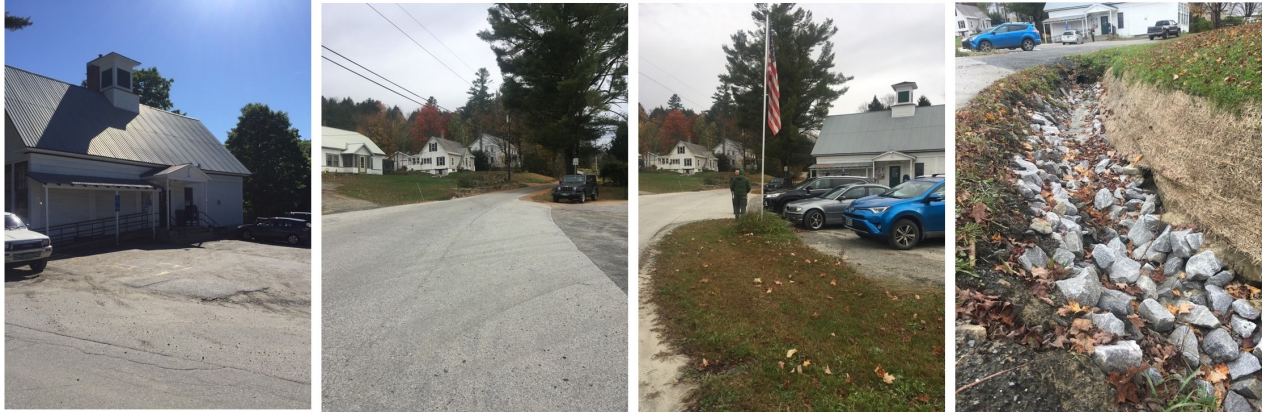
Stormwater from the Post Office runs over the pavement into a culvert, down a ditch along Moscow Woods Rd and into the Kingsbury Branch.

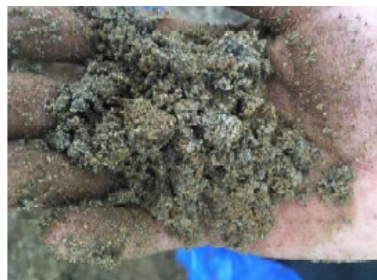
**Figure A17. Soils at the Calais Post Office were generally sandy.**

Soils are mapped as being very good at this site (Hydrologic Group A), so an analysis was conducted to evaluate the potential for an infiltration practice. Soils were assessed using a hand auger (Figure A16) and were found to be generally sandy and appropriate for infiltration (Figure A17). The soil profile with photos can be found in Appendix A14.

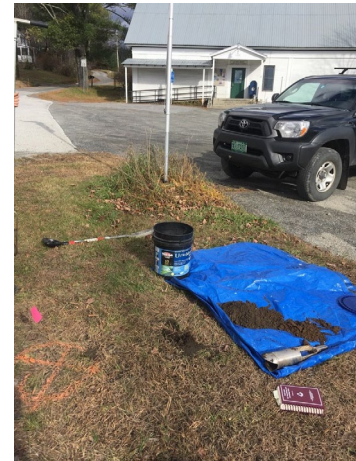
**Figure A16. Soils were assessed in the greenspace adjacent to the Post Office where the proposed infiltration practice would be located.**

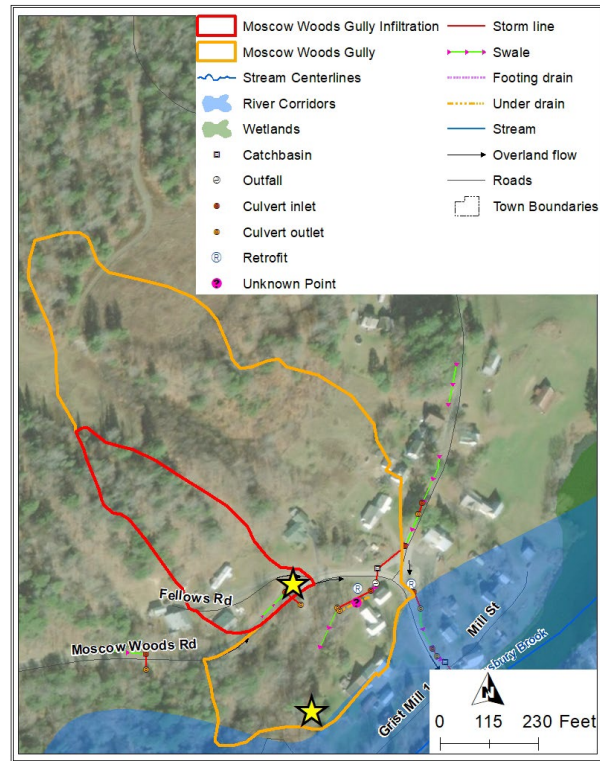
**Figure A18. The drainage area for the proposed BMP is shown in red. The recommended locations for the BMPs are shown with stars.**

The main concept for this site includes two practices. The first is to construct an infiltration basin west of the intersection of Fellows Rd and Moscow Woods Rd and add a dry well in the bottom of the basin (see starred location within the red drainage area on the map in Figure A18). The dry well will both provide additional storage and allow drainage to infiltrate when the ground surface is frozen and infiltration is not possible in the basin. As part of this proposed design, Moscow Woods Rd would be regraded to elevate the south side to better direct runoff to basin. The ditching along the north side of Moscow Woods Rd should be formalized and stabilized with stone. The eroding ditch along south side of Fellows Rd should also be stabilized and lined with stone. This ditch will also be directed to the basin. The second part of this design includes stabilizing gully erosion below the culvert outlets. (see starred location within the orange drainage area on the map in Figure A18). The infiltration practice would also reduce the volume of stormwater that is directed to this eroding gully. See the photos and associated descriptions in Figure A19. The landowner where the gully stabilization is proposed, John Risse, has expressed his willingness to proceed with further design. Additional outreach should be carried out to ensure that all impacted property owners by the proposed Fellows Rd infiltration basin are amenable to the retrofit.

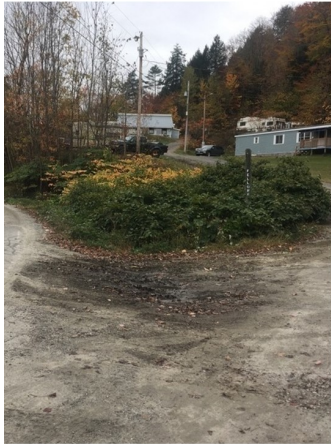
Proposed location for an infiltration basin. Stormwater collects in this area and is piped across the street to an eroding gully.

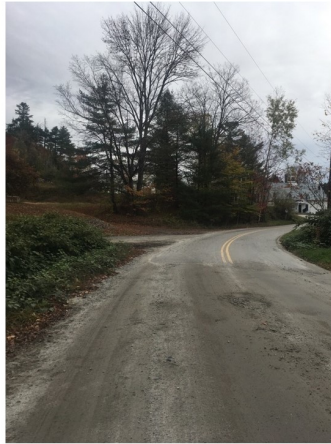
Drainage from Moscow Woods Rd is causing erosion in the same gully that receives drainage from Batten Rd by the Post Office (pictured).

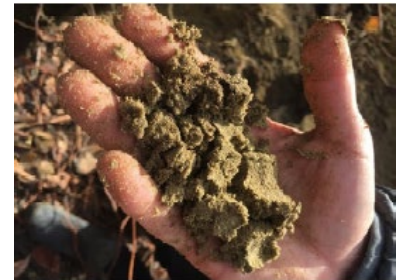
**Figure A20. Soils were generally sandy.**

Soils are mapped as being very good at this site (Hydrologic Group A), so an analysis was conducted to evaluate the potential for an infiltration practice. Soils were assessed using an excavator (Figure A21) and were found to be generally sandy (Figure A20). Soils conditions observed during analysis were appropriate for an infiltration-based practice. The soil profile with photos can be found in Appendix A14.

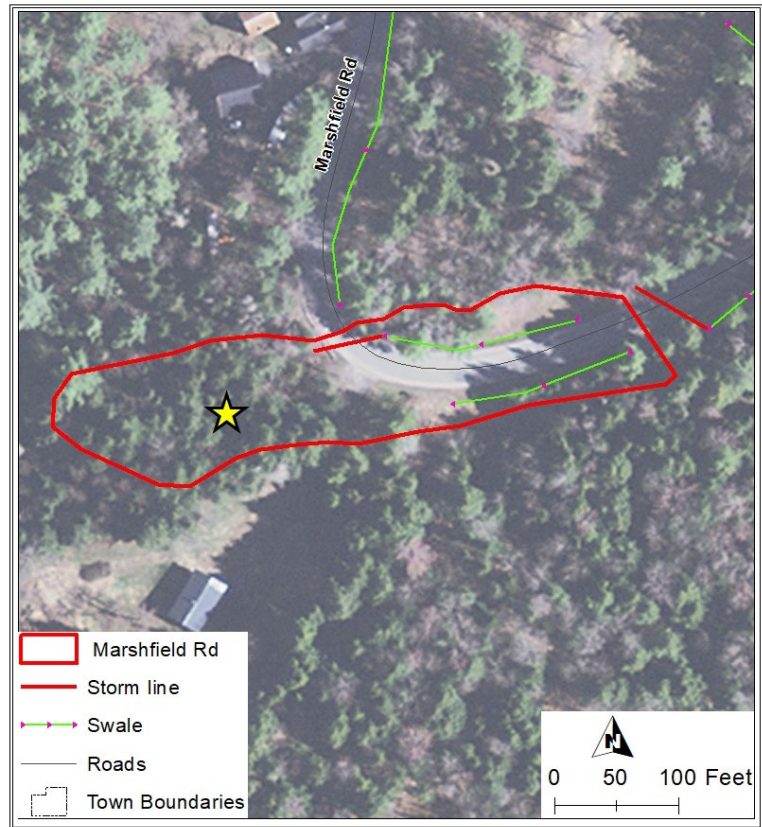
**Figure A22.** The Marshfield Rd drainage area is shown outlined in red. The recommended location for the proposed gully stabilization is shown with a star.

The proposed retrofit includes improving ditching with check dams above culvert inlet. Stabilize gully below culvert outlet including a series of step pools (see starred location in Figure A22). See the photos and associated descriptions in Figure A23. Owners of the adjacent house have expressed their willingness to proceed with further design.

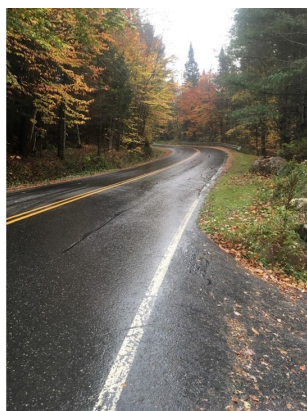
Marshfield Rd is steep and winding. Stormwater is collected in roadside ditching.

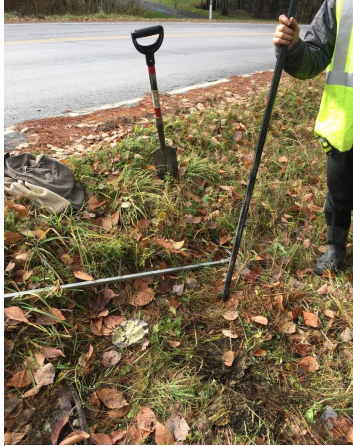
**Figure A25.** A hand auger and shovel were used to assess soil conditions and infiltration potential.

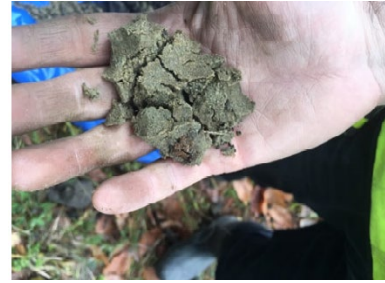
**Figure A24.** Soils were generally loamy.

Soils are mapped as being very good at this site (Hydrologic Group A), so an analysis was conducted to evaluate the potential for an infiltration practice. Soils were assessed using a shovel and hand auger (Figure A25) and were found to be generally loamy with a high percentage of silt (Figure A24).

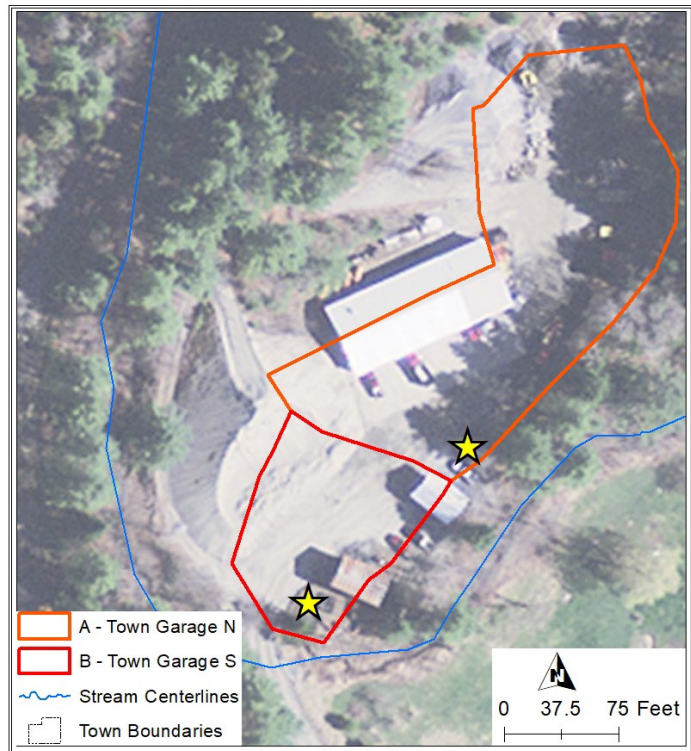
**Figure A26. Drainage areas for the Calais Town Garage site are shown outlined in orange (infiltration basin) and red (ditch improvements and potential dry well). The recommended location for each BMP is shown with a star.**

The Calais Town Garage is located off of VT-14 between Balentine Rd and Lamberton Camp Rd. This site includes the garage building, tank shed, salt shed, equipment and materials storage, and a large sand pile. Tributaries run south and east of the site and eventually pass through a cross culvert under VT-14 and into a tributary of the Kingsbury Branch without treatment. Stormwater from the garage building collects in a low point in the gravel parking lot and over the bank to a tributary. Stormwater from the area around the salt shed drains along the eastern edge of the driveway to a tributary. Erosion was observed where runoff flows from the driveway into the stream. Salt residue was also observed around the front of the salt shed.

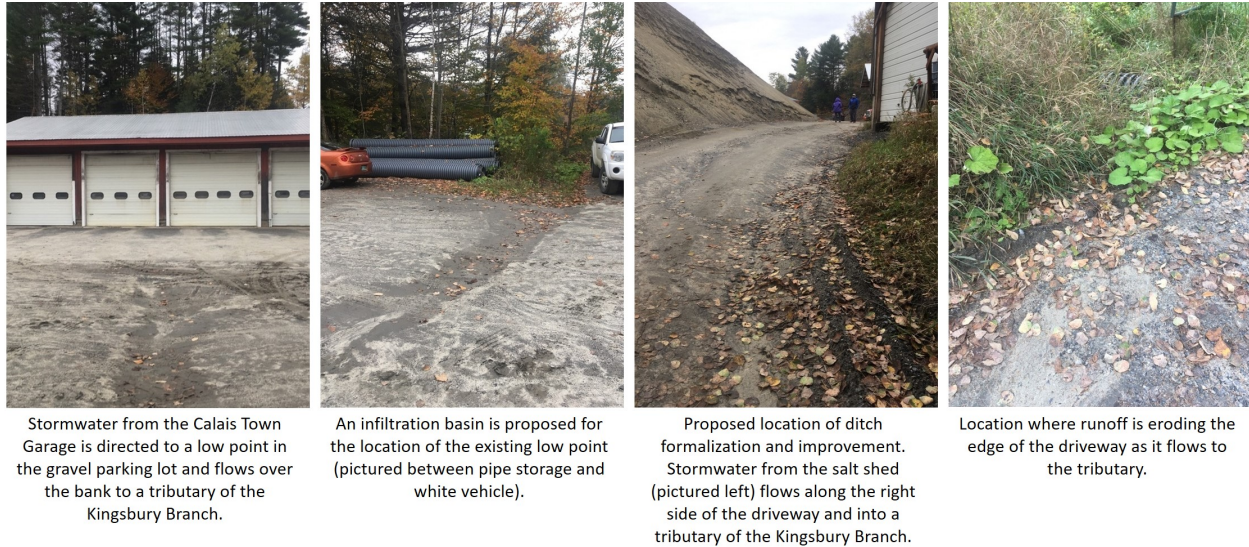
Stormwater from the Calais Town Garage is directed to a low point in the gravel parking lot and flows over the bank to a tributary of the Kingsbury Branch.

**Figure A27. The proposed retrofits are described in the above photos.**

The concept for this site includes moving pipes (currently stored in this location) and formalizing the existing depressed area as an infiltration basin in the parking lot, burying a perforated pipe along the bottom of the basin and creating a stone lip along the easternmost edge of the basin for overflow (see starred location on the right in Figure A26). Regrading the parking lot to better direct drainage to the basin as necessary is also recommended as well as regrading and resurfacing the driveway with Staymat. A swale should be formalized along the eastern edge of the driveway below the salt shed, lining it with stone, and adding check dams. Additionally, a paved apron is recommended for the salt shed in order to facilitate cleanup of salt spills. There is existing erosion where runoff currently enters the stream (see starred location on the left in Figure A28) that should be stabilized. It is also recommended that a retaining wall along the stream west of the sand pile be added to prevent sand spillage and sediment transport. See the photos and associated descriptions in Figure A27.

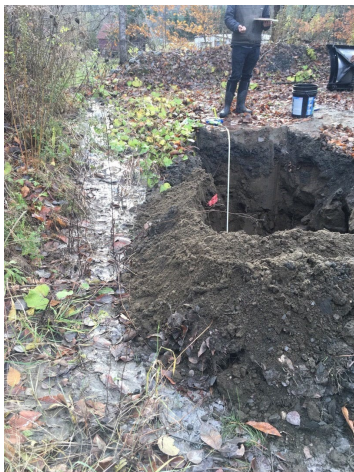
**Figure A28. An excavator was used to assess soil conditions and infiltration potential.**

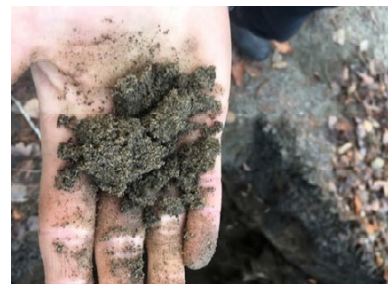
**Figure A29. Soils were generally sandy.**

Soils are unmapped at this site, but surrounding soils are mapped as being very good (Hydrologic Group A), so an analysis was conducted to evaluate the potential for an infiltration practice. Soils were assessed using an excavator (Figure A28) and were found to be generally sandy (Figure A29). Soils conditions observed during analysis did not prompt a need to alter the proposed retrofit design. Note that the buried garbage will need to be removed from this location or the basin will need to be lined. See Appendix A14 for this site’s complete soil log.

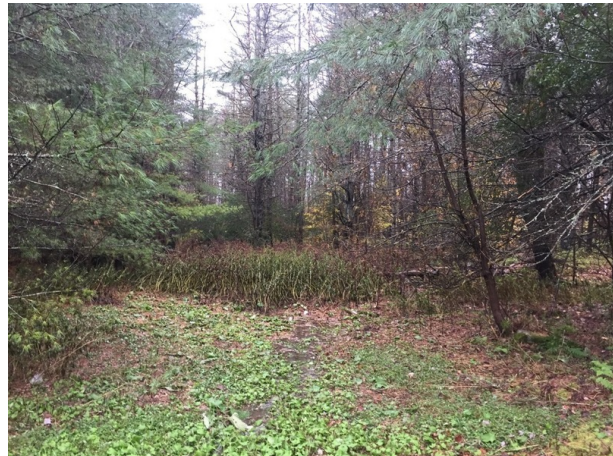
Figure B9. Stormwater draining to the pictured greenspace will be treated in a gravel wetland.

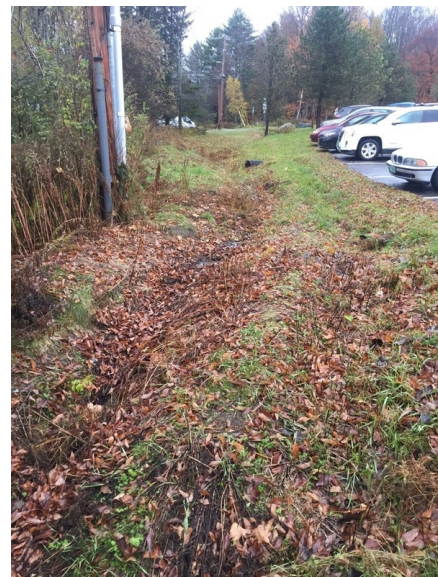
Figure B10. Stormwater draining from the pictured swale will be treated in a gravel wetland.

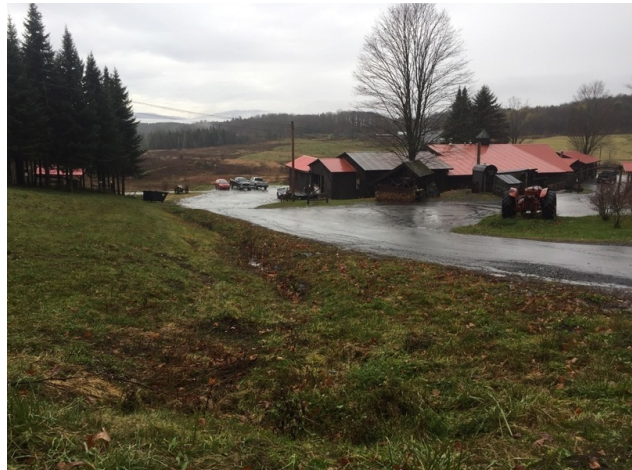
**Figure B11.** A gravel wetland will treat stormwater runoff from the Morse Farm Maple Sugarworks property.

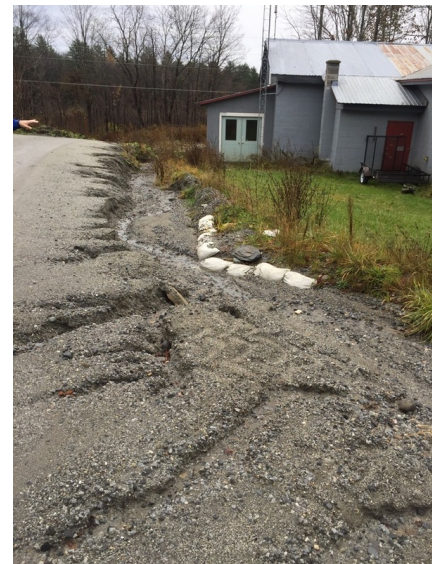
**Figure B12.** Sediment traps are proposed at the Town Garage and Fire Station site.

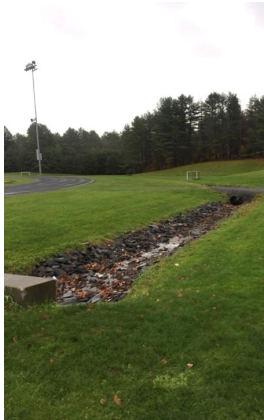
Stormwater from the school is directed to a series of swales south of the track. Drainage from the swales flows to a low point beyond the tree line.

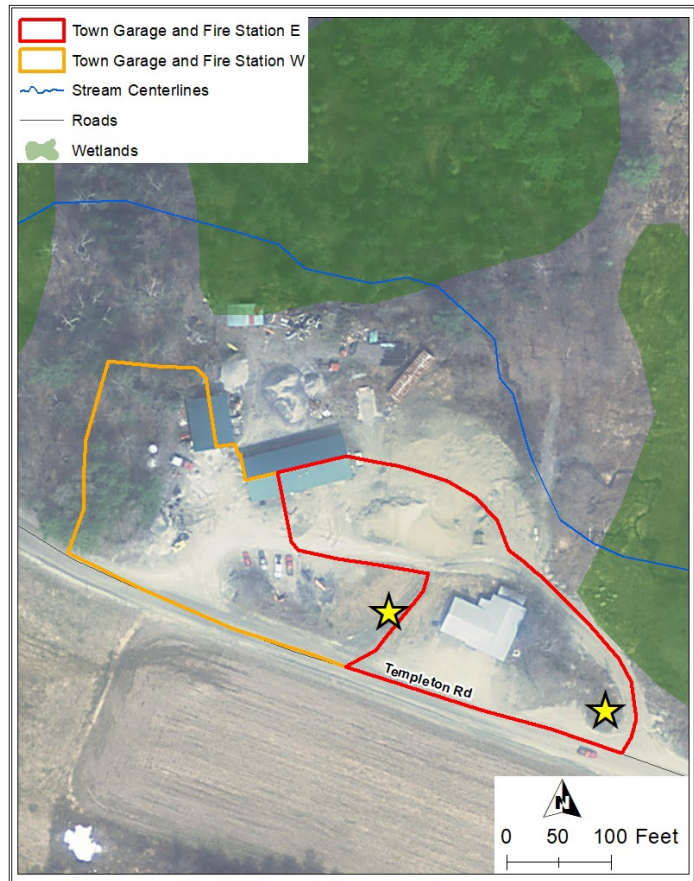
**Figure B20. The two proposed sediment traps are shown with yellow stars. The drainage areas for these two practices are shown in orange (west) and red (east).**

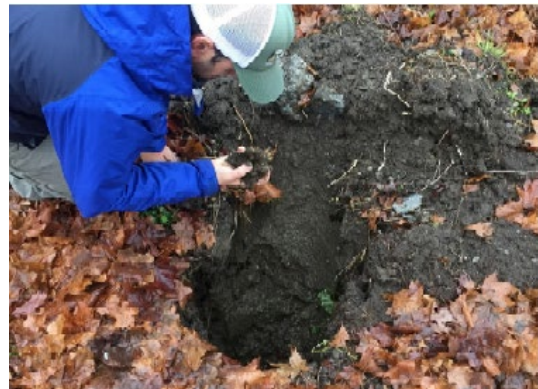
**Figure B24. Soils were generally loamy.**

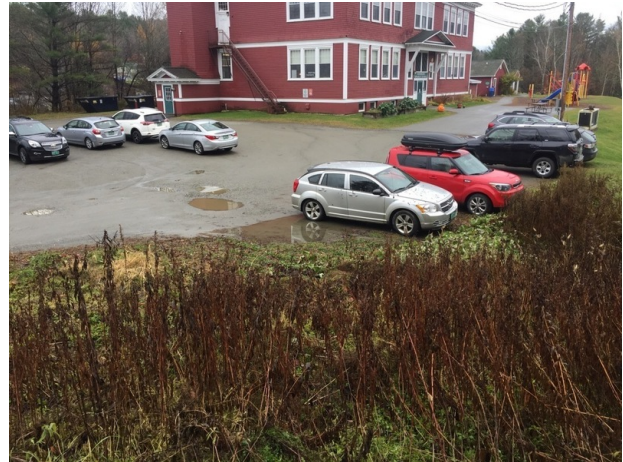
**Figure C9.** Stormwater runoff from the Woodbury School’s parking lot will be treated in a gravel wetland.

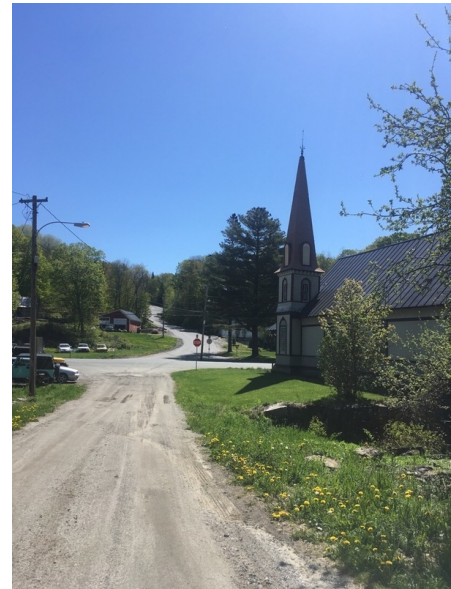
**Figure C10.** A subsurface chamber system and sediment trap will treat runoff from Church St.

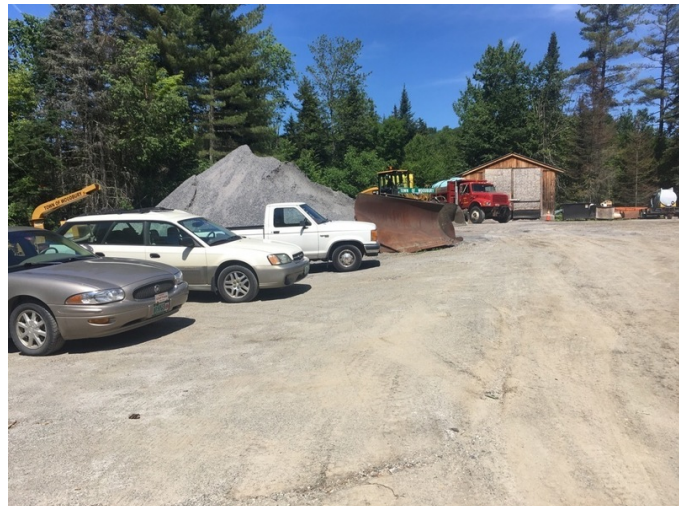
**Figure C11.** A sediment trap or sedimentation basin will treat runoff from the Woodbury Garage site.

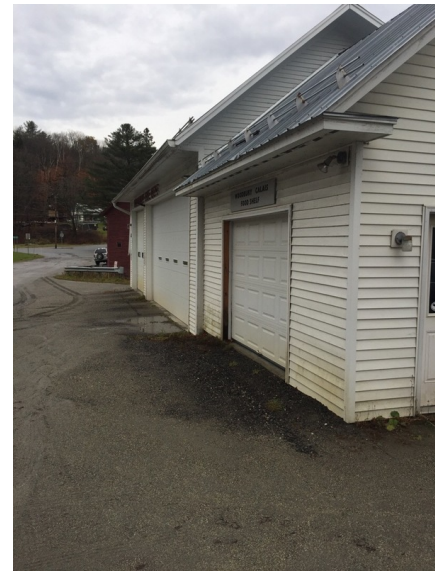
**Figure C12.** A subsurface chamber system is proposed to treat runoff from the Fire Department & Food Shelf site.

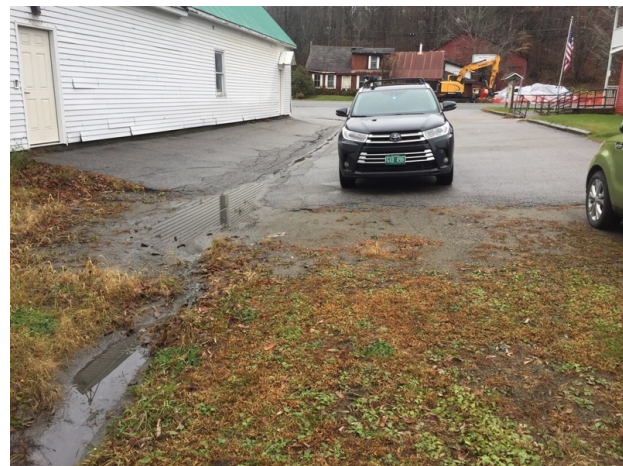
**Figure C13.** A subsurface chamber system is proposed to treat runoff from the Fire Station and Post Office site.

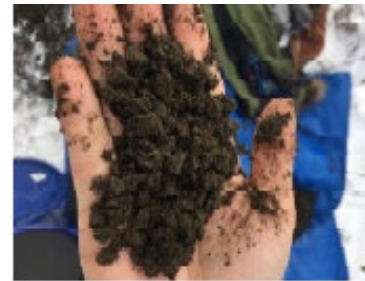
**Figure C16. Soils were generally loamy.**

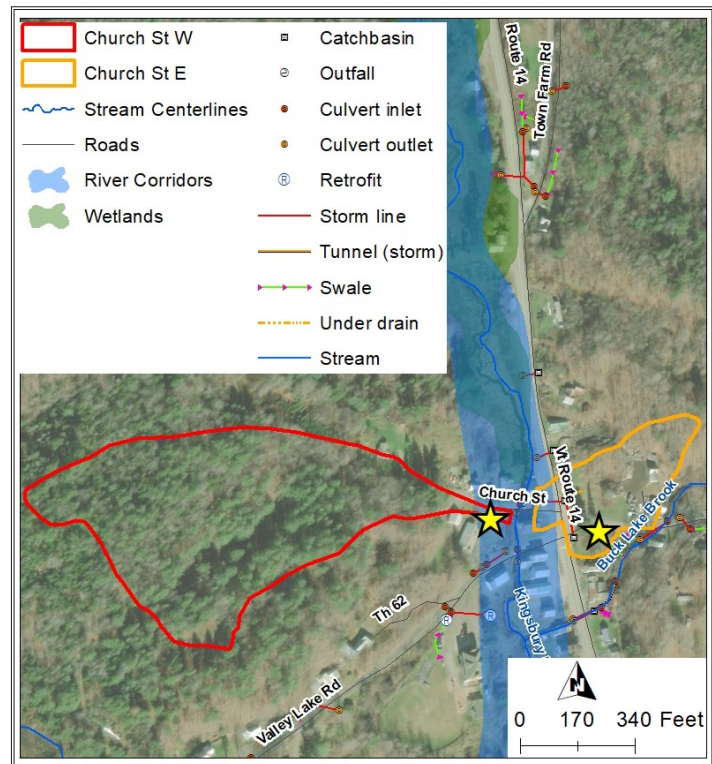
**Figure C18. A subsurface chamber system and sediment basin are proposed to manage drainage from Church St and the surrounding area. The recommended location for each BMP locations is shown with a star.**

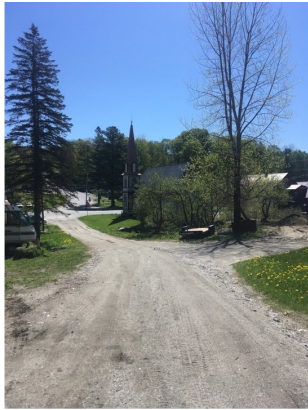
Church St drains to the Kingsbury Branch. A sediment trap is proposed after the driveway by the tree on the right.

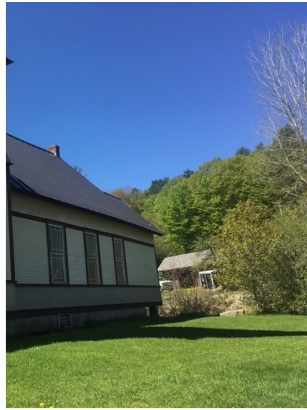
A subsurface infiltration chamber system is proposed along the road in the lawn north of the church.

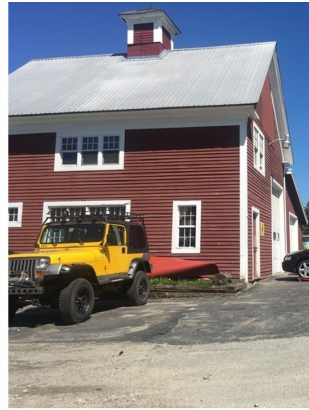
A new catchbasin and pipe connection at the garage will direct stormwater to the new subsurface system.

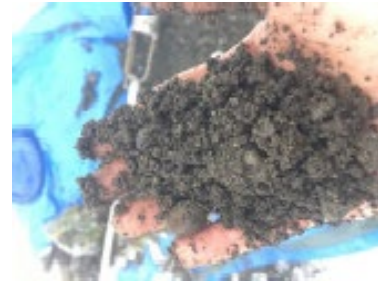
**Figure C21. Soils were generally loamy with many coarse fragments.**

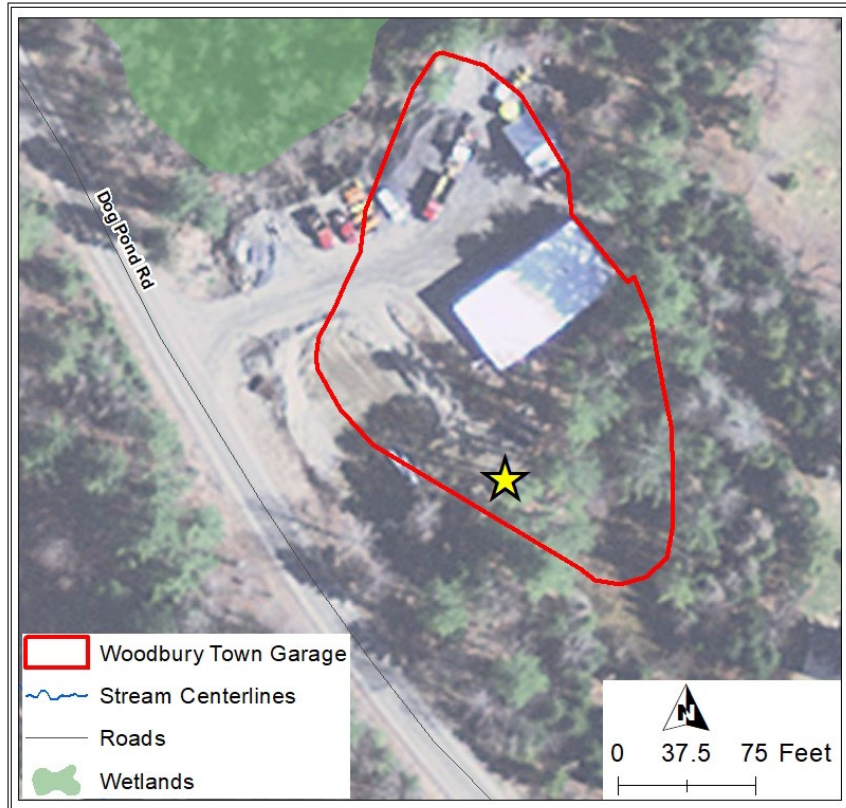
**Figure C22.** The drainage area for the proposed BMP is shown in red and the location of the BMP is shown with a star.

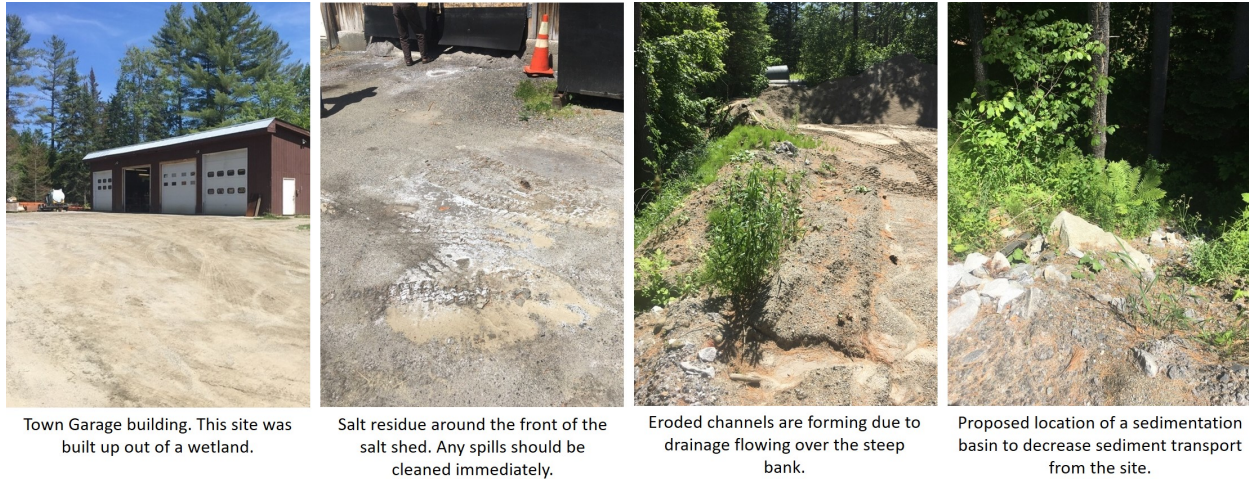
Town Garage building. This site was built up out of a wetland.

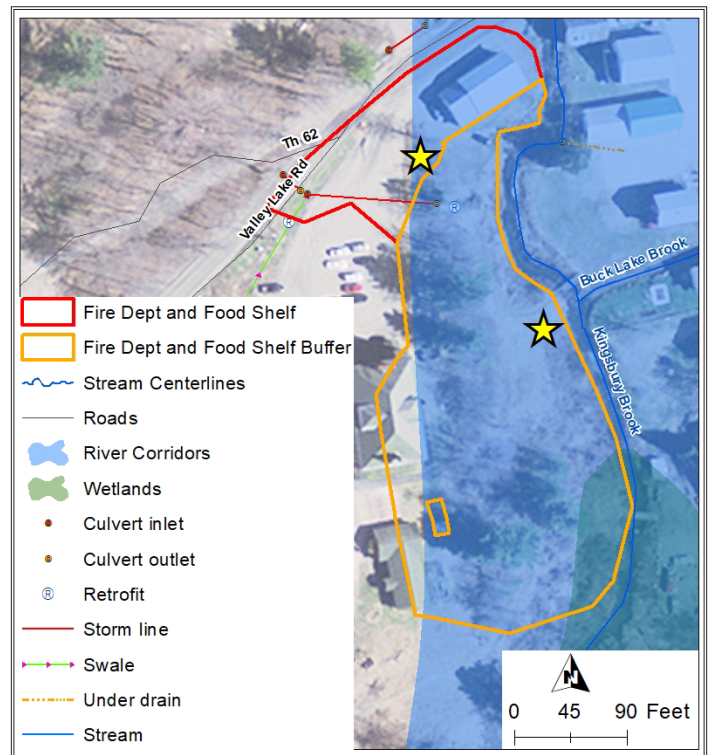
**Figure C24. The proposed drainage areas for the subsurface infiltration chambers (red drainage area) and riparian buffer (orange drainage area) are shown.**

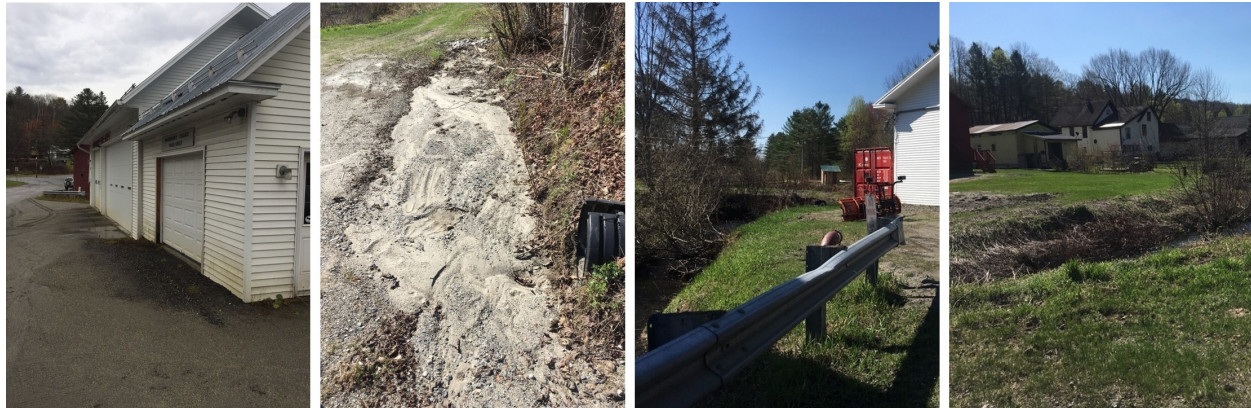
The Women’s Auxiliary Fire Department and Woodbury’s Food Shelf share a building on Valley Lake Rd. Gutters from the roof will be directed to a proposed dry well located behind the building.

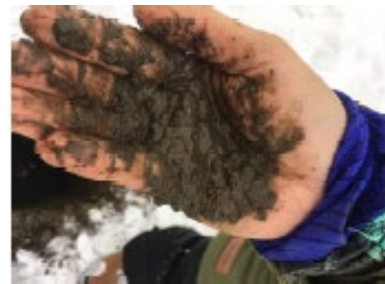
**Figure C27. Soils were generally loamy with many coarse fragments.**

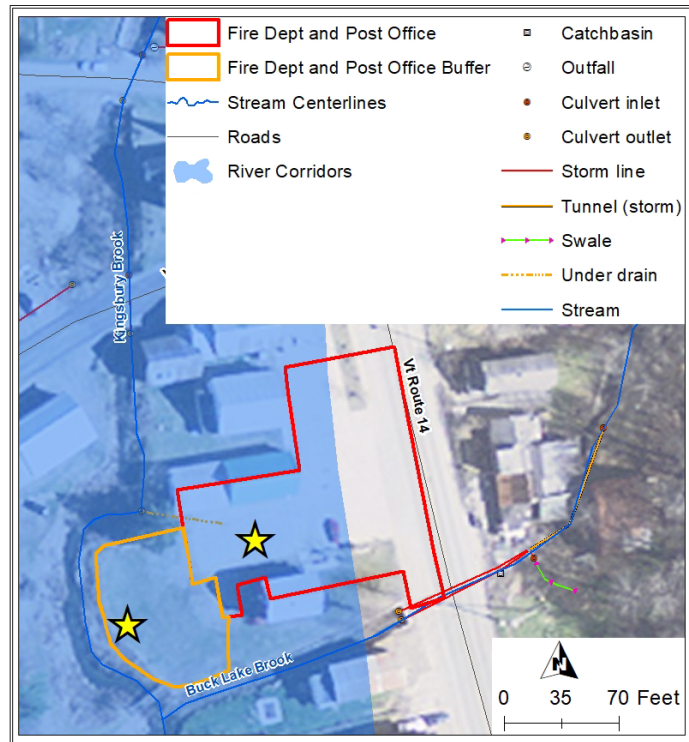
**Figure C28. Proposed retrofits include subsurface infiltration (red drainage area) and a riparian buffer improvement (orange drainage area).**

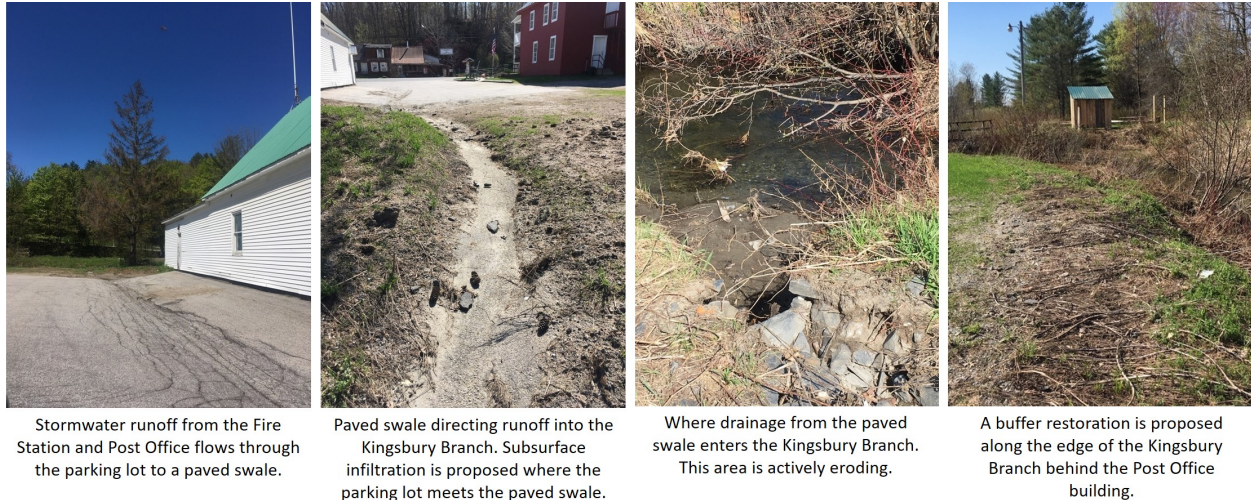
Stormwater runoff from the Fire Station and Post Office flows through the parking lot to a paved swale.

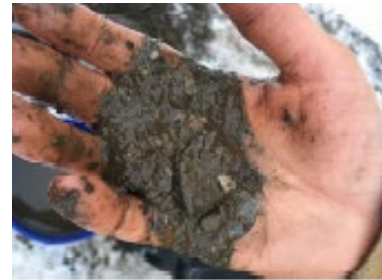
**Figure C31. Soils were generally sandy and loamy.**
