Re: Initial Site Investigation Report  
Corinth Town Hall Property, 1387 Cookville Road, Corinth, Vermont  
WES Project # 1-0324-1

# Initial Site Investigation

**Corinth Town Hall Property  
1387 Cookville Road  
Corinth, Vermont 05039**

**March 2007**

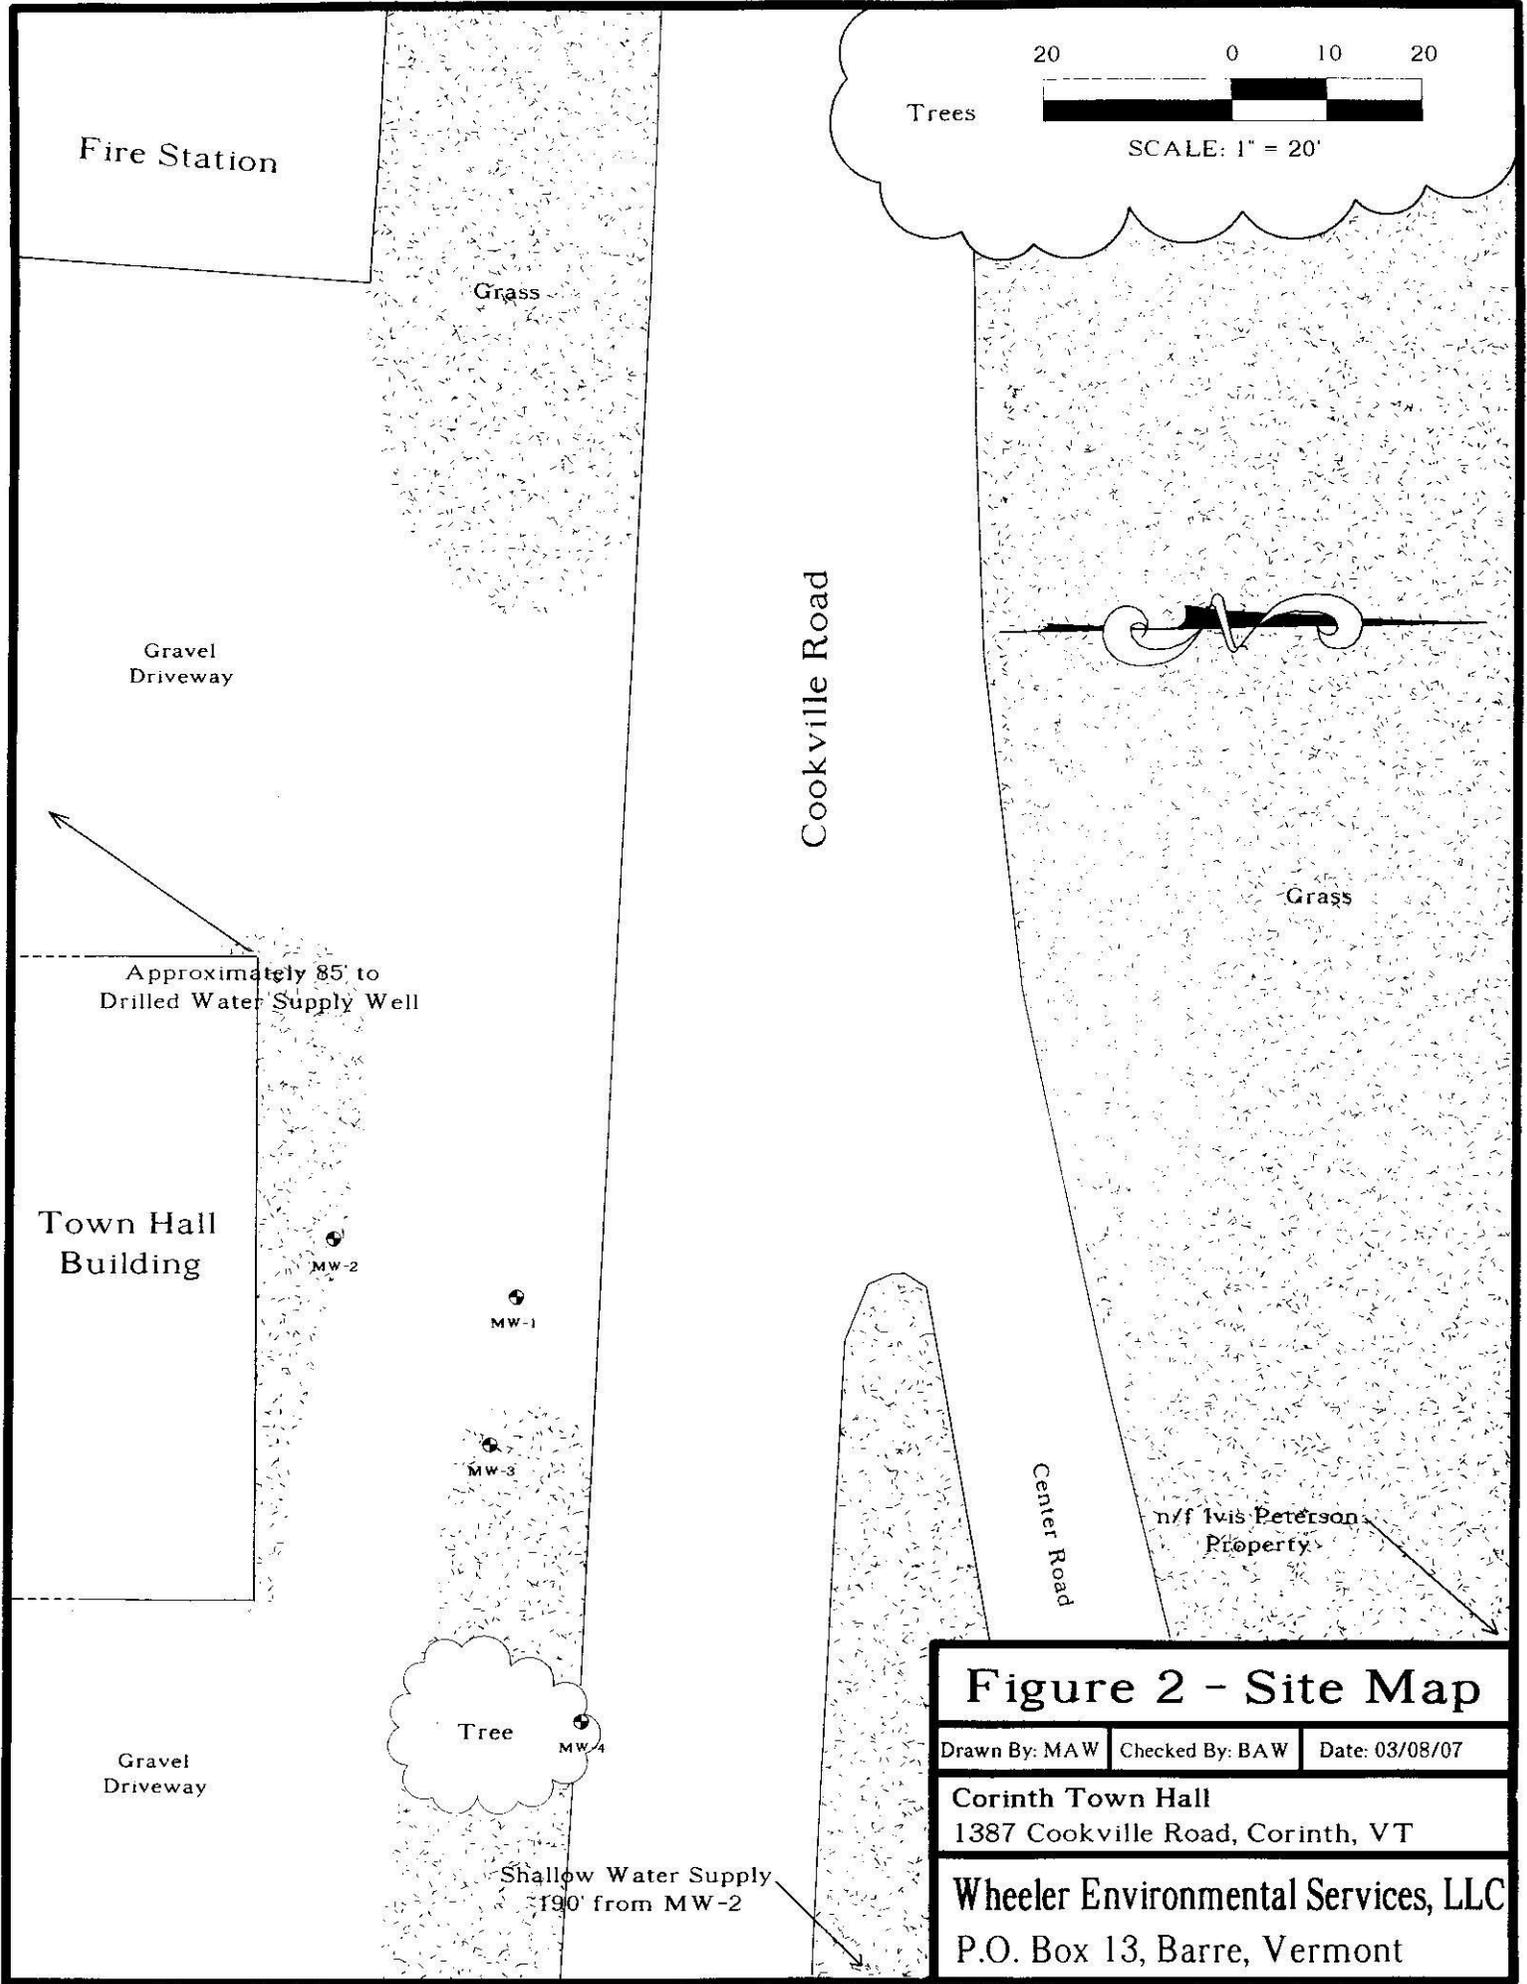
## Figure 2 - Site Map

The work performed and the results obtained are described and summarized below. The locations of the borings and groundwater monitoring wells are shown on Figure 2 – Site Map.

Monitoring well MW-1 is located at the edge of Cookville Road, approximately 30 feet north of the Town Hall building. The total depth of this boring is 14 feet. Groundwater was encountered in this boring at approximately 6 feet bgs.

Monitoring well MW-2 is located in the former UST location. The total depth of this boring is 9 feet. Groundwater was encountered in this boring at approximately 6 feet bgs.

Monitoring well MW-3 is located approximately 25 feet north of the Town Hall building and 16 feet east of monitoring well MW-1. The total depth of this boring is 14 feet. Groundwater was encountered in this boring at approximately 6 feet bgs.

Monitoring well MW-4 is located approximately 36 feet northeast of the northeast corner of the Town Hall building and 31 feet east of monitoring wells MW-3. The total depth of this boring is 12 feet. Groundwater was encountered in this boring at approximately 6 feet bgs.
