SPOILS MANAGEMENT PLAN

BENNINGTON PFOA REMEDIATION TRENCH SPOILS DISPOSAL SITES

MS&K, Inc.
P.O. Box 139
Bennington, VT 05201

Original Document: October 17, 2017

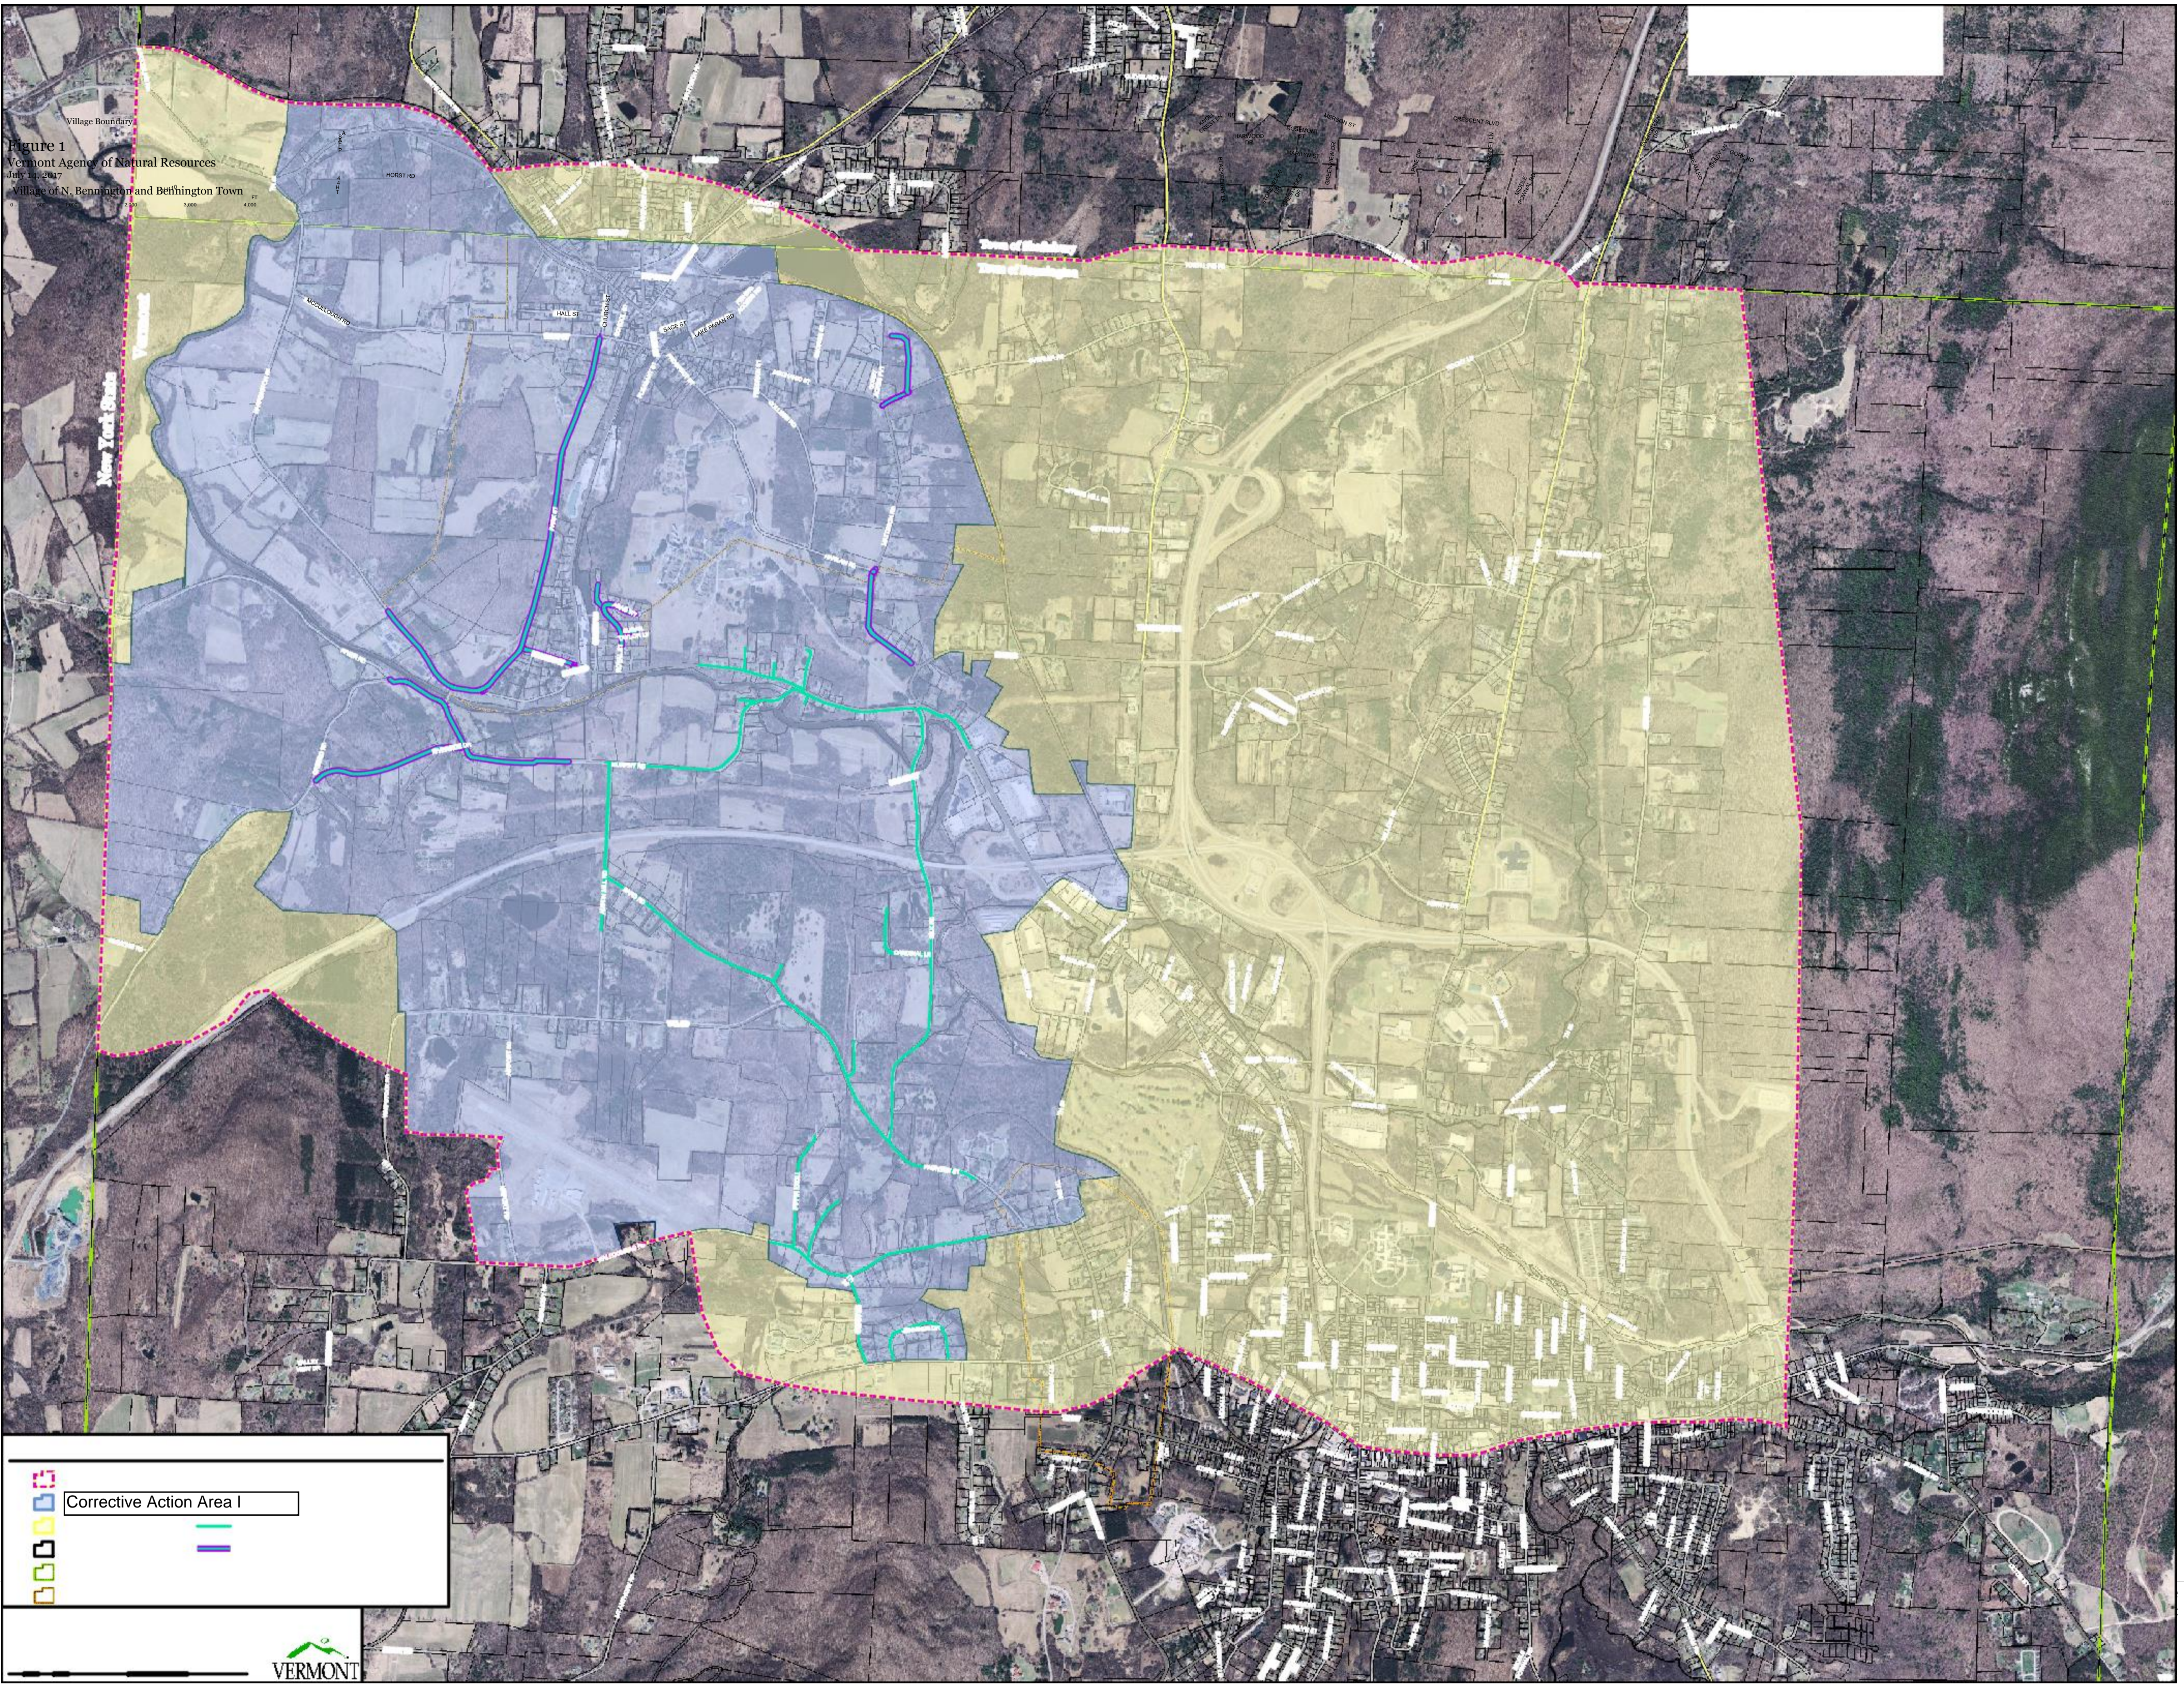
Figure 1
Vermont Agency of Natural Resources
July 14, 2017
Village of N. Bennington and Bennington Town

- Corrective Action Area I

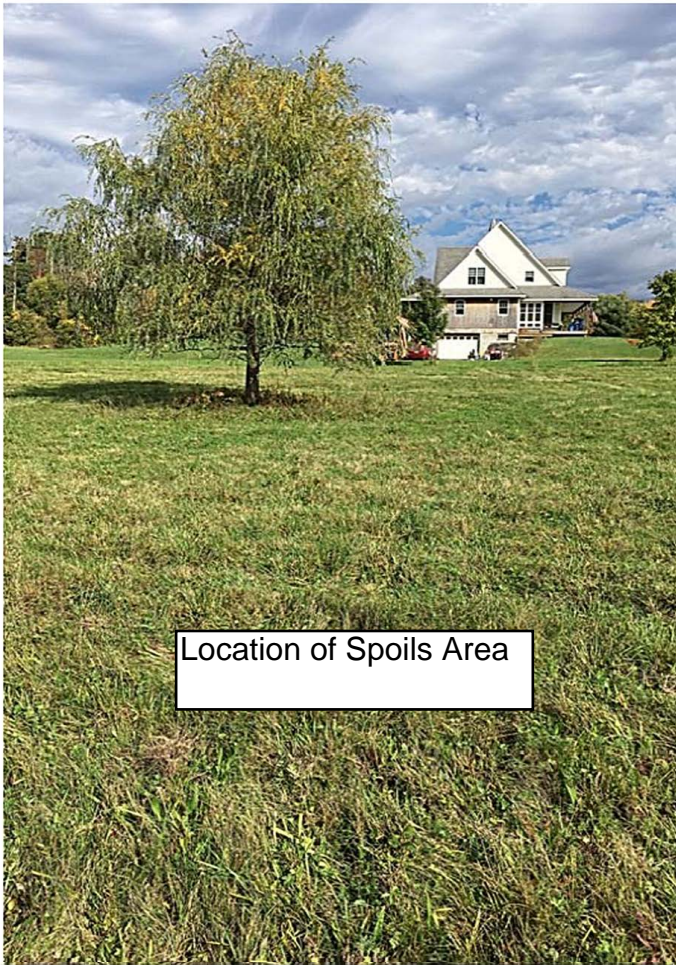
Location of Spoils Area

View to an easterly direction

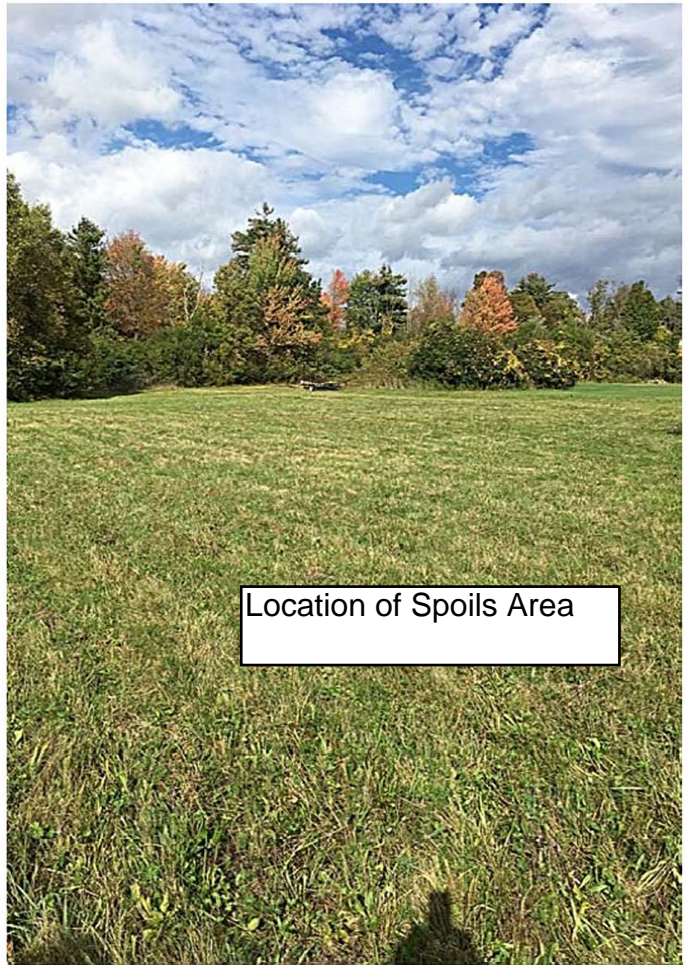
Location of Spoils Area

View to a northerly direction

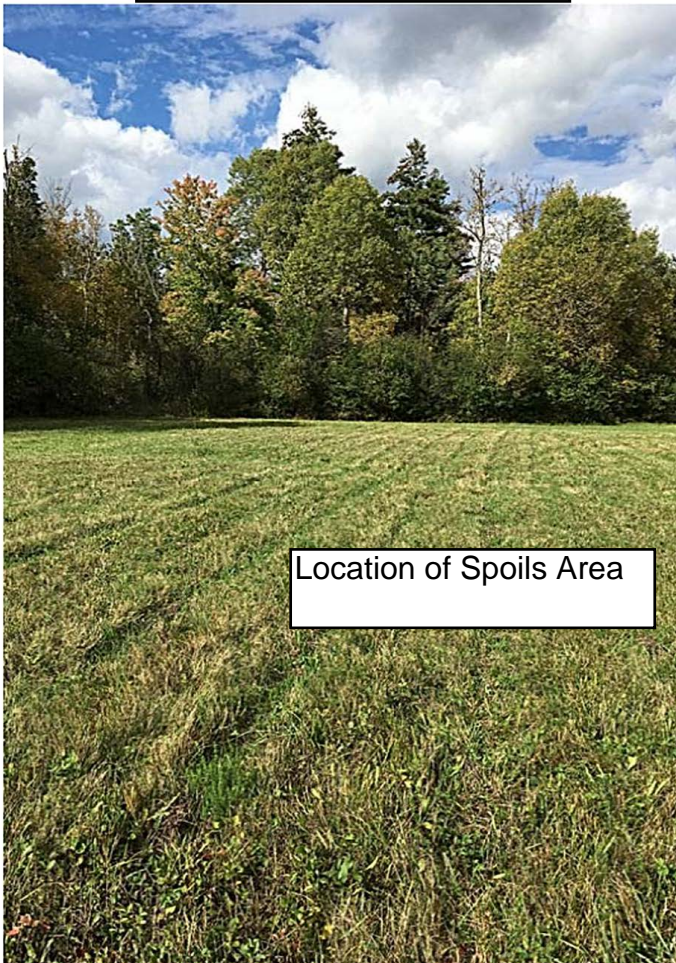
Location of Spoils Area

View to a northerly direction

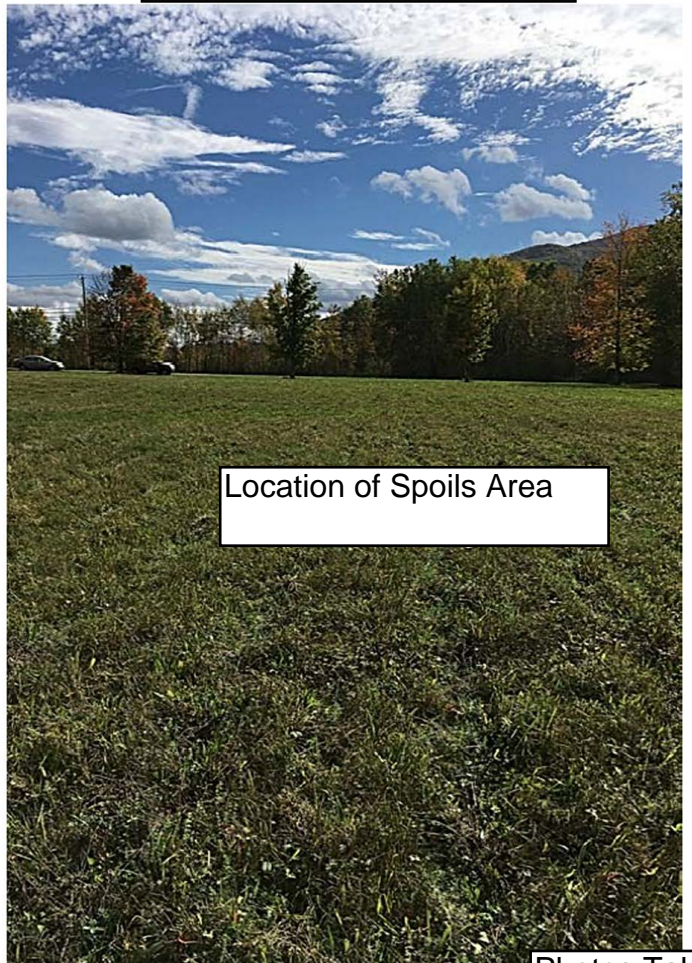
Location of Spoils Area

View to a southerly direction

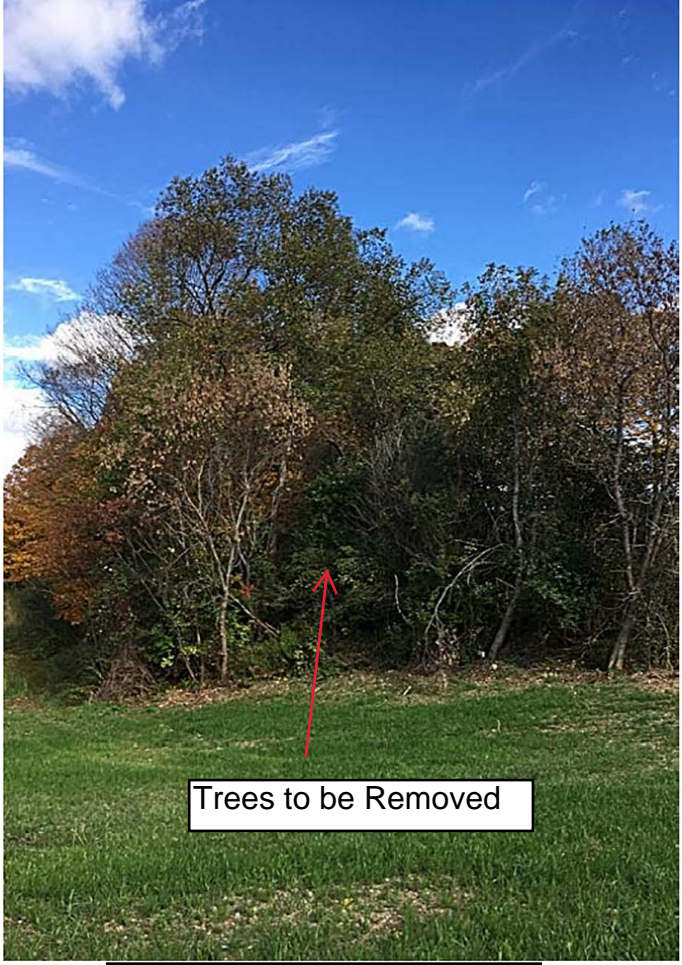
Trees to be Removed

View to a northerly direction

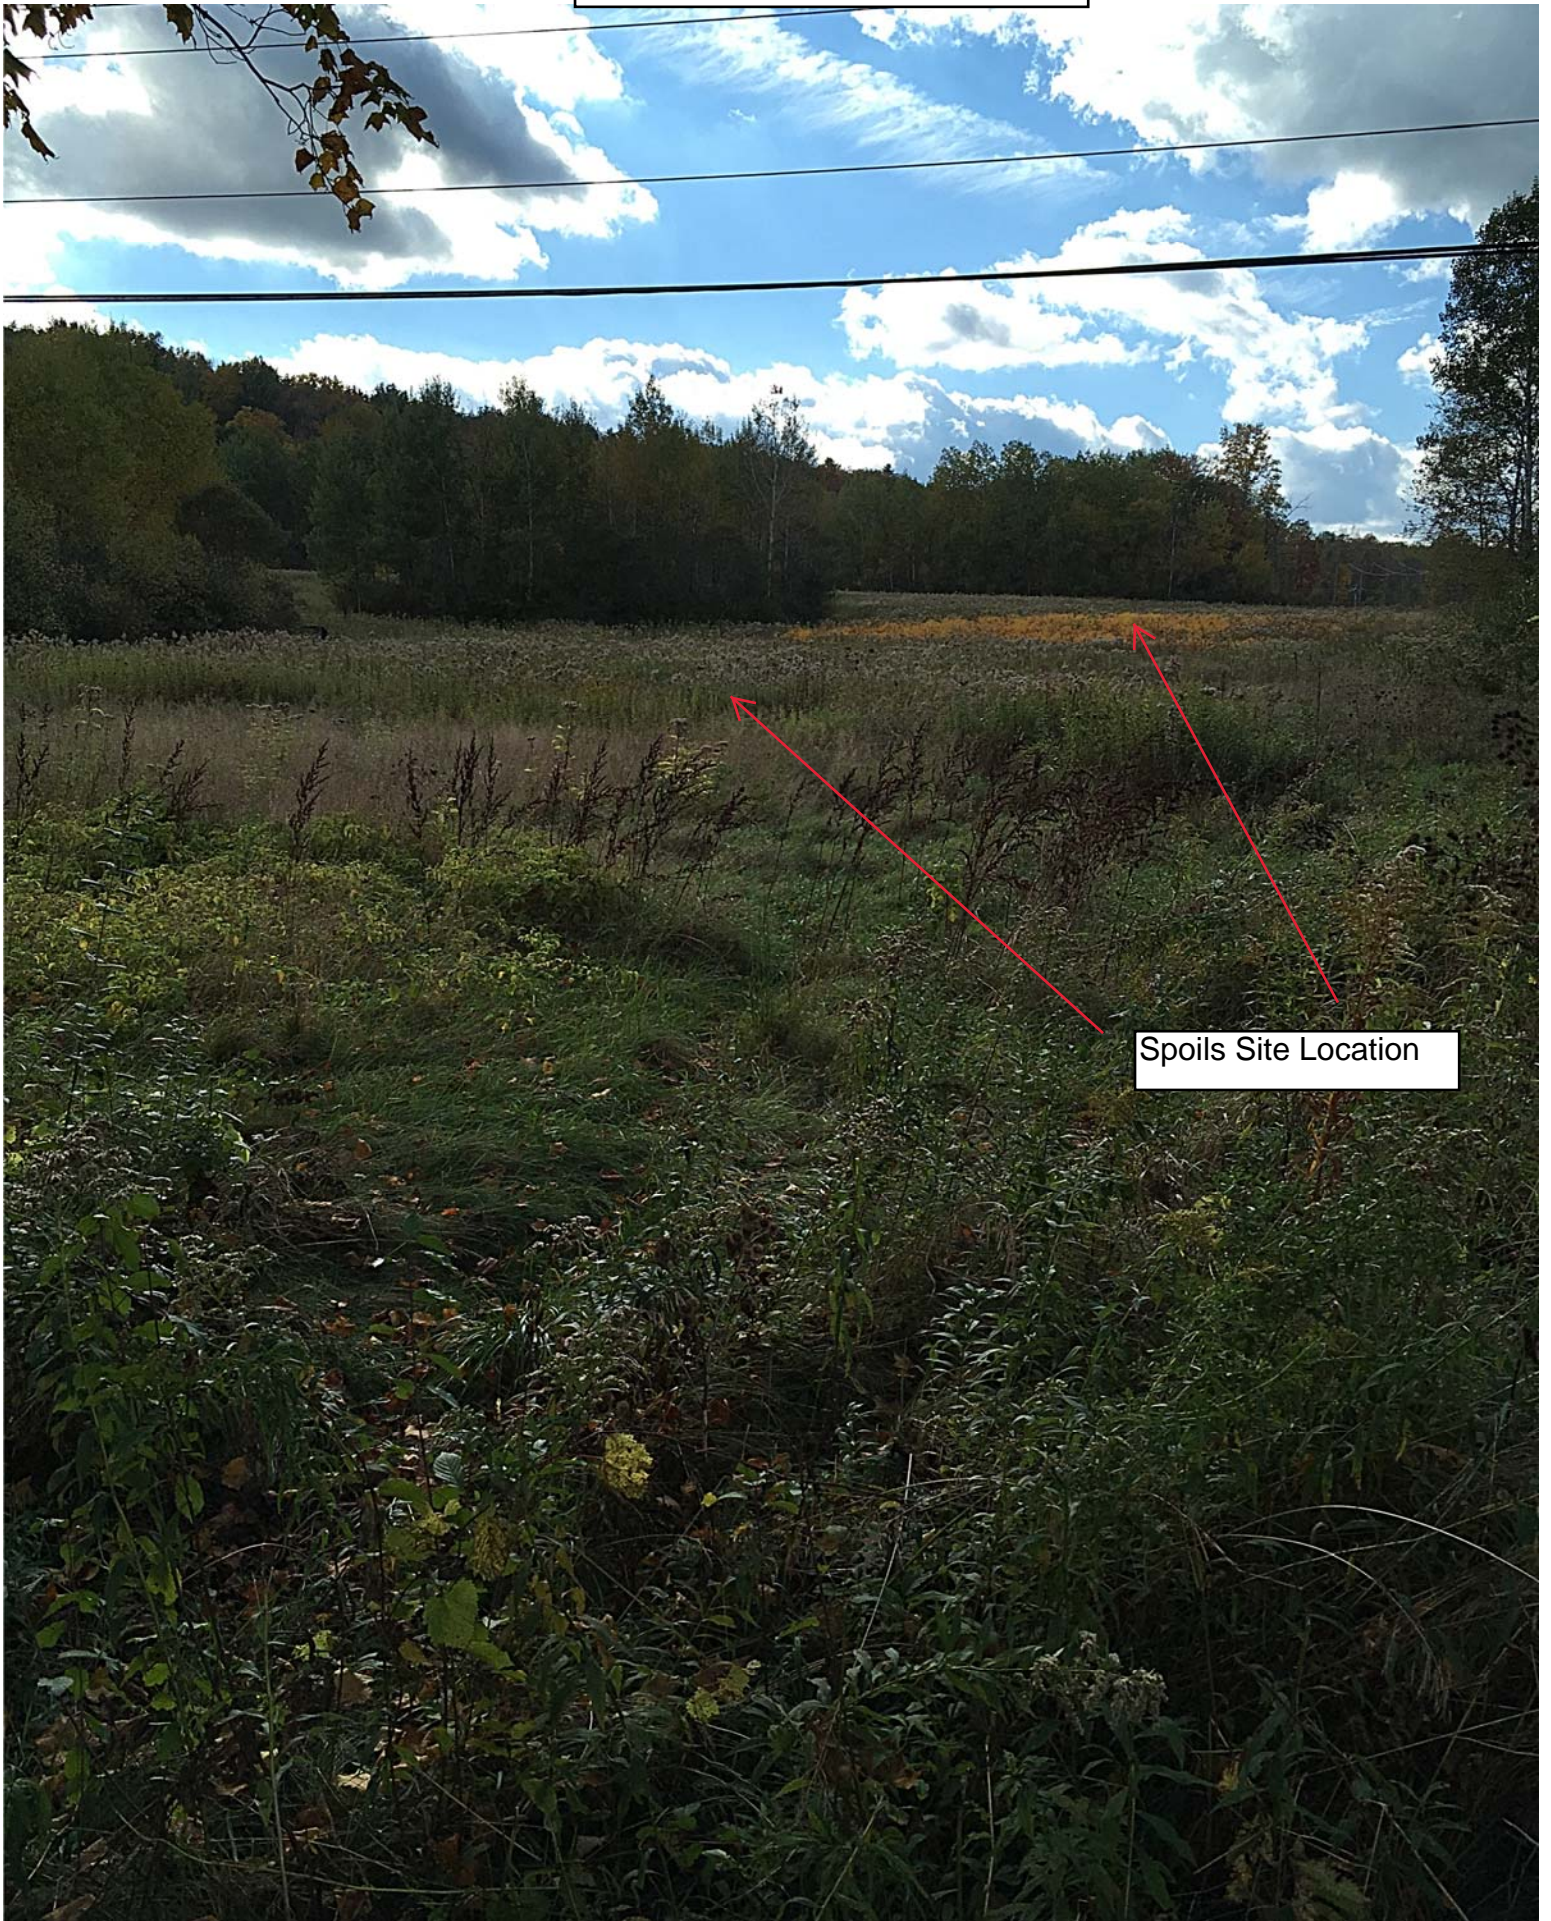
Silk-Bridge Roads Spoils Site

Spoils Site Location

View to a westerly direction

Applicable standards and conditions in the Vermont Construction General Permit 3-9020 will be met and best management practices will be utilized for this project. A construction entrance will be constructed and silt fence will be installed on the eastern downslope side of the proposed spoils area prior to site disturbance.

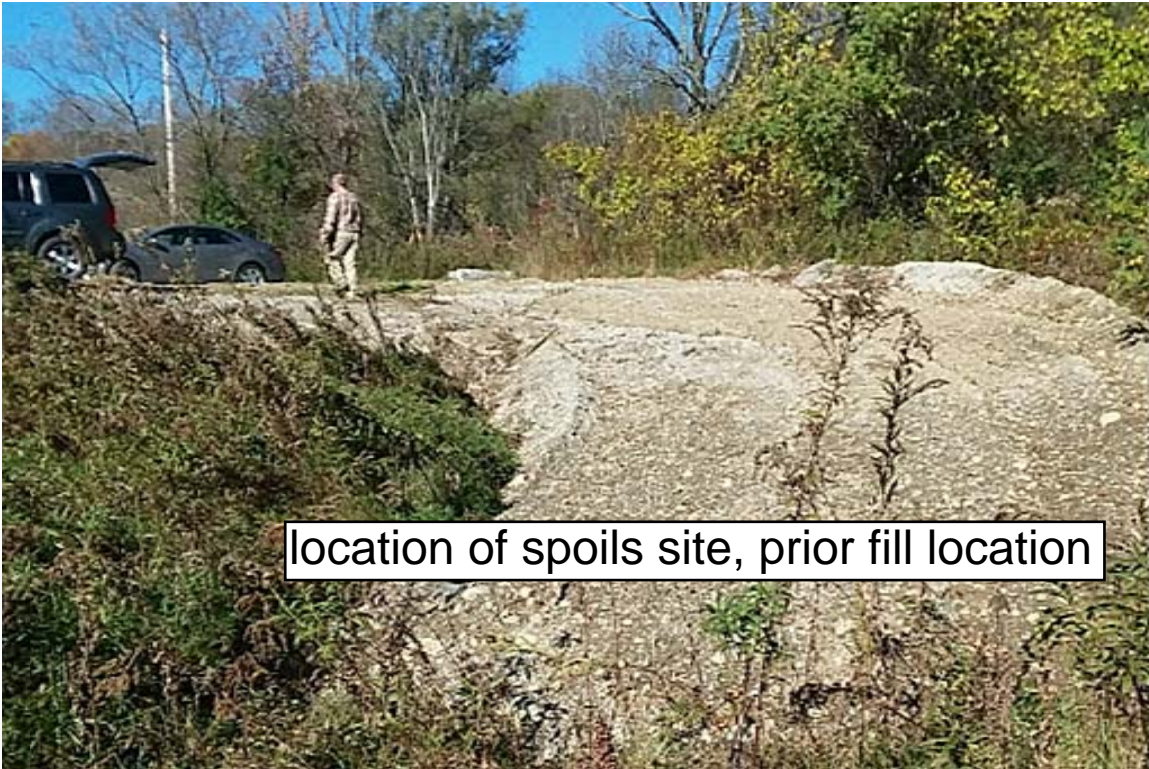
location of spoils site, prior fill location

View to a northwesterly direction

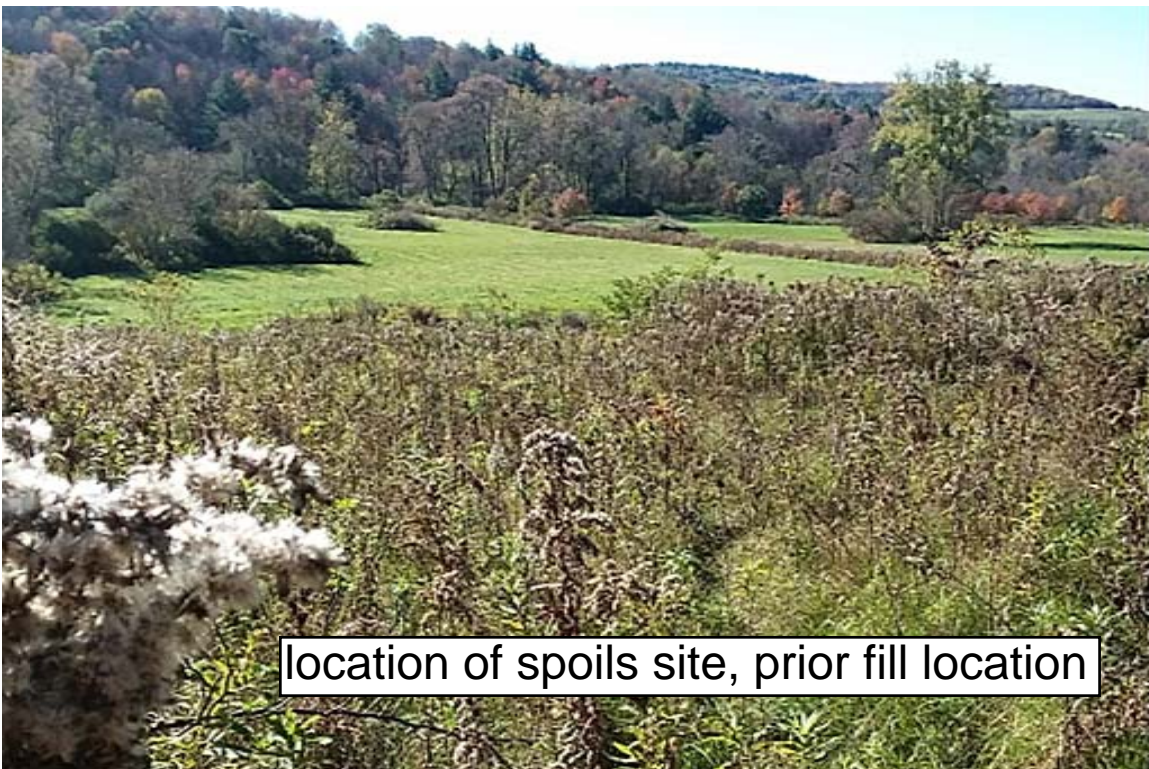
location of spoils site, prior fill location

View to a southwesterly direction. Mowed area contains the 100 year floodplain.

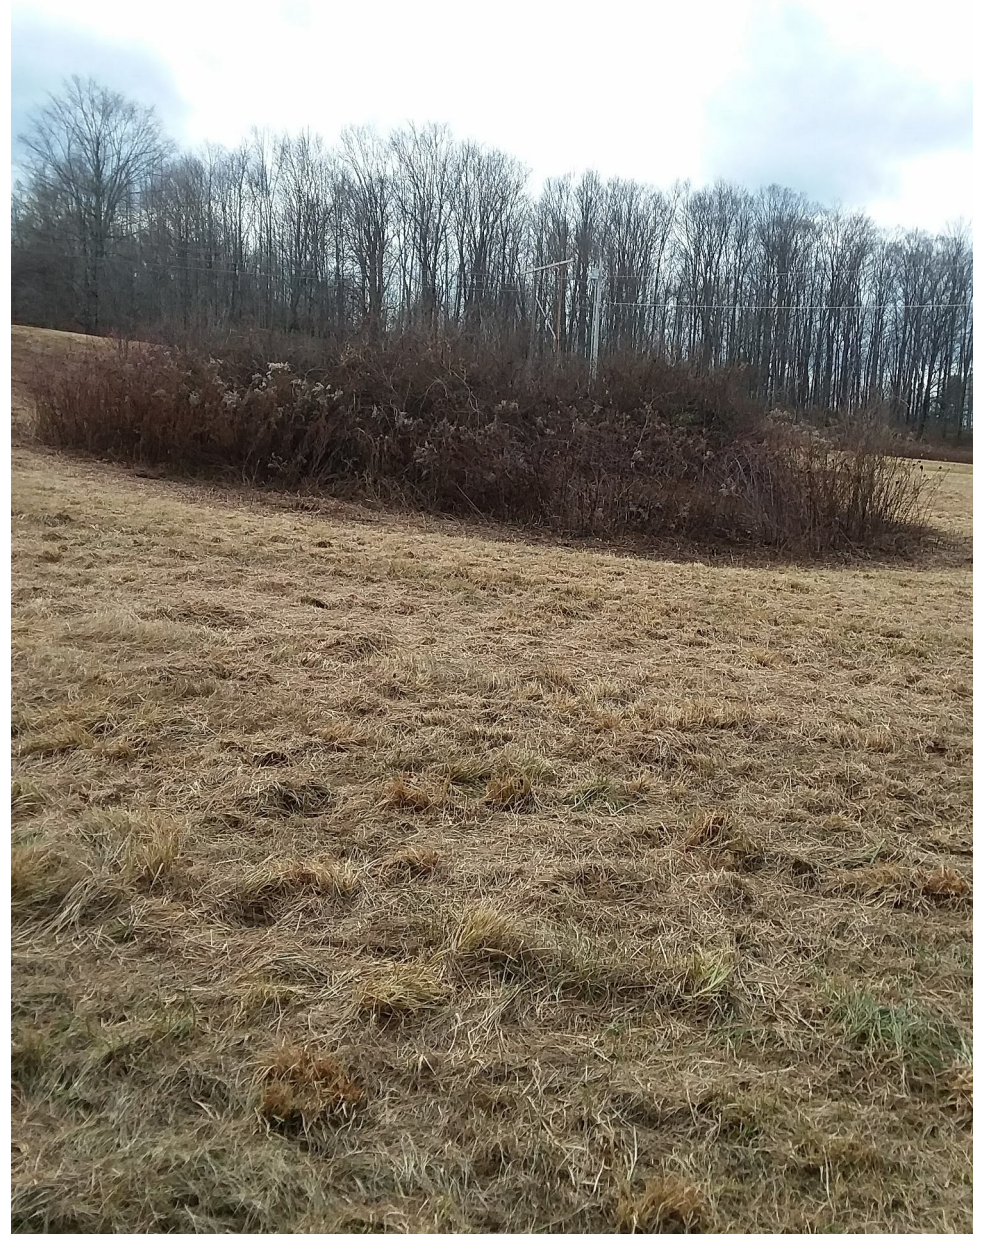
Spoils Site, Riverside Drive, Photo 1

View looking southeast to northwest where spoils would be placed.

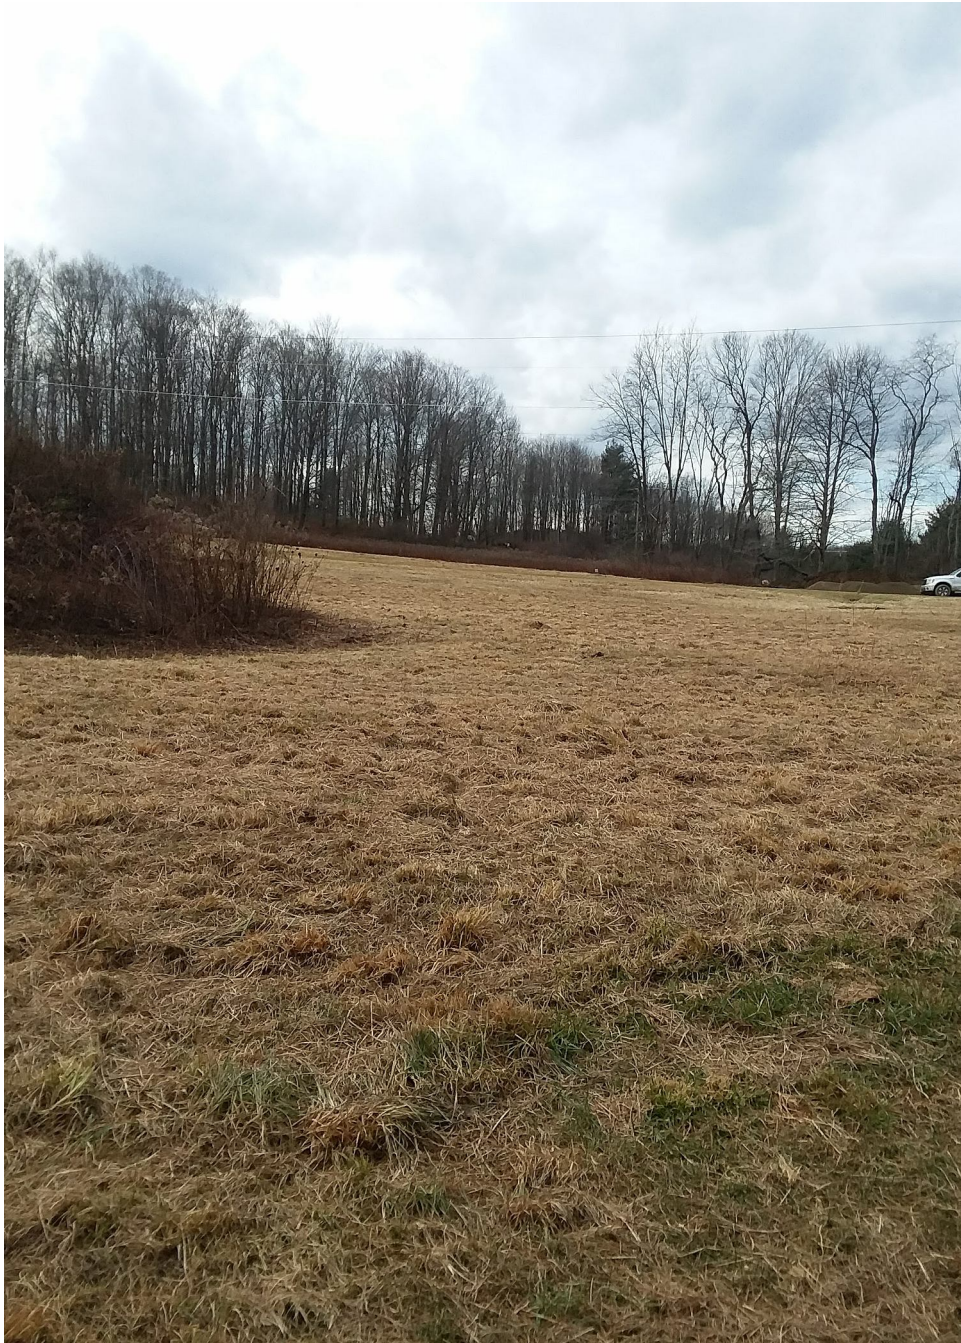
Spoils Site, Riverside Drive, Photo 2

View looking southeast to northwest where spoils would be placed.

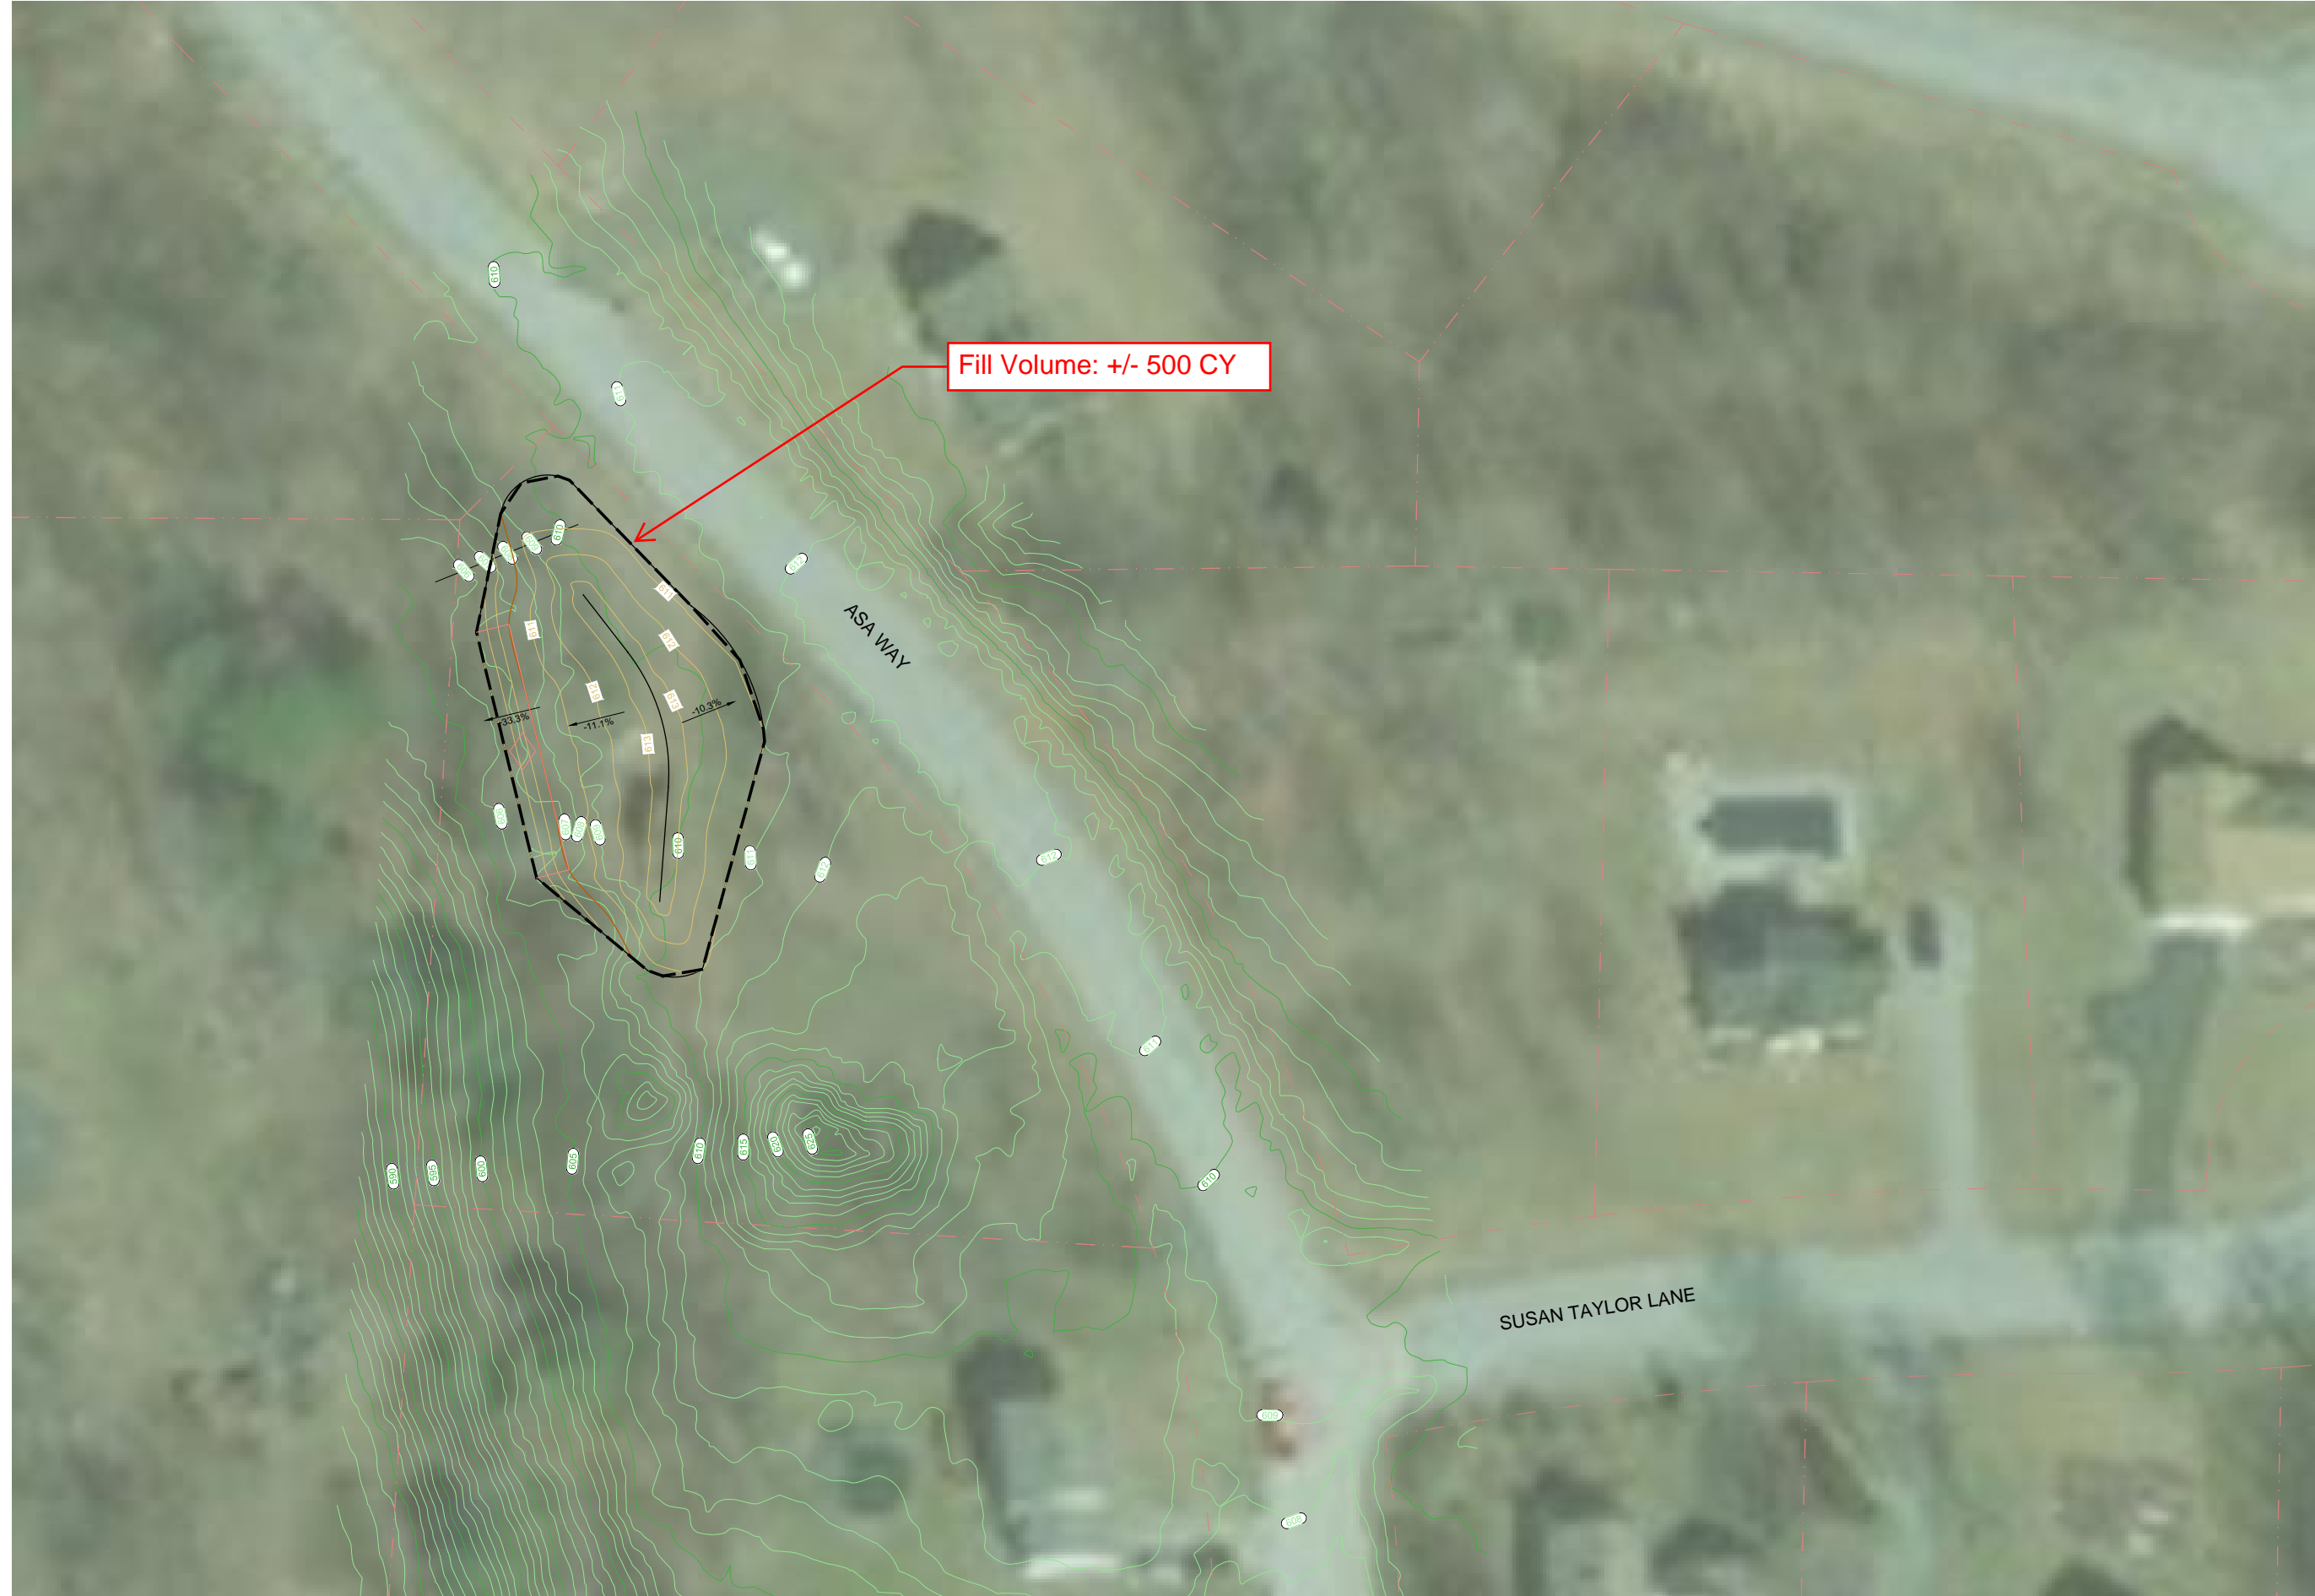
ASA WAY SPOILS SITE
0 30 60 Feet

Fill Volume: +/- 500 CY

Applicable standards and conditions in the Vermont Construction General Permit 3-9020 will be met and best management practices will be utilized for this project. A construction entrance will be constructed and silt fence will be installed on the western downslope side of the proposed spoils area.

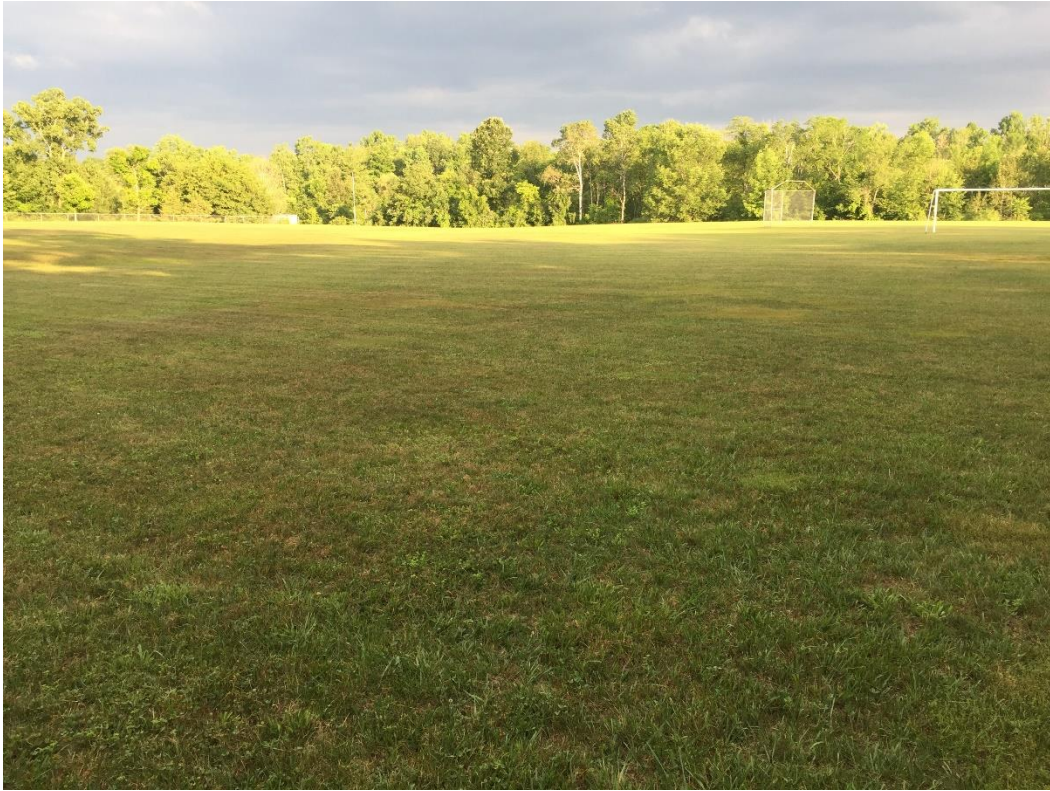
East-Central side of site, looking west. Spoils will be used to extend the soccer field toward the existing baseball field to the south.
