RE: Town of Norwich Pool Dam Reconstruction, Stream Alteration Permit Application

VERMONT AGENCY OF NATURAL RESOURCES
STREAM ALTERATION INDIVIDUAL PERMIT APPLICATION

NORWICH POOL DAM REHABILITATION PROJECT

The purpose of this project is to repair the Norwich Pool Dam which failed during Tropical Storm Irene. The repairs are intended to meet the following objectives:

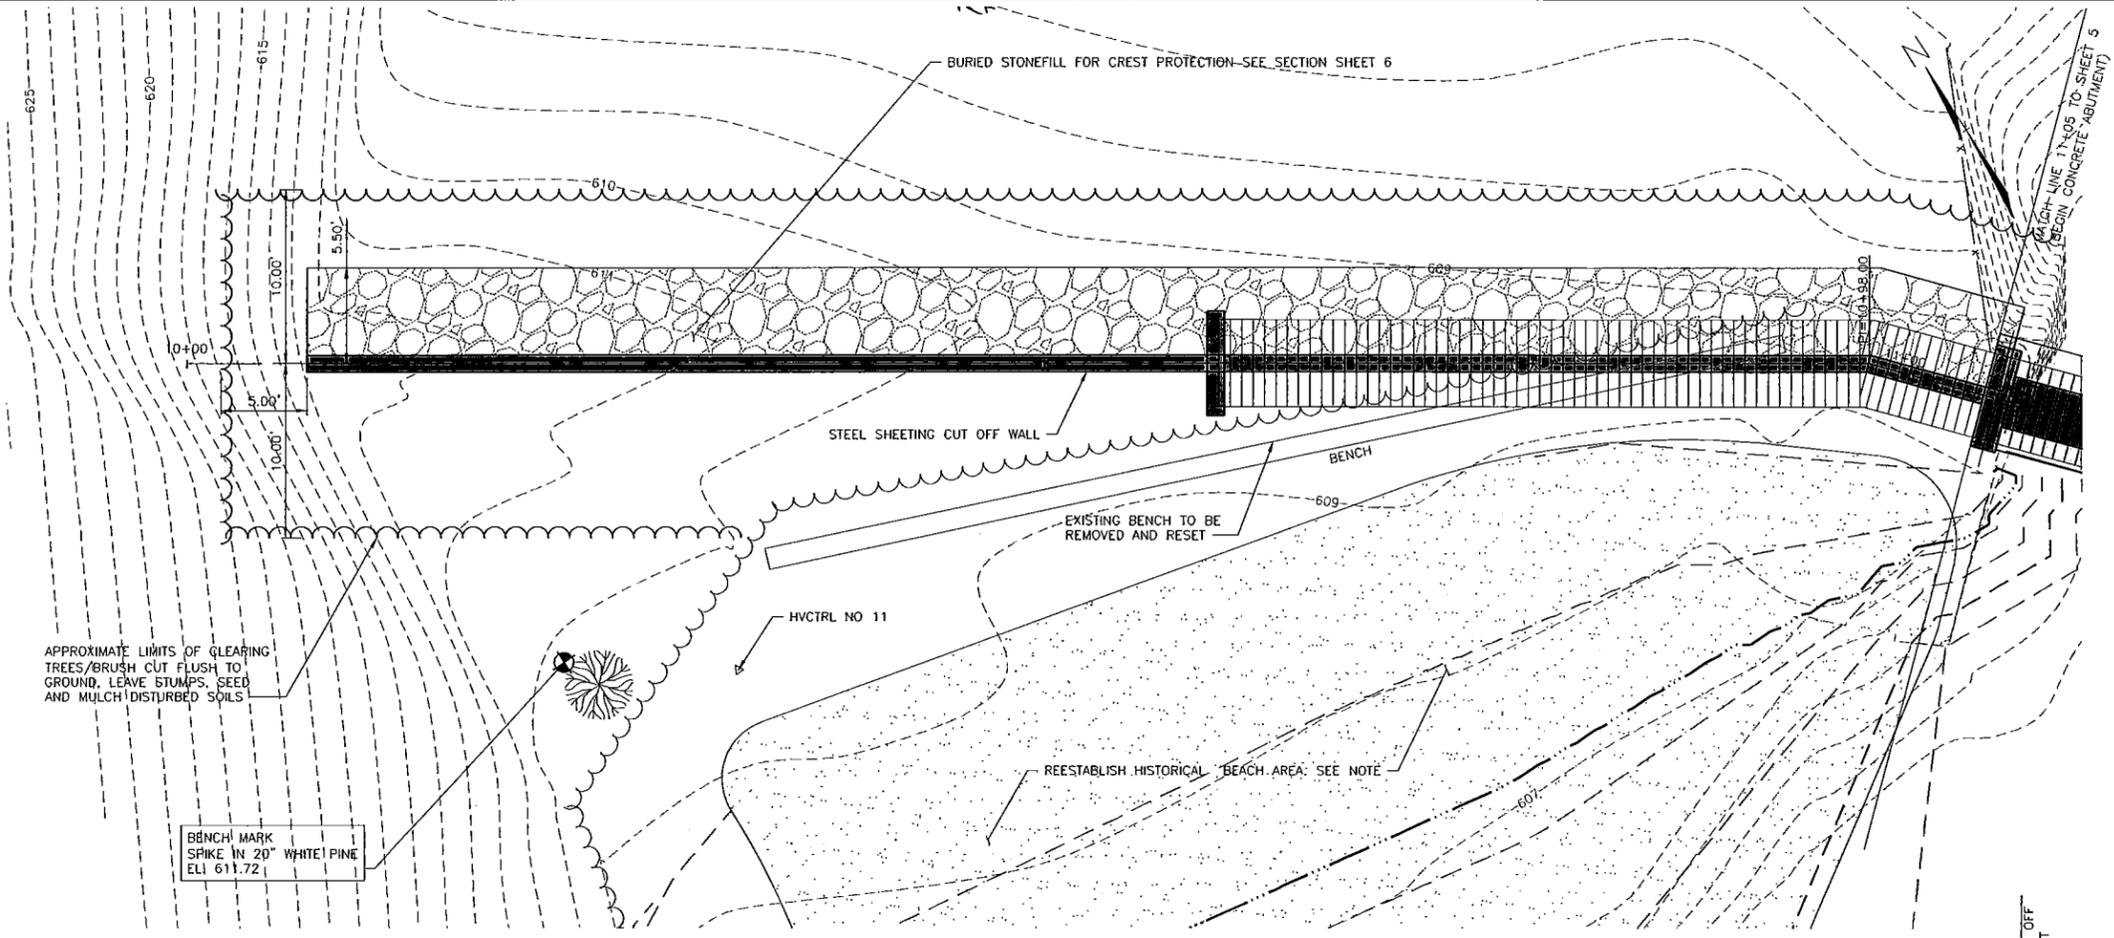
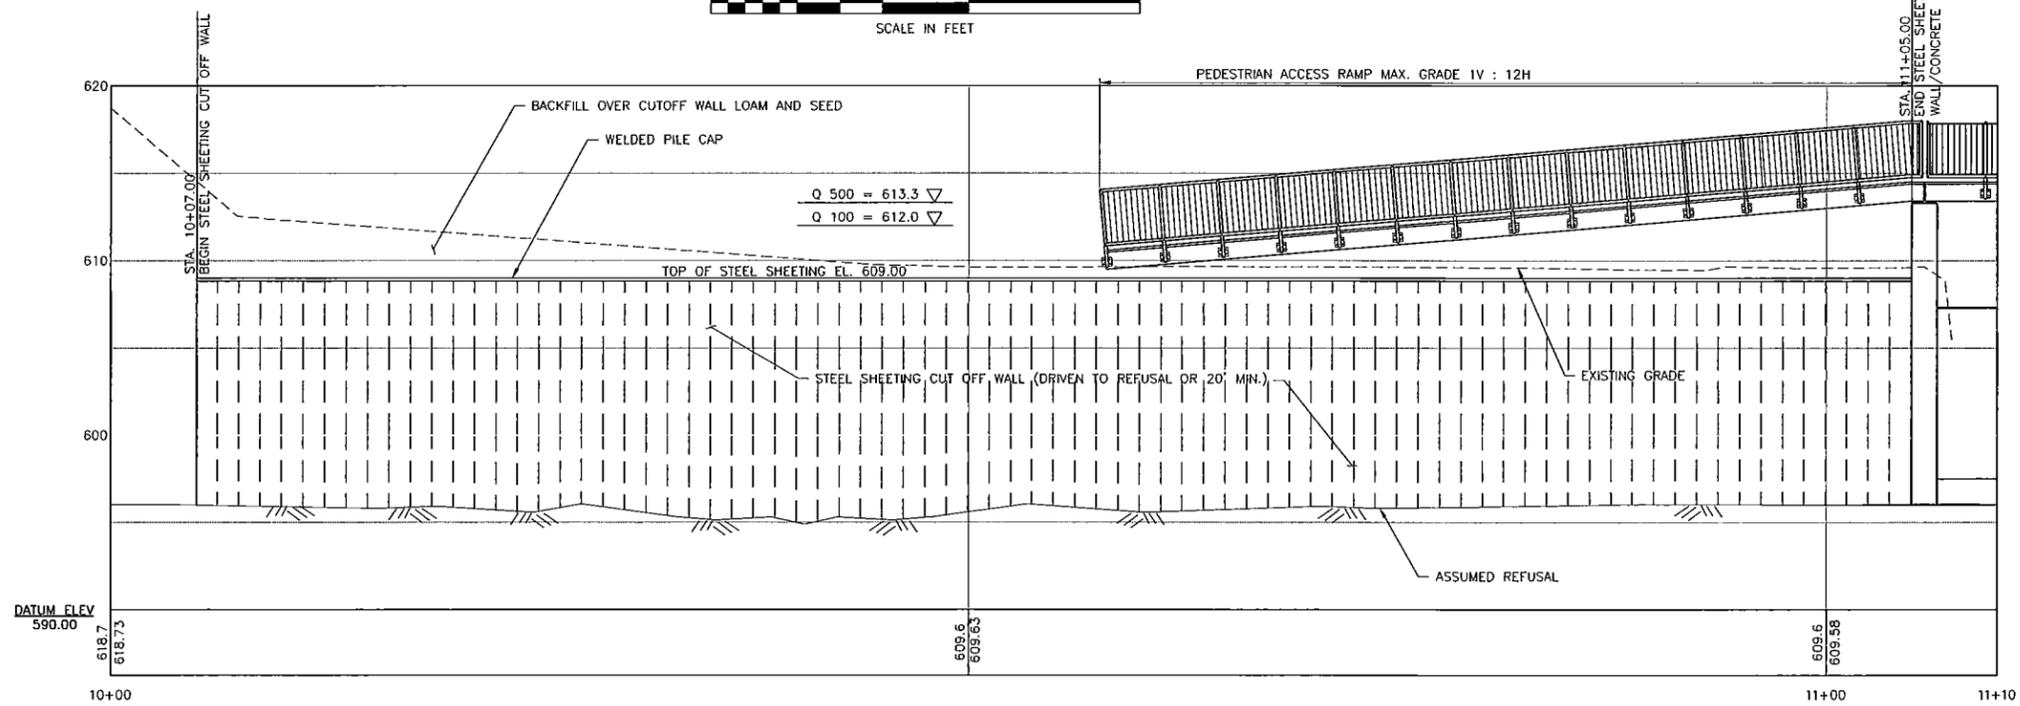
SHEET TITLE
 AUXILIARY SPILLWAY REPAIR
 PLAN AND ELEVATION

1. Left Auxiliary Spillway: structural steel sheeting will be driven to bedrock or 20-ft (whichever is encountered first). The purpose of this sheeting is to prevent head cutting and erosion that could potentially occur during a design storm within the auxiliary spillway. Erosion and associated head cutting would be stopped at the steel sheeting and prevented from propagating into the pool area and preventing failure of this area. A 5-ft wide, 2-ft deep stonefill wall, designed in accordance with the US Army Corps of Engineers' method of riprap sizing as documented in Engineering Manual 1110-2-1601 will be placed on the downstream side of the steel sheet piling as an additional erosion barrier and protection of the auxiliary spillway crest.

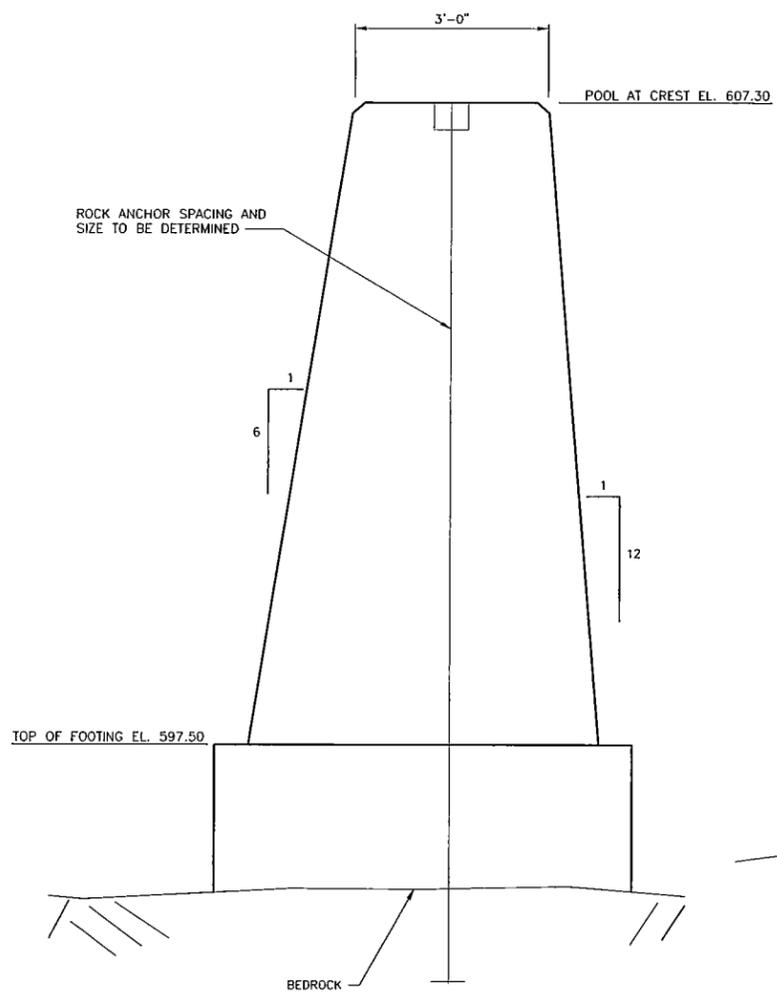
SECTION CONCRETE SPILLWAY DAM
SCALE: 3/4" = 1'-0"

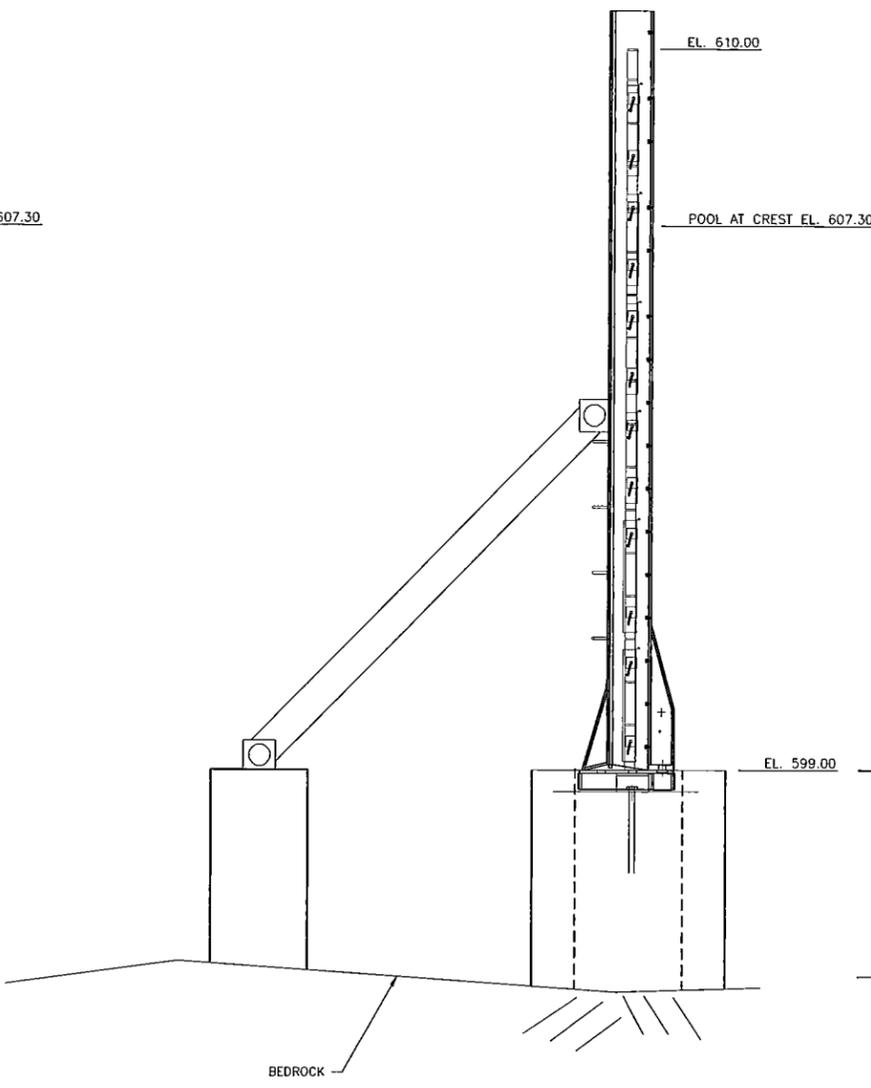
SECTION REMOVABLE STOP LOGS
SCALE: 3/4" = 1'-0"

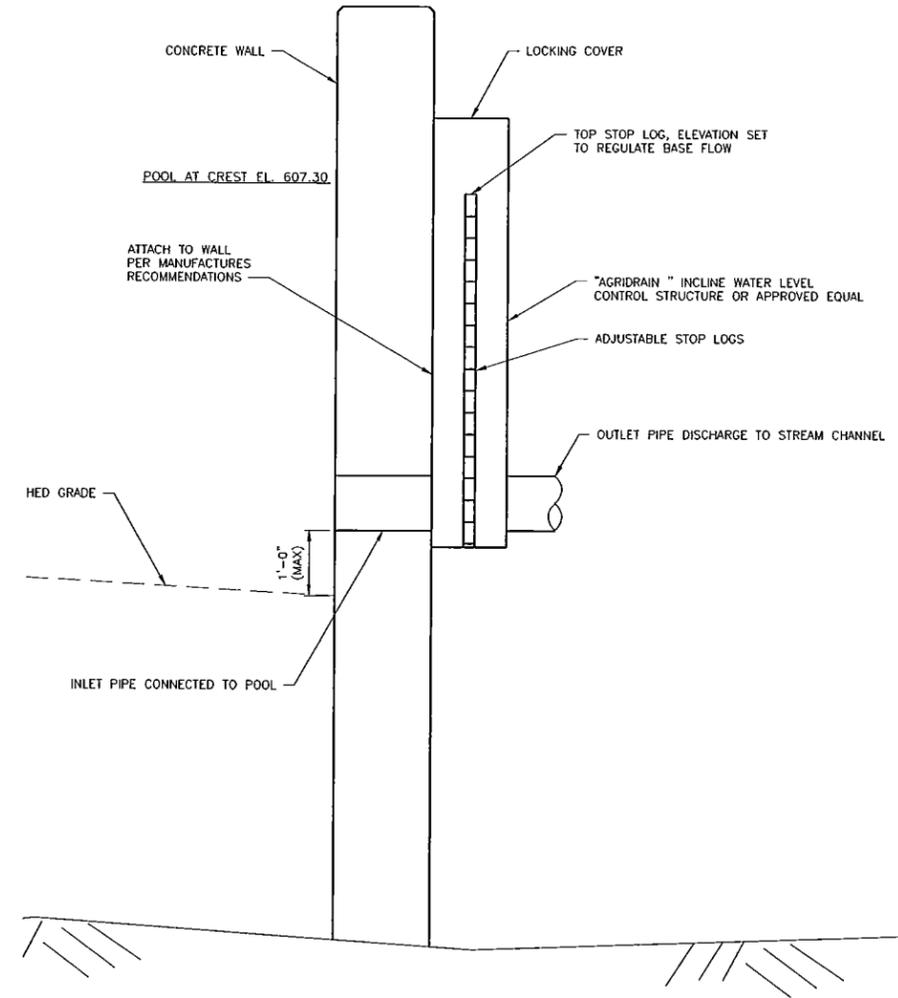
SECTION COLD WATER DISCHARGE STRUCTURE
SCALE 1" = 1'-0"

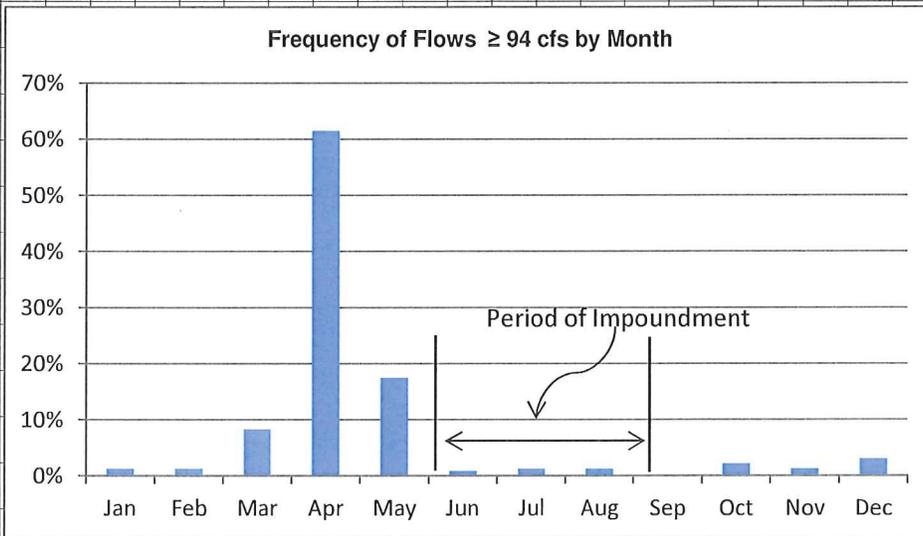
Events greater than 94 cfs from the historical mean daily flow record:

Total Recorded Observations:	20,826	
Total Observations ≥ 94 cfs:	229	
Total Observations ≥ 94 cfs Falling in June - August:	8	← 3.5% of flows ≥ 94 cfs occurred June-Aug

Daily Mean Flows ≥ 94 cfs Occuring June-Aug 1958 - Present		
8/28/2011	267	cfs
6/30/1973	242	cfs
6/27/1998	130	cfs
7/1/1973	120	cfs
8/7/1990	114	cfs
8/10/1976	112	cfs
7/2/1973	106	cfs
7/3/1973	98	cfs

Most large flows capable of moving a significant amount of sediment occurred in March, April and May

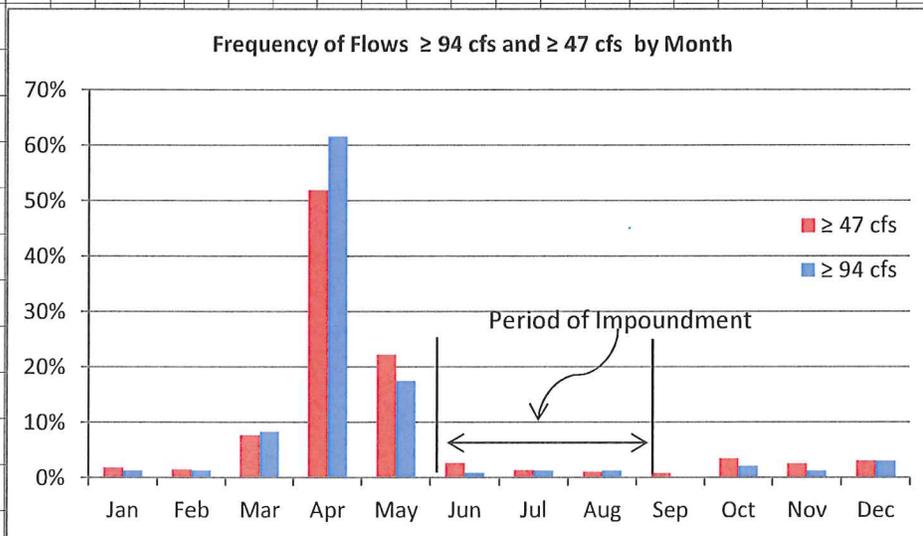
Total Recorded Observations:	20,826
Total Observations ≥ 47 cfs:	1,675
Total Observations ≥ 47 cfs Falling in June - August:	84

← 5.0% of flows ≥ 47 cfs occurred June-Aug

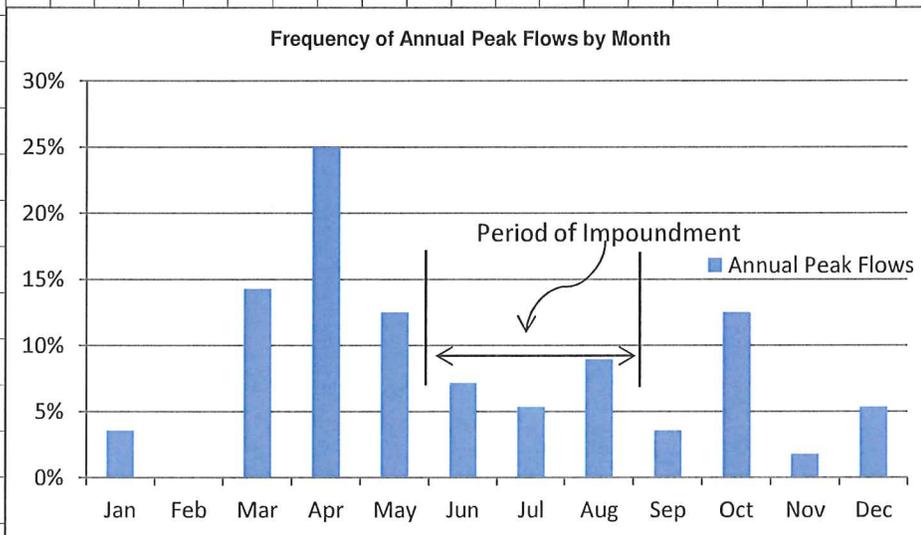
The Monthly occurrence of annual peak flows at the East Orange gage are also investigated

Total Recorded Peak Annual Observations:	56		
Total Peak Observations Falling in Sept - April:	44	← 78.6%	Occurred Sept - April
Total Peak Observations Falling in June - August:	12	← 21.4%	Occurred June - Aug

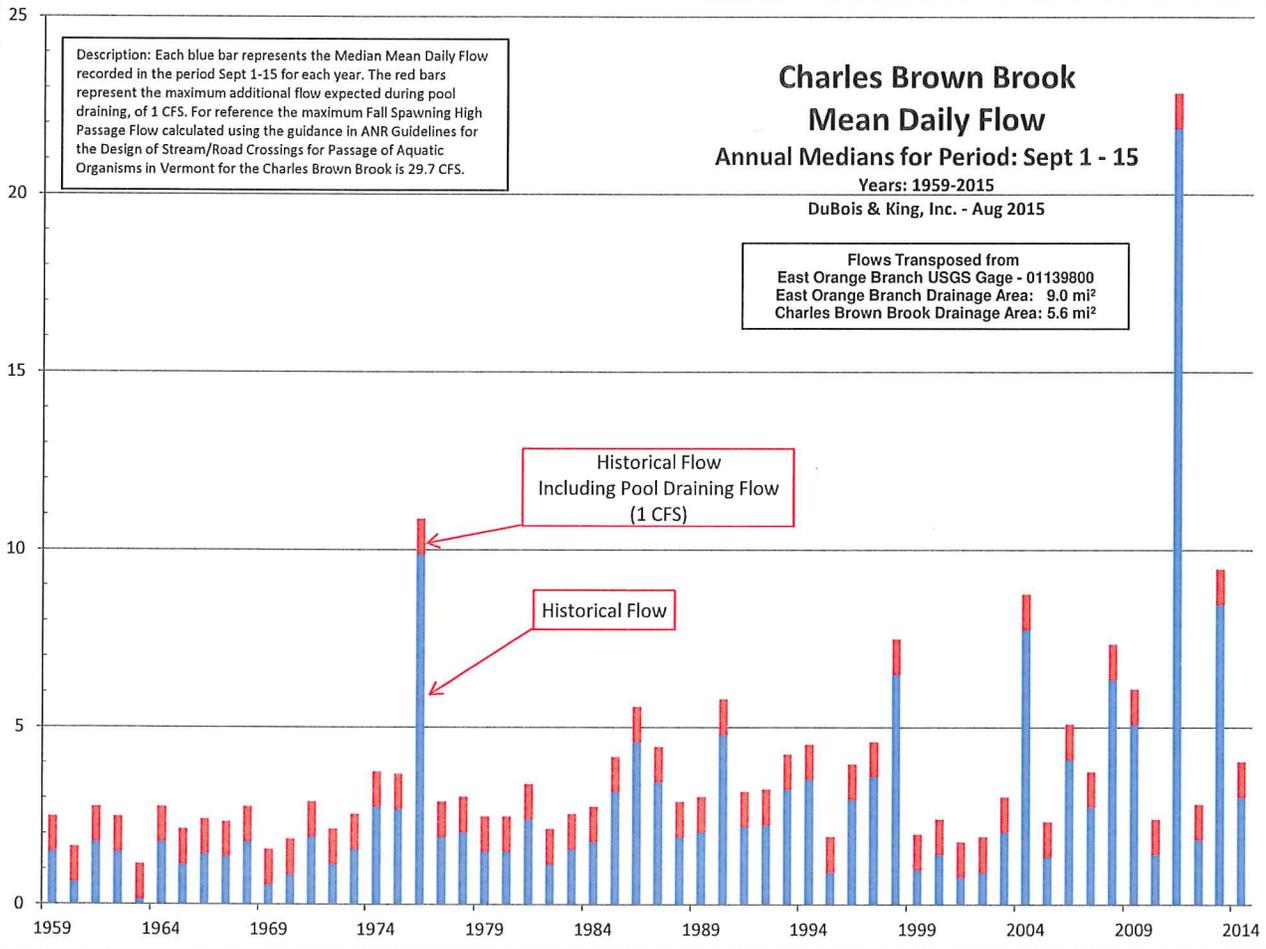
Flows Transposed from
East Orange Branch USGS Gage - 01139800
East Orange Branch Drainage Area: 9.0 mi²
Charles Brown Brook Drainage Area: 5.6 mi²

NOTE: FLOWS NOTED CORRESPOND TO A 5.6 SQUARE MILE (3,584 ACRE) DRAINAGE AREA.
