# Upper & Middle White River Watershed Corridor Plan

Barnard, Hancock, Pittsfield, Rochester, and  
Stockbridge, Vermont  
July 15, 2015

Prepared by:  
Bear Creek Environmental, LLC  
149 State Street, Suite 3  
Montpelier, Vermont 05602

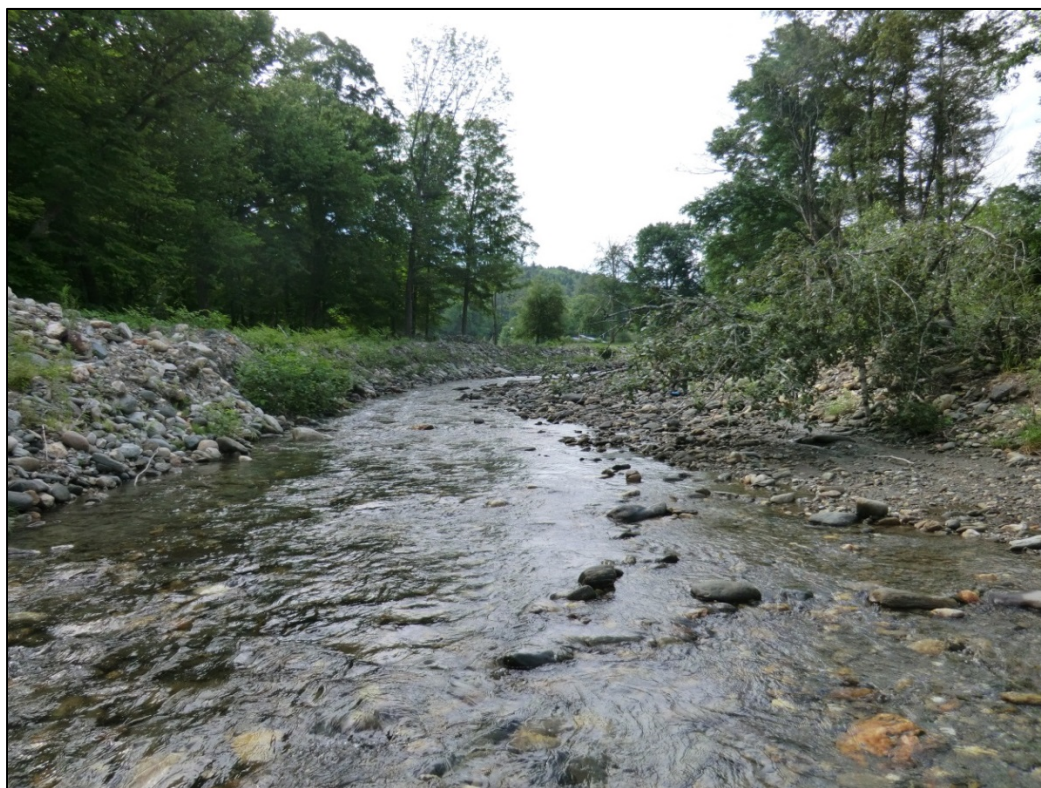
Segment T3.02-C begins just below the confluence of Pond Brook and continues upstream for 1,800 feet to just above the Rt. 12 Bridge between Mount Hunger Road and Chateauguay Road. This segment has a lower slope and wider valley than the segments just upstream of it, creating an *alluvial fan*. It is an area where significant deposition occurs due to a reduction in water velocity that allows sediment to drop out during high flows. Following Irene, this segment was extensively dredged, windrowed, and bermed, lowering the streambed and cutting off floodplain access. The Route 12 Bridge over Locust Creek was destroyed by floodwaters. The channel has widened significantly, which likely occurred due to aggradation during Irene. Planform in this segment has been drastically altered by channelization, and numerous flood chutes have been cut off by windrowing. These channel alterations have caused T3.02-C to be in **poor** geomorphic condition. The segment is in **fair** habitat condition due to a lack of diverse bed features from windrowing, as well as poorly vegetated riparian zones.

**Figure 5.7.** T3.02-C was extensively windrowed following Tropical Storm Irene.

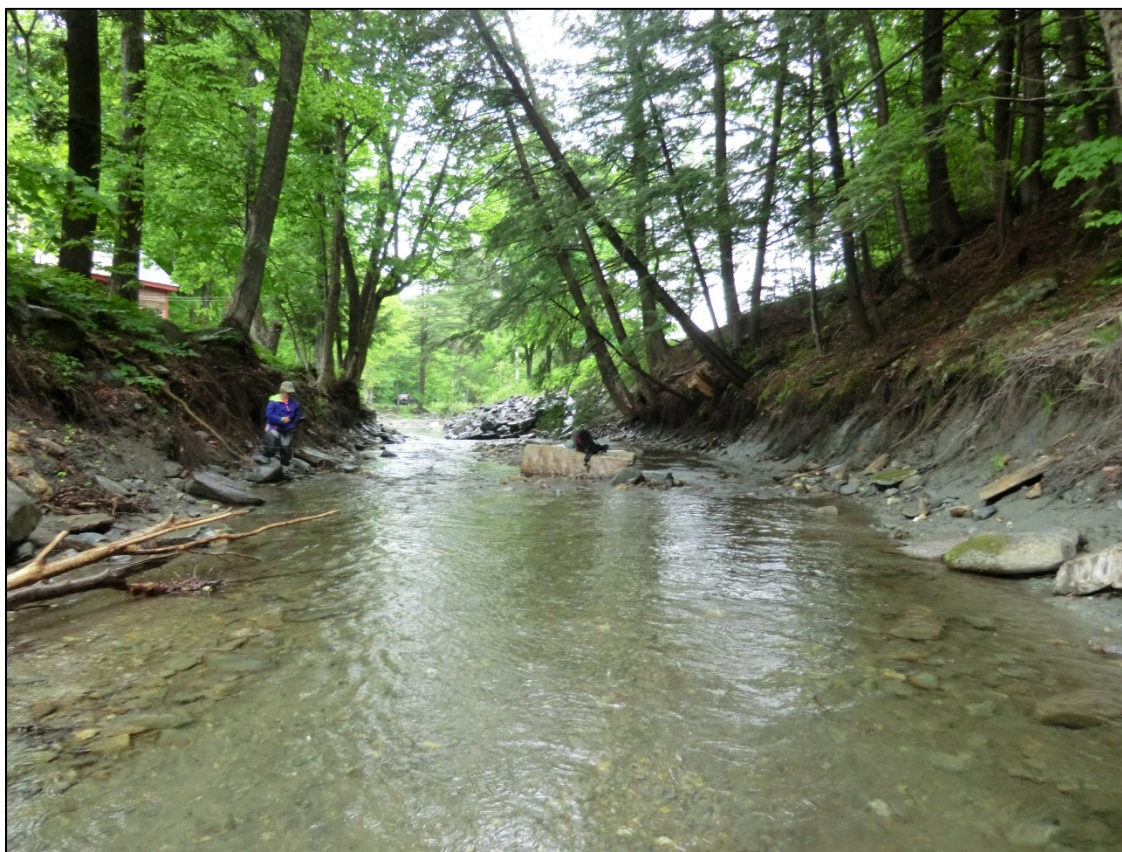
Segment C on reach four of Locust Creek is characterized by a slightly narrower river valley than segment B. It is a shorter segment, only 1,200 feet long, and begins just downstream of a private driveway bridge to 2353 and 2357 Chateauguay Road and ends just above the next Chateauguay Road bridge. This segment has undergone extreme incision, and continues to downcut through areas of deposition via two headcuts. According to conversations with creek-abutting landowners, the stream channel cut down several feet during Tropical Storm Irene into glacial till. It is currently beginning the widening process, causing bank erosion, one mass failure, and bank slumping. This deeply incised channel has lost access to its floodplain and will continue to widen throughout the near future. Two houses directly on the banks of Locust Creek within T3.04-B are at significant risk due to the widening channel. This segment is in **poor** geomorphic condition and **fair** habitat condition.

**Figure 5.12.** Extreme channel incision has occurred and continues to occur in T3.04-C.

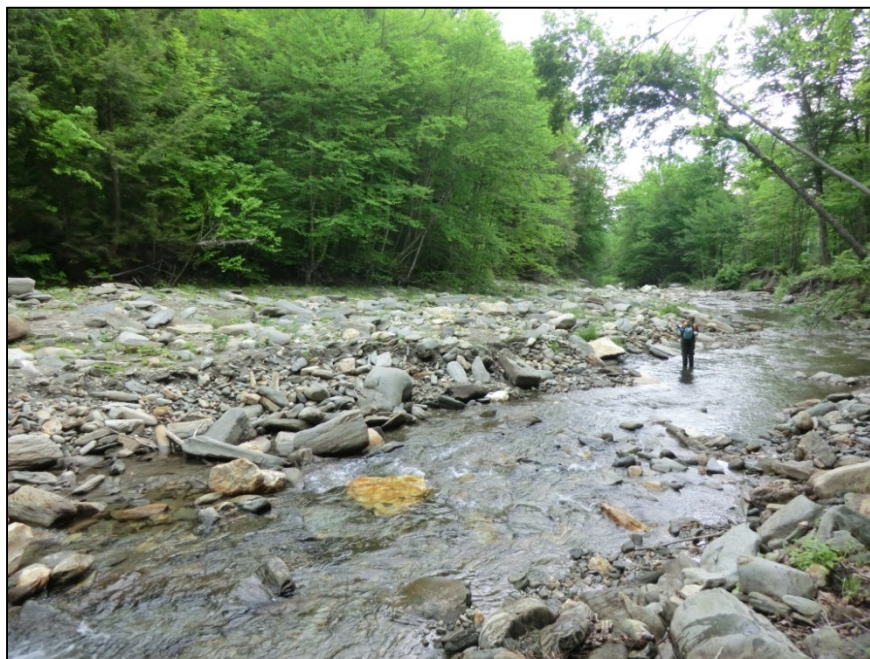
The downstream-most segment on T3.05 flows through a well forested area, beginning just above the Chateauguay Road Bridge in T3.04-C, and continues upstream for 2,800 feet to just below the Town Highway 46 Bridge. This section of Locust Creek has undergone major incision, and a large headcut, which is cutting through debris and sediment, is present at the top of the segment. Two ledge grade controls are preventing further incision at the downstream end of the segment. Glacial till and clay are common along the stream banks. Channel widening has also occurred in this area, and bank erosion is abundant. Large depositional features occur throughout T3.05-A and are forming a juvenile floodplain. Planform adjustment is also common via flood chutes on bars and the floodplain. Due to channel incision, some floodplain access has been lost, causing a stream type departure. Overall, T3.05-A is in **fair** geomorphic condition due to various adjustment processes occurring in the segment. It is also in **fair** habitat condition due to unstable stream banks and lacking woody debris cover.

**Figure 5.13.** Many areas of T3.05-A are very wide and aggradational, building a juvenile floodplain.

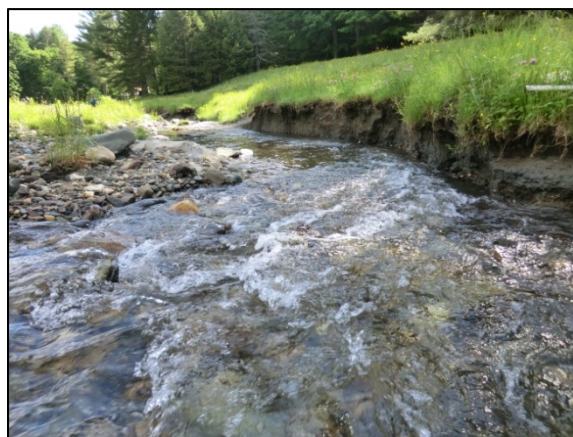
The downstream-most segment on Pond Brook begins at the confluence with Locust Creek and continues upstream for approximately 4,000 feet to where surrounding land use and reference stream type change near 7939 Route 12. Pond Brook is a narrow wetland channel by reference in segment T3.2-S3.01-A, but the majority of adjacent wetlands in this section have been converted over time to agricultural and residential land. Channel incision in this segment is moderate. The majority of the segment was historically straightened, likely to produce crop land, and the brook is now pushed up against its east valley wall in many places. A few short sections within this segment were windrowed or dredged post-Irene. There is little woody vegetation along the banks to provide root structure; subsequently the lack of riparian buffers is contributing to bank erosion. Bank armoring is scattered throughout T3.2-S3.01-A, but most of it is failing and not preventing further erosion. Three mass failures are present along the east valley wall. A constructed log dam exists within the segment and is creating a barrier for aquatic organism passage. This segment is in **fair** geomorphic condition due to historic channel management that has led to incision. It is also in **fair** habitat condition as a result of altered adjacent wetlands, unstable banks, and poor riparian buffers.

**Figure 5.18.** Riparian buffers are lacking in T3.2-S3.01-A and bank erosion is abundant.

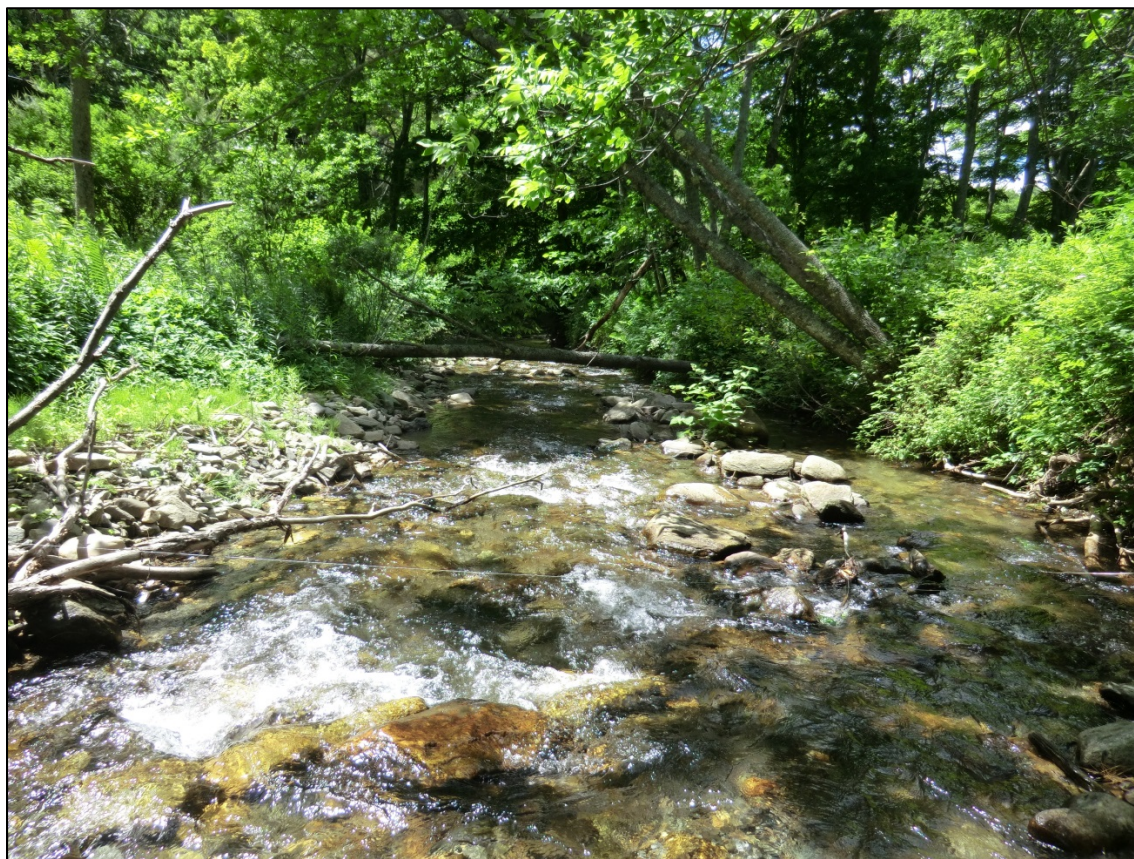
Segment B on reach one of Pond Brook flows through primarily forested land along Route 12 for 5,700 feet, ending at the Route 12 culvert near 7129 Route 12. The brook flows through a very broad valley in this segment, though the valley narrows in three locations where the channel is also slightly steeper. The brook has mostly natural planform in this segment, except for a few areas where it was historically straightened along Route 12. Segment B has incised only very slightly, and has not widened. Four channel constrictions are present and are creating extra deposition and scour features in their proximity. Overall, Pond Brook has excellent floodplain access in this segment and has not undergone much recent geomorphic change. For these reasons, segment B is in **good** geomorphic condition. It is in **fair** habitat condition due to a lack of large pools and altered adjacent wetlands.

**Figure 5.19.** T3.2-S3.01-B has good floodplain access and well forested buffers.

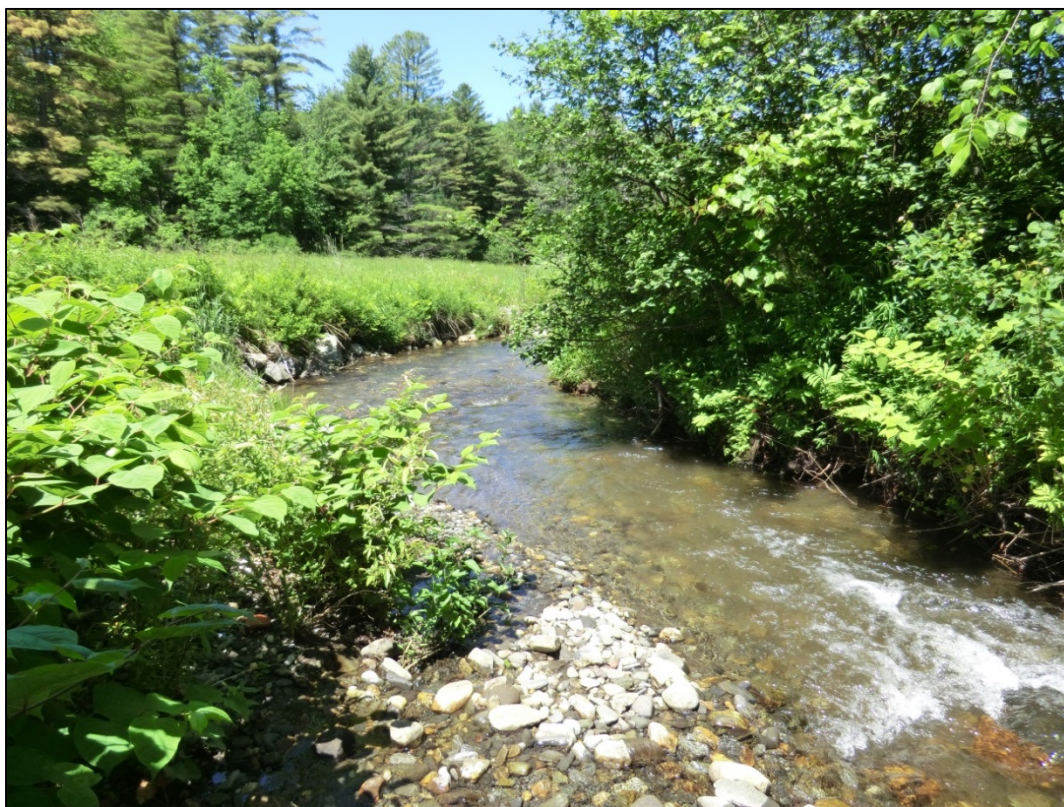
The upstream-most segment on Pond Brook included in this assessment is 3,600 feet in length and flows through mainly residential land. The reach ends just below the Route 12 culvert near the southeastern intersection of Route 12 with Davis Road. Similar to segment A on Pond Brook, this segment is a narrow wetland channel by reference but most of its adjacent wetlands were altered over time and converted to different land uses. Davis Road and Route 12 encroach upon the brook in several locations in this segment, and the brook was historically straightened along them in certain areas. Bank erosion and armoring are scattered throughout the segment. Despite historic channel alteration, T3.2-S3.01-C has not incised or widened and has continuous floodplain access. These factors cause this segment to be in **good** geomorphic condition. It is in **fair** habitat condition as a result of impacted banks and buffers and lacking woody debris in the channel.

**Figure 5.20.** Pond Brook is a narrow wetland channel in T3.2-S3.01-C with impacted buffers.

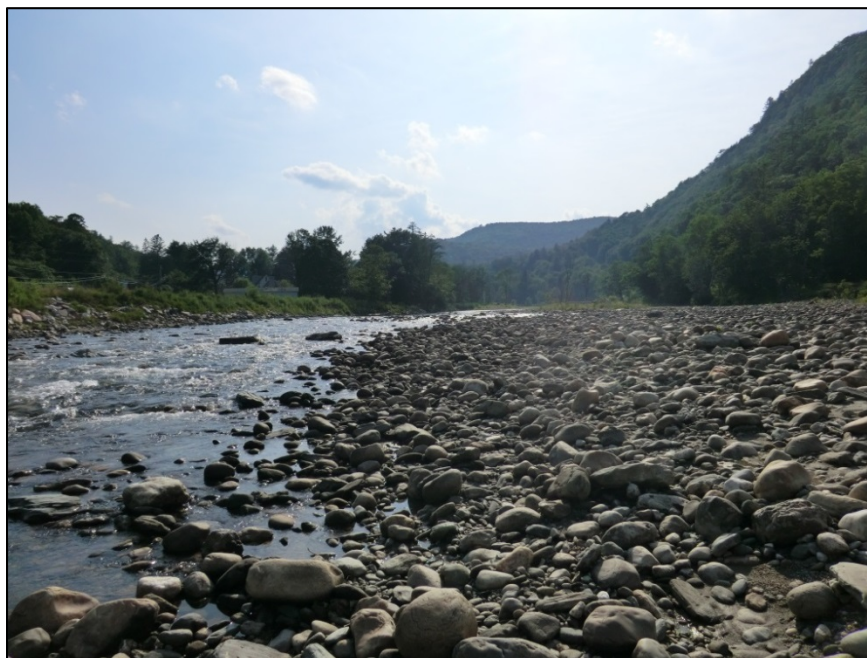
The downstream-most reach on the White River included in this assessment is reach fourteen in Stockbridge. It begins just above the confluence of Lilliesville Brook and continues upstream for 7,300 feet to just below the Gaysville Bridge. The lower half of R14 was historically straightened due to the construction of River Road and Vermont Route 107 within the White River valley. The upper portion of the reach has a more natural, sinuous planform. Historic channel alteration, such as straightening, has led to moderate historic incision within R14. Despite this, the White River retains good floodplain access throughout this reach. The river has aggraded and widened substantially and will continue to do so as it moves toward a least erosive state. During Tropical Storm Irene, floodwaters caused the formation of a mass failure along the river's northern valley wall. The storm also likely contributed to the aggradation and widening observed during assessment. Bank armoring is continuous where the river flows along River Road and Route 107. Due to historic and active channel adjustment processes within R14, the reach is in **fair** geomorphic condition. The over-widened channel present in R14 lacks diverse bed features, in-stream woody debris, and well forested riparian buffers, which causes it to be in **fair** habitat condition.

**Figure 5.21.** Reach R14 on the White River is very wide and aggradational.

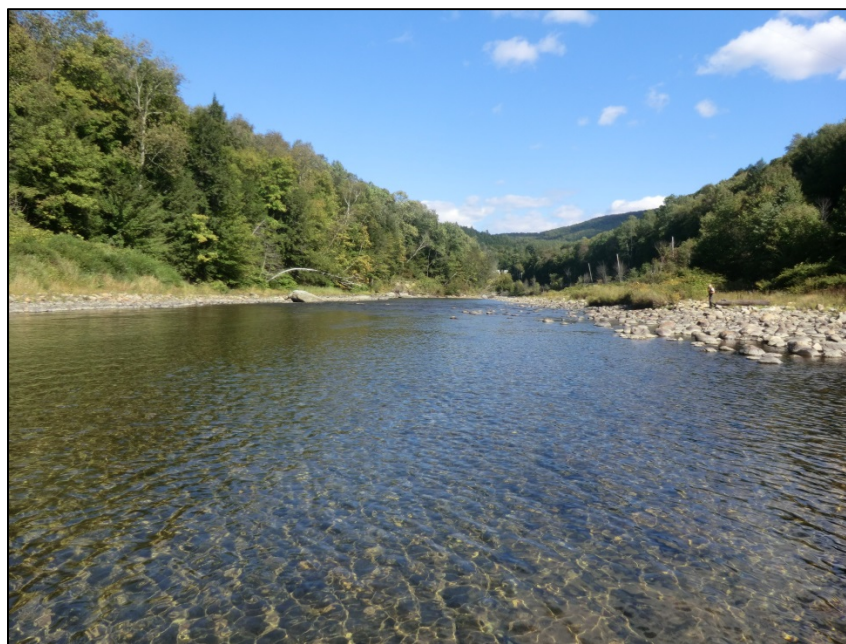
The second segment on reach sixteen of the White River is characterized by continuous corridor encroachment by Route 107 and extensive historic channel straightening. It begins at the Blackmer Boulevard Bridge and extends upstream 2,900 feet to where the river channel becomes narrower. The straightening and encroachment that the White River has been subjected to due to Route 107 have led to extreme historic incision and loss of floodplain access. The majority of the southern bank of the river has been riprapped along Route 107. The river has widened to the north where there is no bank armoring to prevent it, creating extensive bank erosion. This segment is aggrading and building a juvenile floodplain on its large bars. Major infrastructure damage occurred within R16-B during Tropical Storm Irene. The Blackmer Boulevard Bridge was damaged due to a landslide that occurred adjacent to the bridge. The Route 107 embankment was also damaged in at least two locations and had to be rebuilt post-flood. It is likely that gravel mining occurred within R16-B during flood recovery work, though it is difficult to identify exactly where. The severe incision and widening present in R16-B have caused it to be in **fair** geomorphic condition. This segment is also in **fair** habitat condition because its overly-wide channel provides little cover and lacks a diversity of bed features.

**Figure 5.23.** The White River is overly-wide in R16-B and is building large bars.

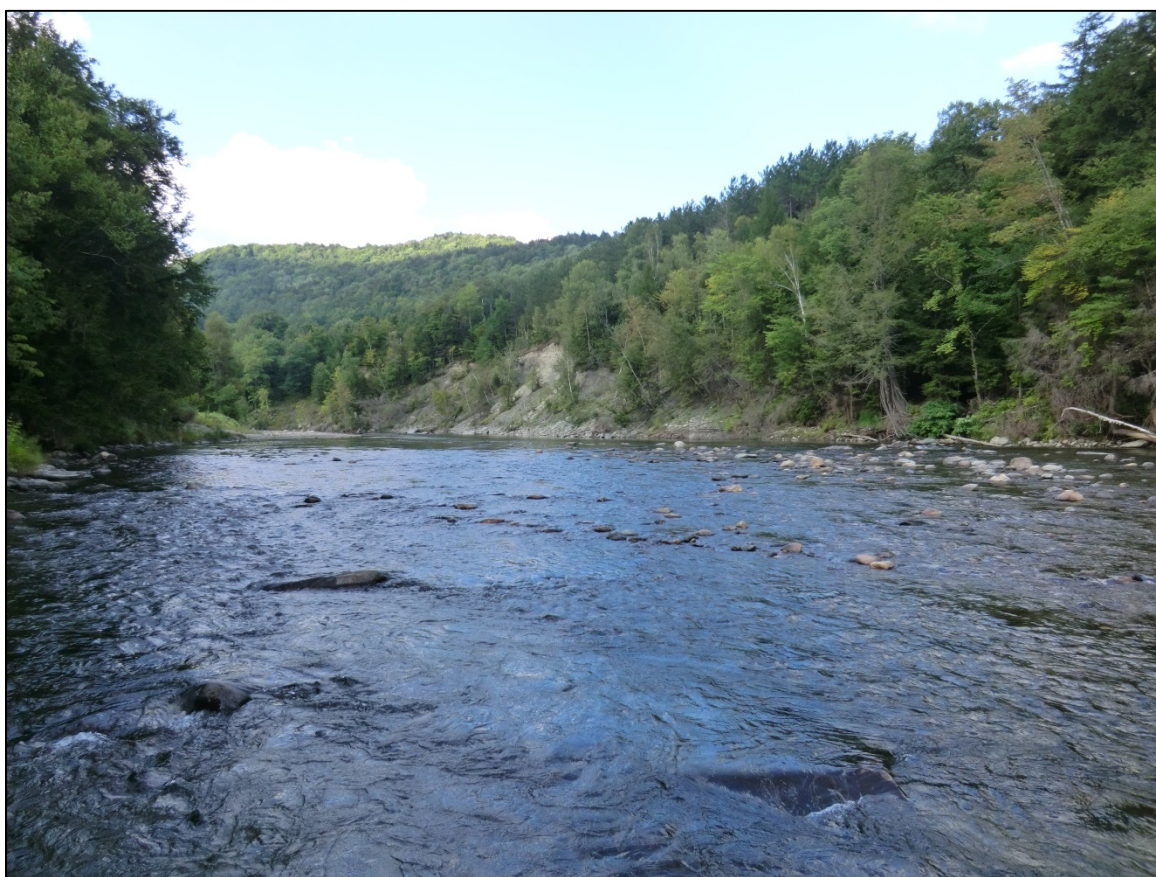
Reach seventeen on the White River was not divided into any segments during assessment. The river flows through a semi-confined valley in this reach, beginning where it flows away from Route 107, continuing upstream for 6,500 feet, and ending at the confluence of the Tweed River. Blackmer Boulevard encroaches upon the river corridor frequently, but historic channel straightening appears to have been minimal. Major historic incision has occurred in R17, which has led to loss of floodplain access and a stream type departure. The White River has widened significantly in this reach, and bank erosion and mass failures are abundant. The downstream end of R17 majorly aggraded during Irene, and was subjected to gravel mining post-flood where the river flows toward Route 107. This reach is currently in **fair** geomorphic condition as a result of its loss of floodplain access and overly-wide channel. Habitat is also in **fair** condition here due to unstable banks, lack of connectivity to its floodplain, and changing morphology.

**Figure 5.25.** R17 has incised and widened significantly.

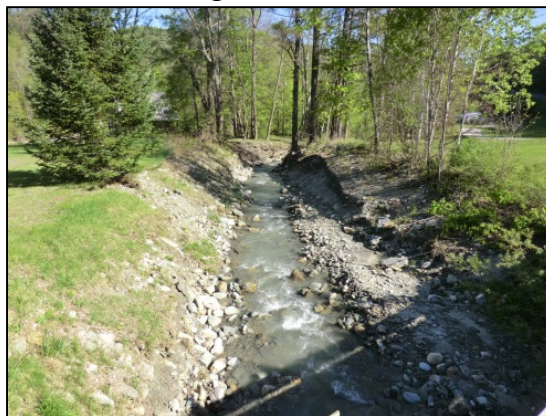
The downstream-most segment on reach one of Little Stony Brook extends from the confluence with the White River upstream about 1,100 feet to above the Route 107 bridge. This segment is an alluvial fan, which forms due to a significant drop in channel slope and widening of the valley as it opens up into the White River valley. Segment A is a natural area of significant deposition and has a braided bedform by reference. Development is abundant along this section of Little Stony Brook, and as a result it has been historically managed to be a single-thread channel. During Irene, major deposition occurred within this segment. To protect the houses on the banks of the brook, the channel was dredged and windrowed. Bank failure occurred on the north bank just above the confluence during Irene, and riprap was installed post-flood to protect a house on the bank. Three headcuts are present within R15-S1.01-A due to recent channel excavation. The water surface of the White River is substantially lower than that of Little Stony Brook at its mouth. The White River was extensively riprapped post-Irene in this location, creating a riprap cascade at the mouth of Little Stony Brook. This segment is in **poor** geomorphic condition due to major historic and recent channel alteration. Habitat is in **fair** condition due to a loss of bedform resulting from extensive channel work.

**Figure 5.26.** Extensive dredging and windrowing create an incised channel in R15-S1.01-A.

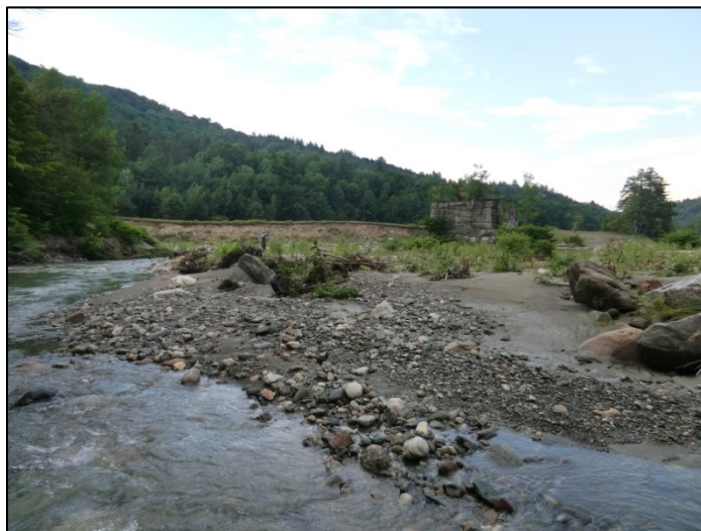
Segment A on reach one of Stony Brook forms an alluvial fan as the stream flows into the White River. It is highly depositional and has a low slope. Vermont Route 107 crosses Stony Brook in this segment. The Route 107 Bridge was destroyed during Tropical Storm Irene and rebuilt thereafter. The new bridge appears to have been built onto large amounts of fill and is so high up that it is now on the valley walls of Stony Brook. The fill and riprap associated with the bridge create a pinch point and alter channel planform. The abutments from the old bridge remain in place in the channel, and two older stone abutments from different bridges are also present. Two large mass failures are present on the western bank along a pull off on Stony Brook Road. If these mass failures continue to erode, they could put the road at risk of washing out. Severe bank erosion has occurred along the eastern bank directly in front of a house, which has been riprapped. Most of T5.01-A has good floodplain access and has not incised. This segment is in **fair** geomorphic condition due to planform alteration and major aggradation. Habitat is also in **fair** condition as a result of lacking woody debris, few pools, and poor riparian buffers.

**Figure 5.29.** T5.01-A is highly depositional and has many old abutments throughout it.

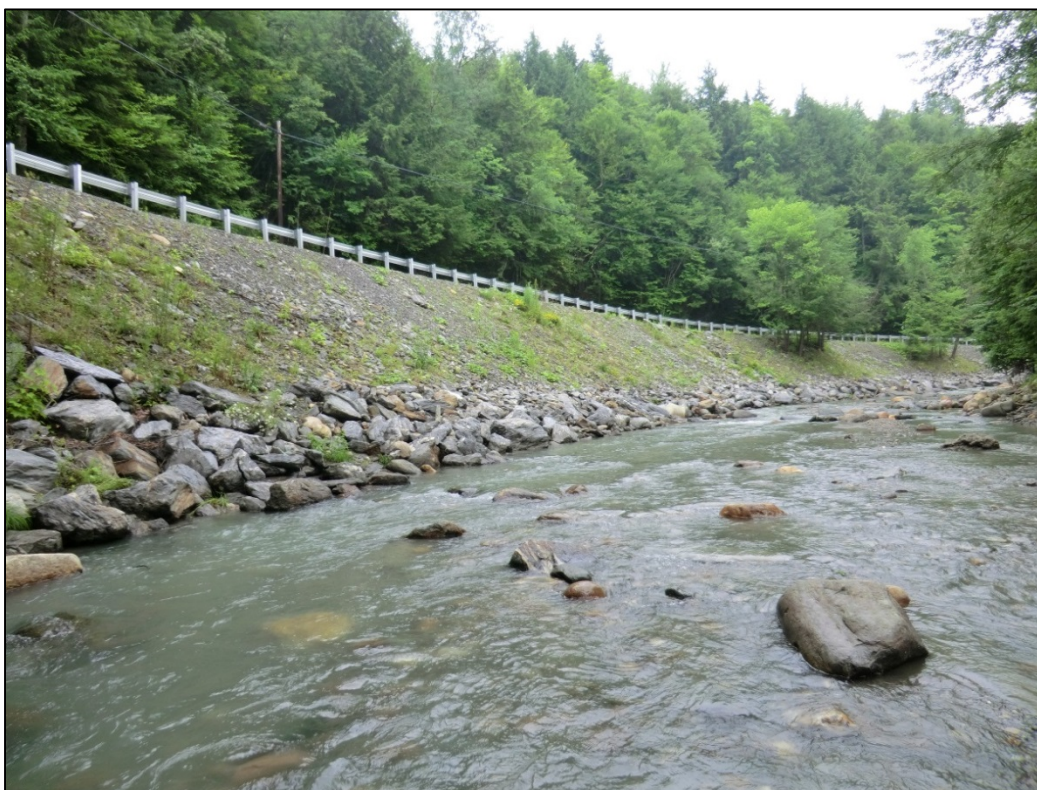
**Figure 5.30.** Much of T5.01-B was historically straightened along Stony Brook Road and is extremely incised.

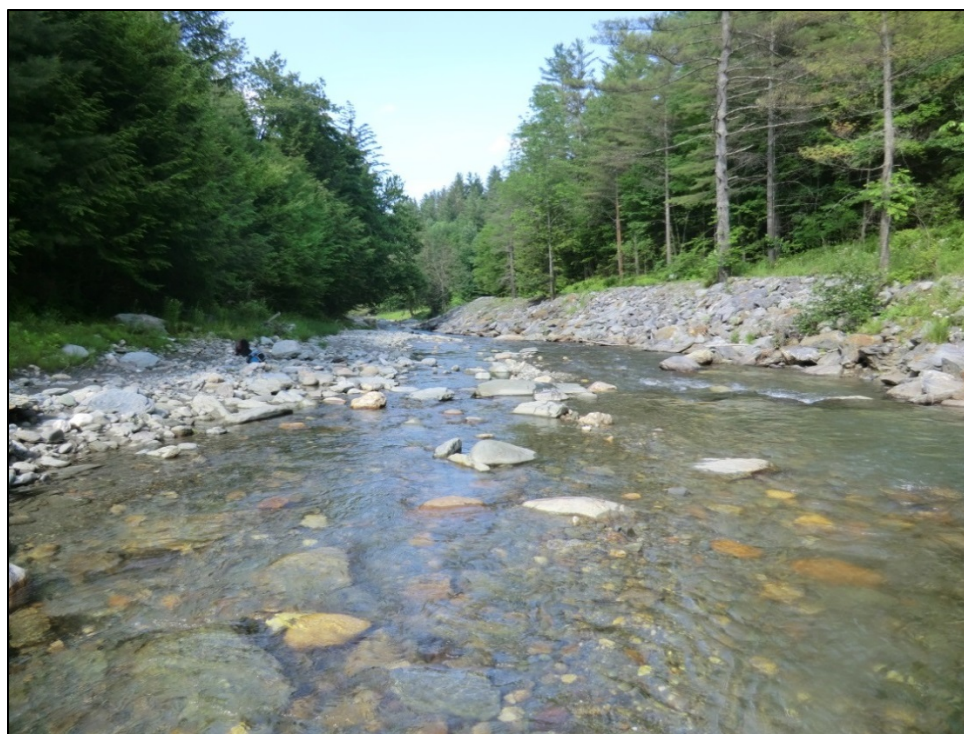
**Figure 5.31.** Bank armoring along Stony Brook Road is extensive in T5.02.

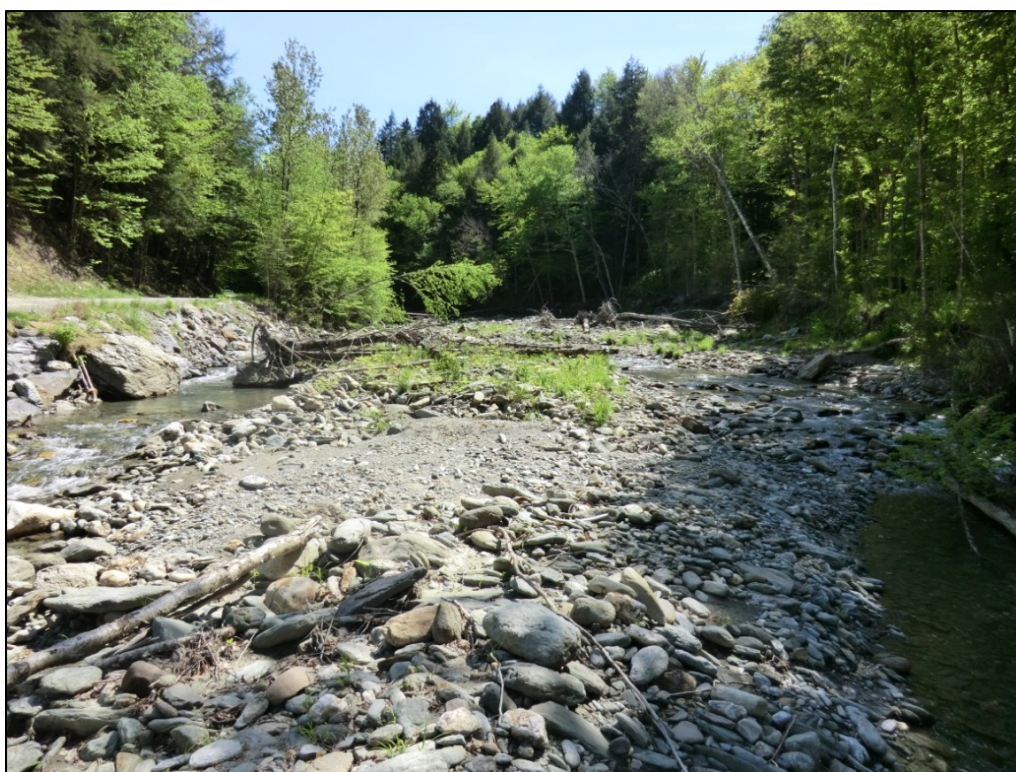
Figure 5.37. Aggradation is abundant throughout T5.05-B.

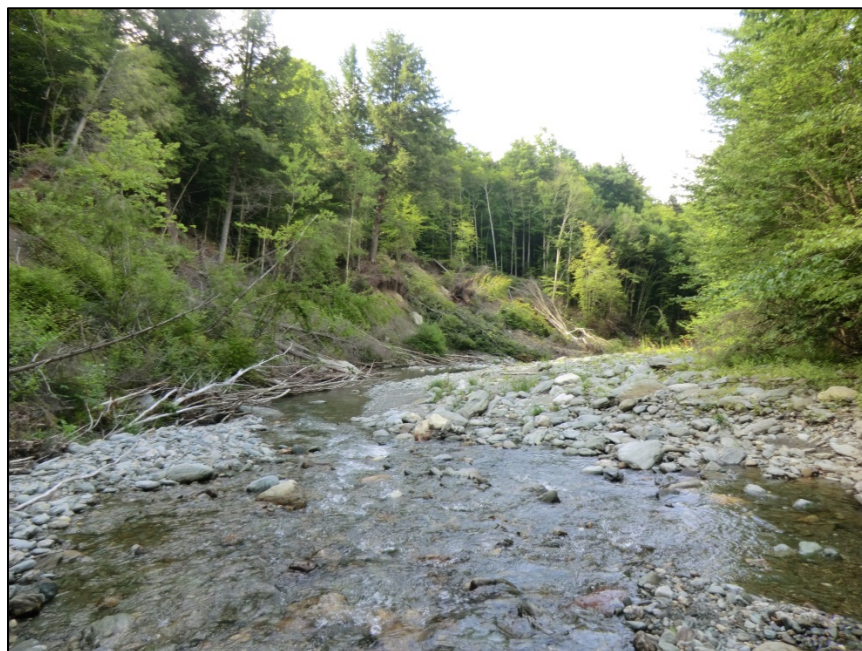
**Figure 5.38.** T5.06-A is majorly aggrading and building a juvenile floodplain.

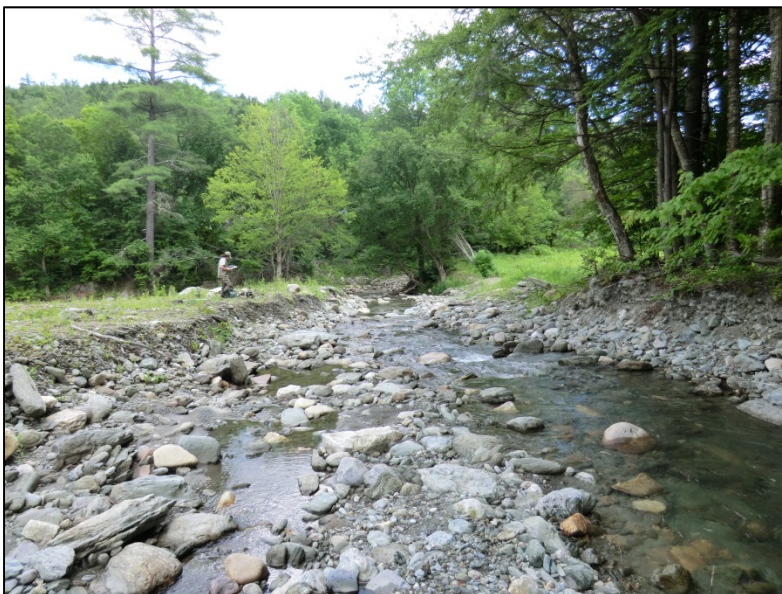
**Figure 5.43.** Fletcher Brook was extensively dredged and windrowed at the alluvial fan in T5.3-S1.01-A after Irene.

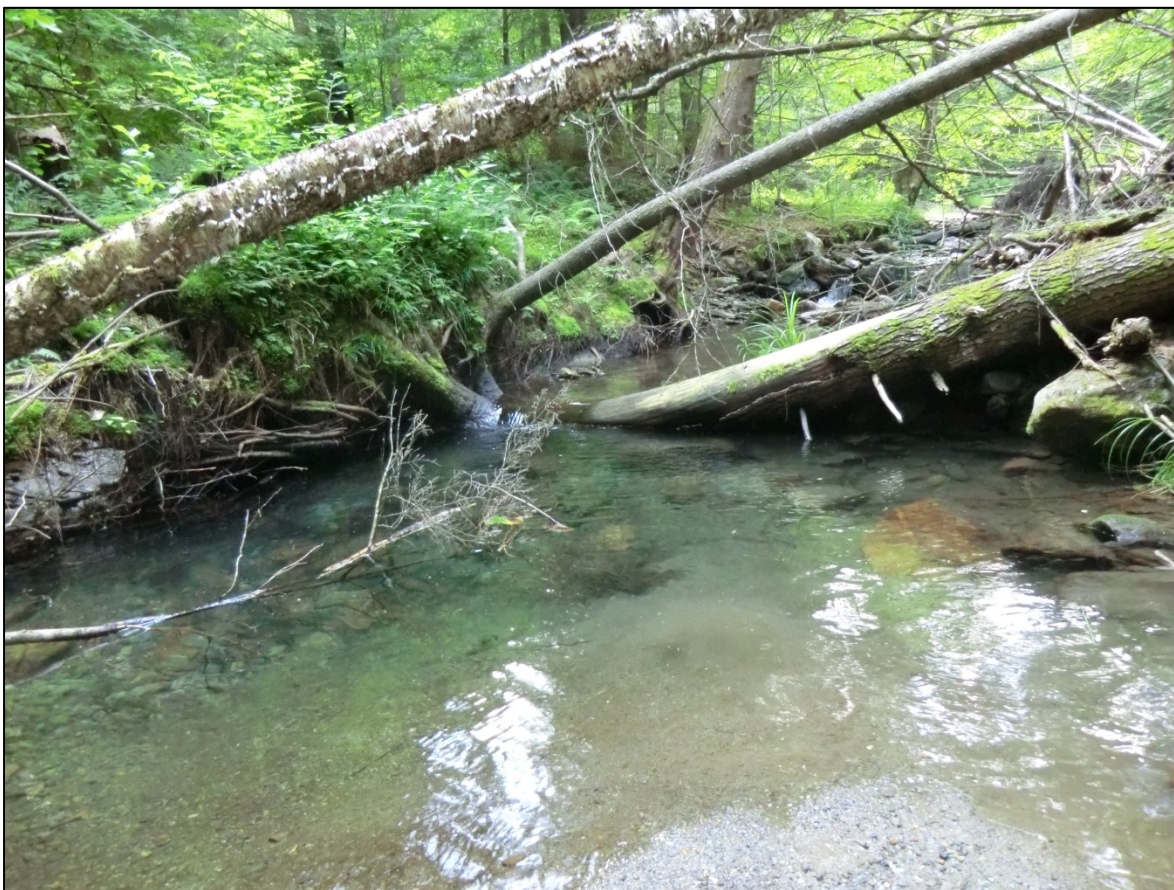
**Figure 5.49.** T6.1-S1.01-C has great habitat features, including abundant plunge pools.

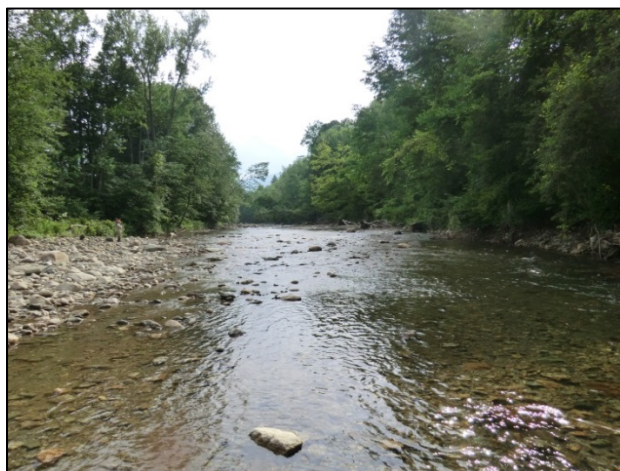
**Figure 5.54.** The West Branch is overly wide and highly aggradational in T7.01-A.

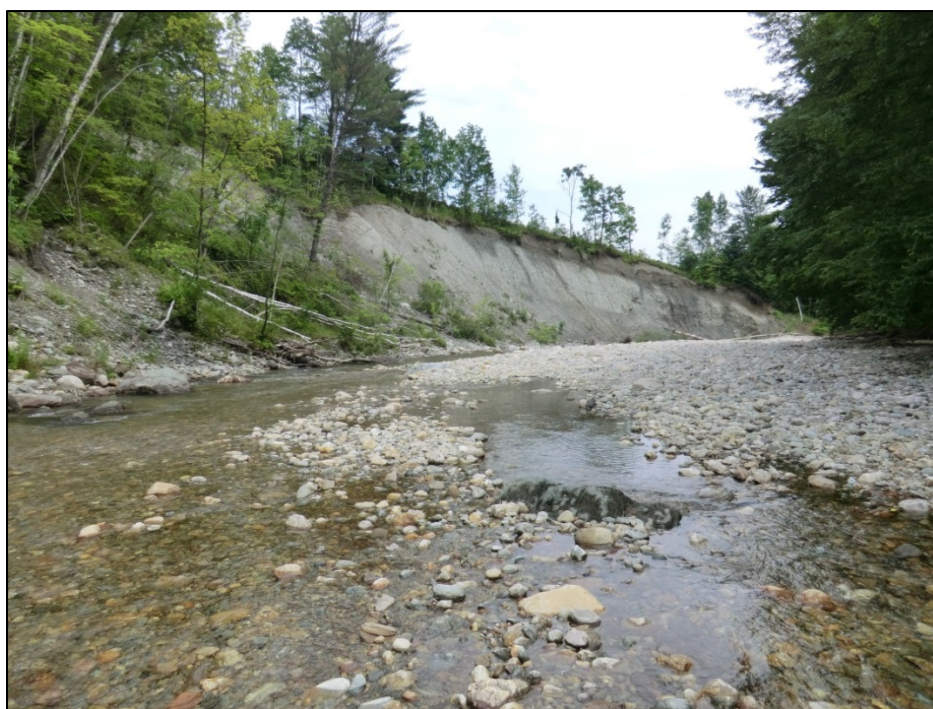
**Figure 5.56.** A wide, aggradational channel is characteristic of T7.02-A.

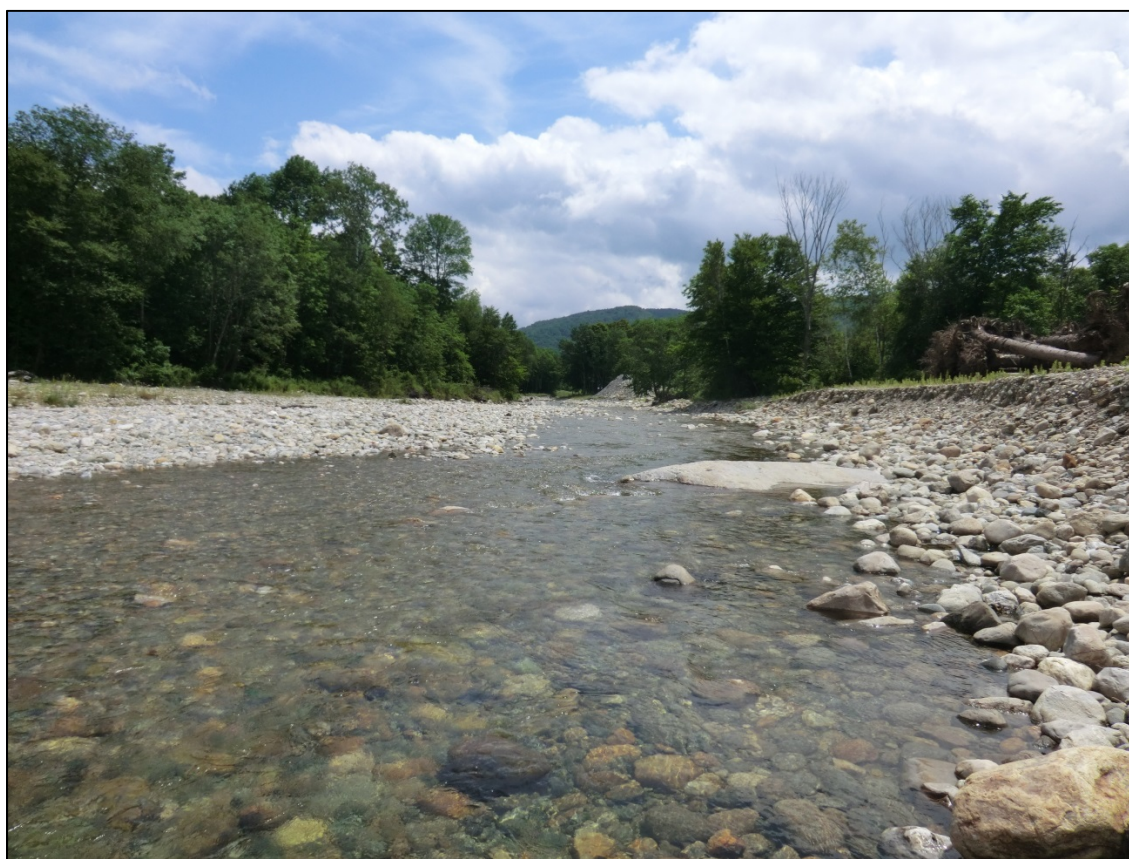
**Figure 5.58.** T7.02-C was subjected to extensive windrowing and gravel mining post-Irene.

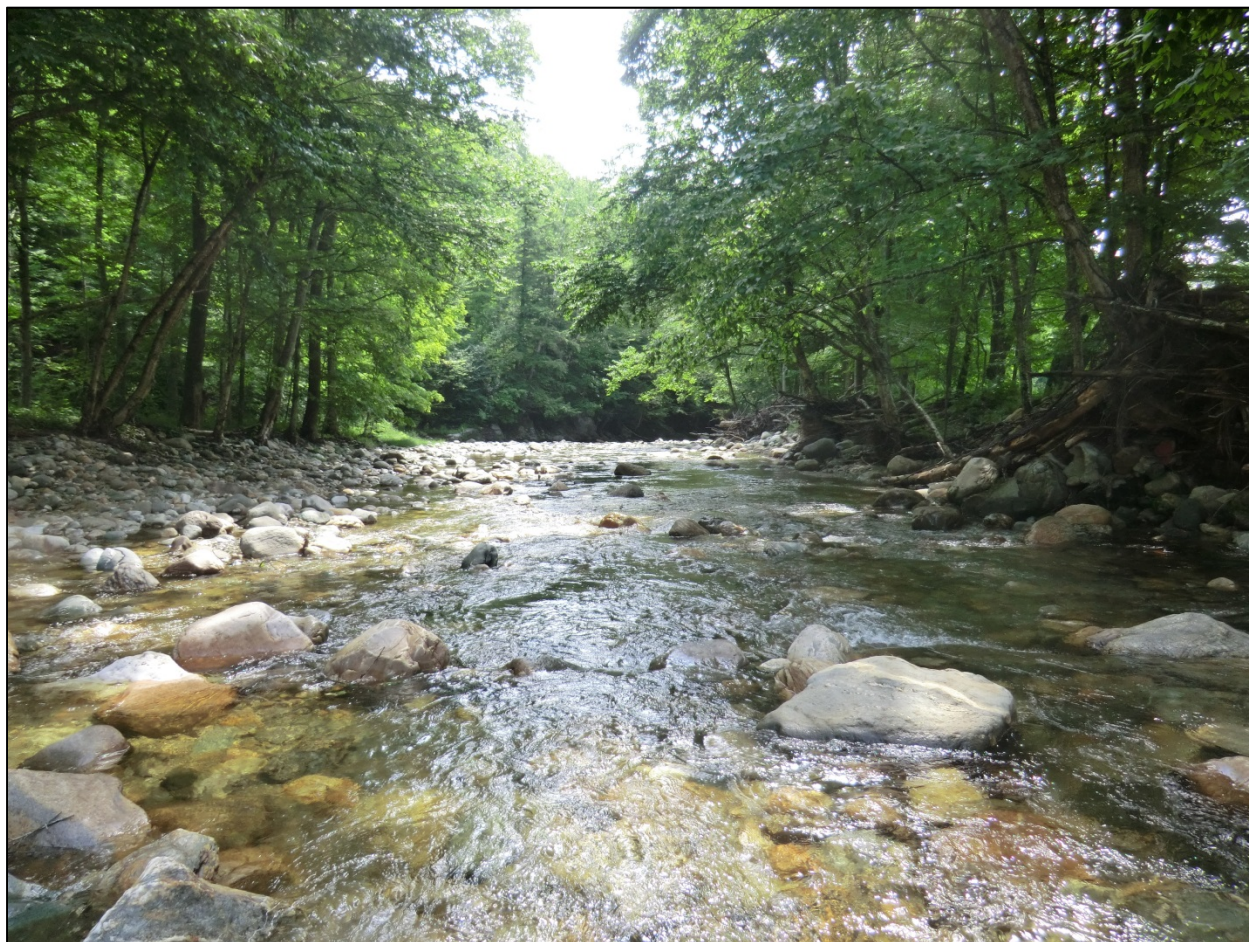
**Figure 5.59.** T7.02-D could not be fully assessed due to a lack of property access.

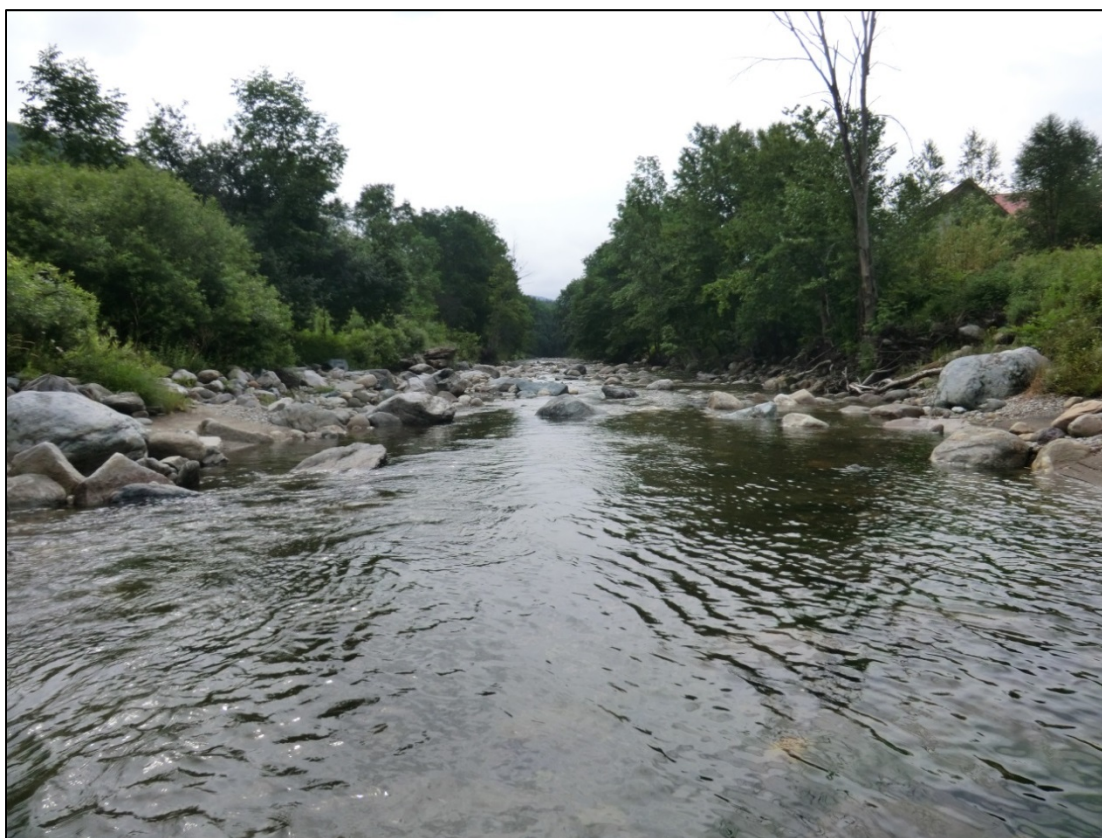
**Figure 5.60.** Extensive historic straightening in T7.02-E has created a featureless, plane bed channel.

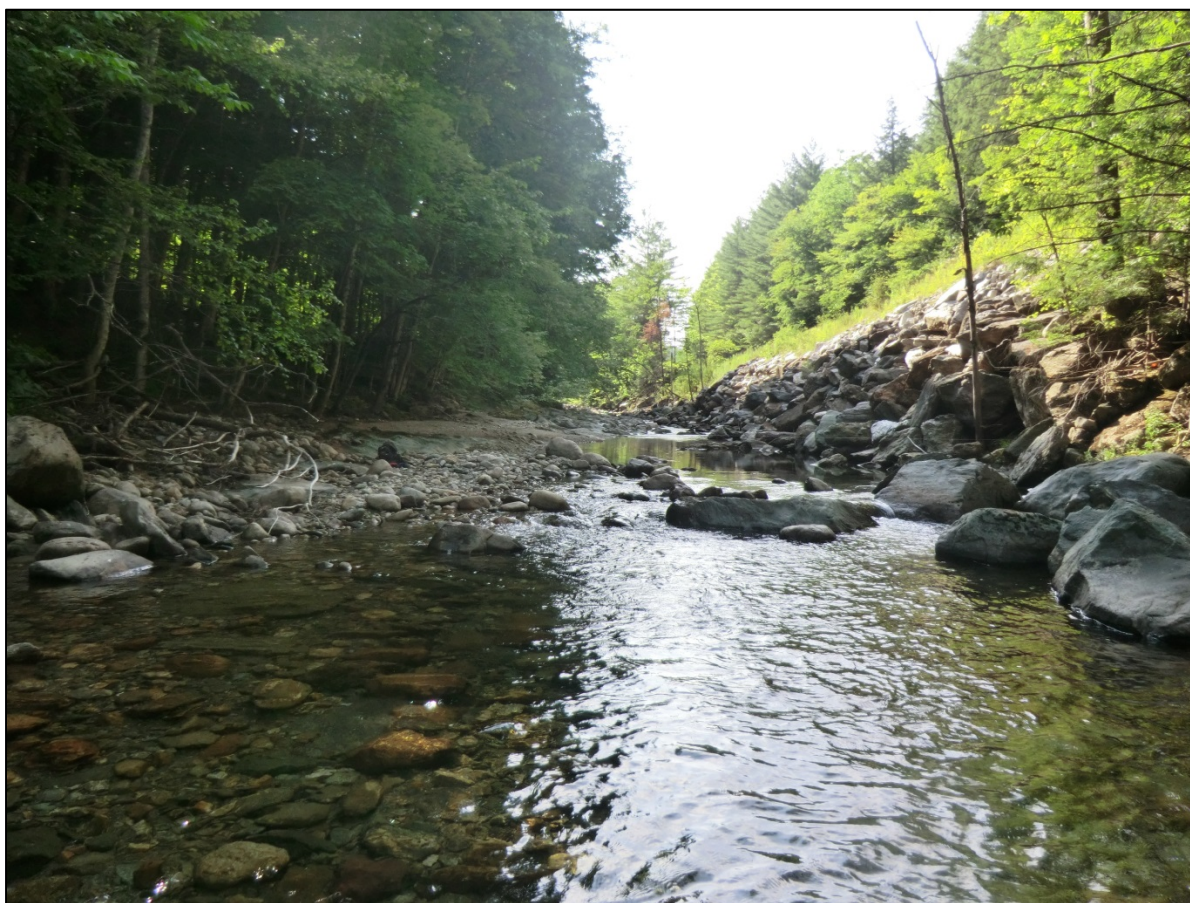
**Figure 5.63.** T8.01-C flows through a semi-confined valley along Route 125.

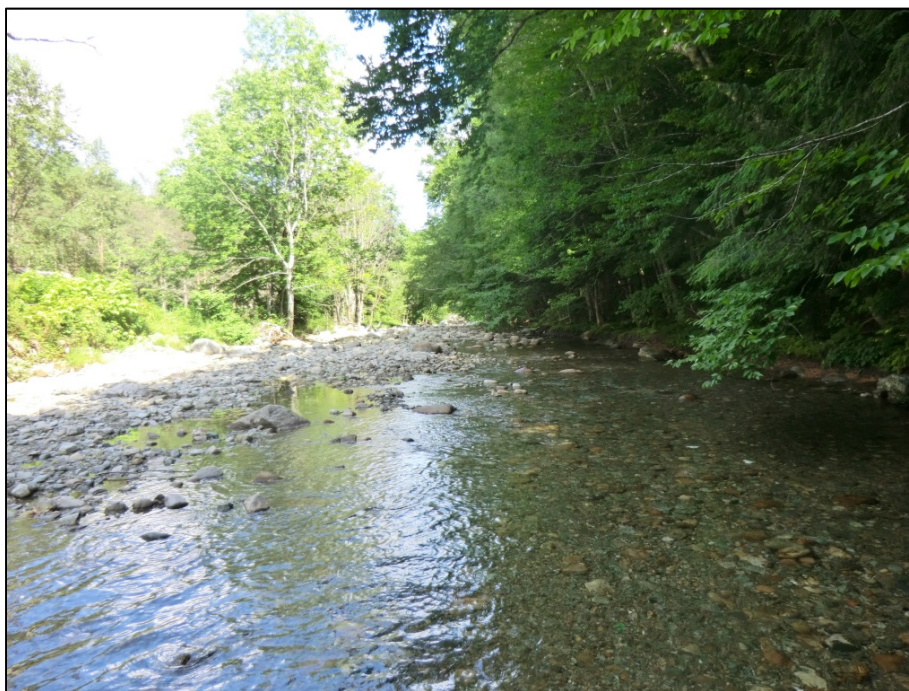
**Figure 5.64.** The Hancock Branch was straightened along its southern valley wall in T8.02-A.

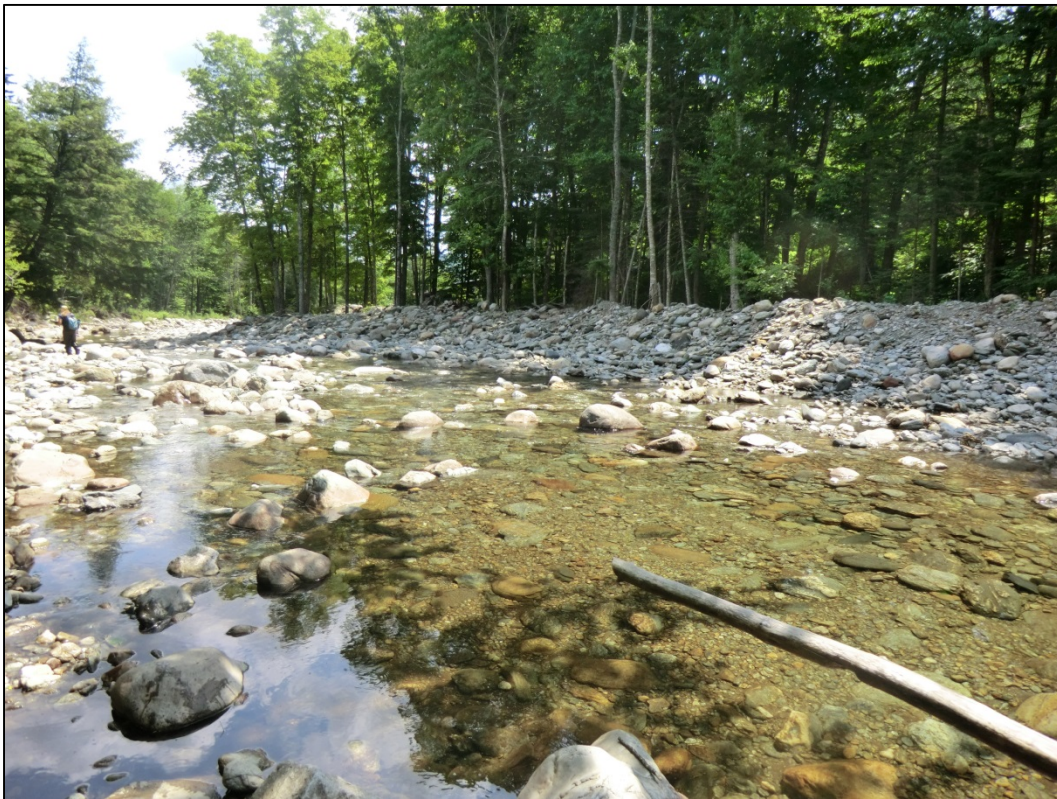
**Figure 5.67.** Windrowing is common in T8.02-D.
