# Upper & Middle White River Watershed Corridor Plan

Barnard, Hancock, Pittsfield, Rochester, and  
Stockbridge, Vermont  
July 15, 2015

Prepared by:  
Bear Creek Environmental, LLC  
149 State Street, Suite 3  
Montpelier, Vermont 05602

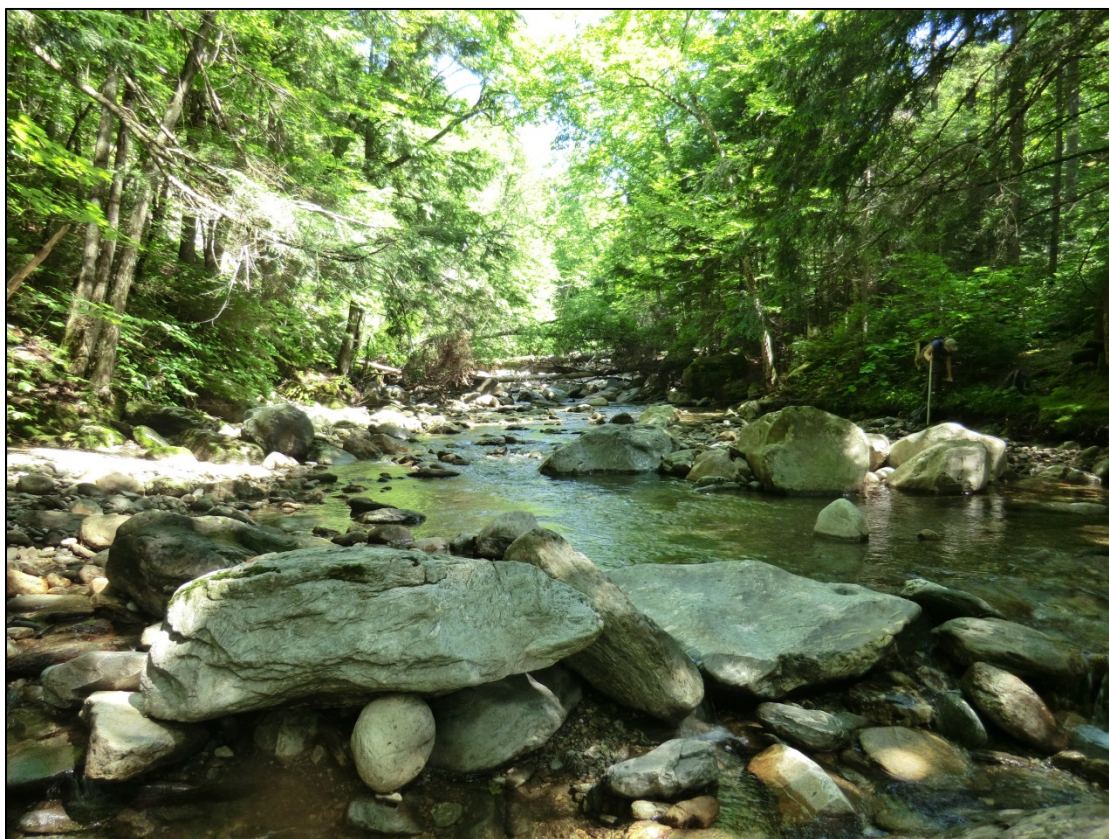
**Figure 5.70.** T8.03-C flows through the Green Mountain National Forest and has very few human impacts.
