# Wardsboro Brook Watershed Corridor Plan

Wardsboro & Jamaica, Vermont  
October 27, 2014

Prepared by:  
Bear Creek Environmental, LLC  
149 State Street, Suite 3  
Montpelier, Vermont 05602

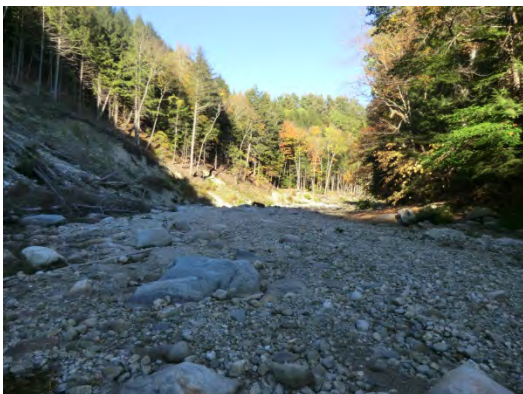
Project #6 –  
Investigate  
Channel  
Alteration

| Project # Segment | Type of Project | Site Description Including Stressors and Constraints | Project or Strategy Description | Technical Feasibility and Priority | Benefits | Potential Partners/ Programs |
|---|---|---|---|---|---|---|
| Project #6<br>T8.01-C | Active Restoration | Channel was heavily dredged and gravel mined post-TSI, lowering the streambed significantly. The brook is trapped between the valley wall and Rt. 100 in this area. | <b>Investigate Channel Alteration &amp; Options to Replace Dredged Material</b> | Low Priority (Interested landowner, but not much available floodplain) | Improved geomorphic stability, habitat, and water quality | Landowners, WRC, VANR, Town of Jamaica |

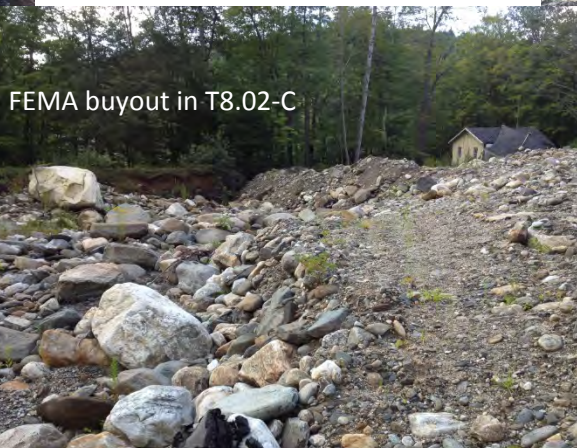
FEMA buyout in T8.02-C

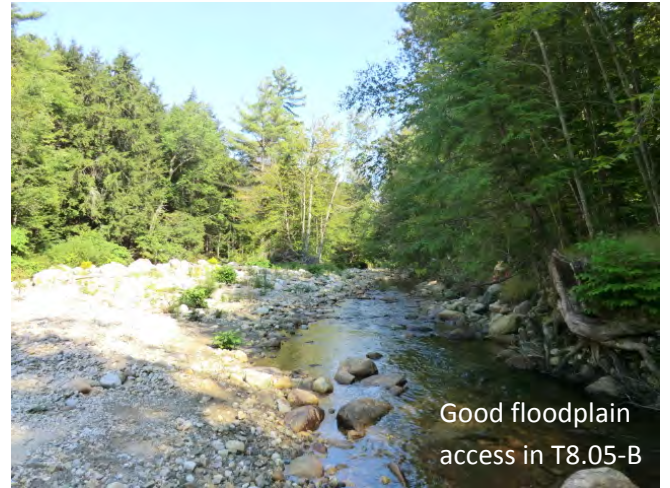
Good floodplain  
access in T8.05-B
