# **Ompompanoosuc River Corridor Plan**

**West Fairlee to Thetford, Vermont**

**April 28, 2011**

**Bear Creek Environmental, LLC**

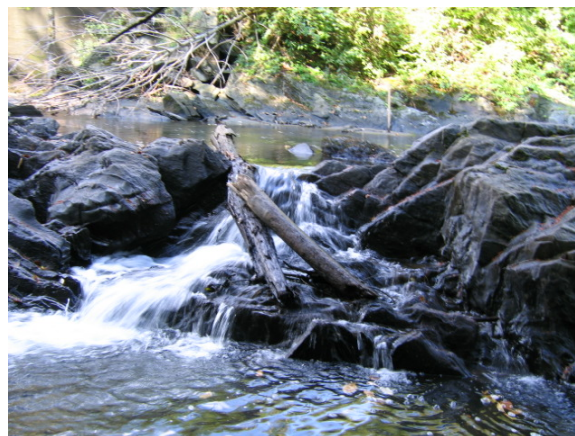
A full rapid geomorphic assessment could not be completed in Segment R15-B due to the bedrock gorge with multiple ledge grade controls (Figure 4.6). The ledge grade controls are providing vertical stability within the reach by preventing the bed from incising.

**Figure 4.6** One of many ledge grade controls in R15-B.

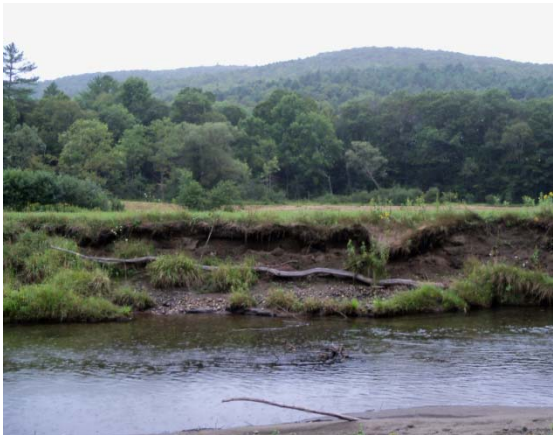
**Figure 4.10** Lack of buffer & extensive bank erosion **Figure 4.11** Recent gravel extraction location in R18

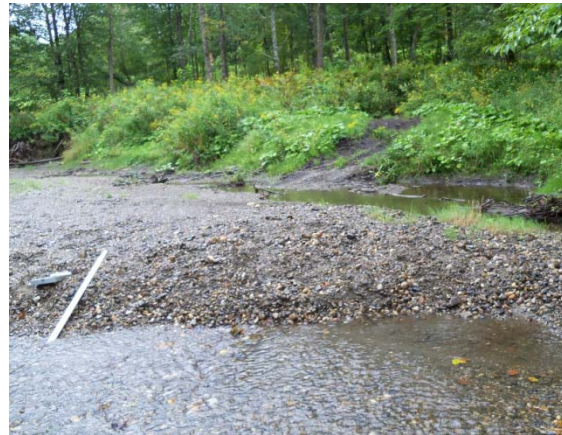
The lower end of reach R18 begins about 1,300 feet downstream of the Cross Road Bridge and continues upstream to the confluence with Schoolhouse Brook. Approximately 70 percent of this mile long reach appears to have been historically straightened. Historic incision has resulted in a stream type departure from a reference stream type of “C” with a vast floodplain to a “B” channel with a narrow floodplain. Reach 18 is undergoing active geomorphic adjustment, and alternates between areas that are widening and areas that are stabilizing and starting to build a juvenile floodplain at a lower elevation. Widening is causing significant bank erosion (Figure 4.10) and has led to a shallow channel, reducing available aquatic habitat and causing a buildup of sediment. The overall geomorphic condition is “poor”. Recent gravel extraction (Figure 4.11) was noted at the downstream end of R18 at the time of the Phase 2 assessment in late August 2010.

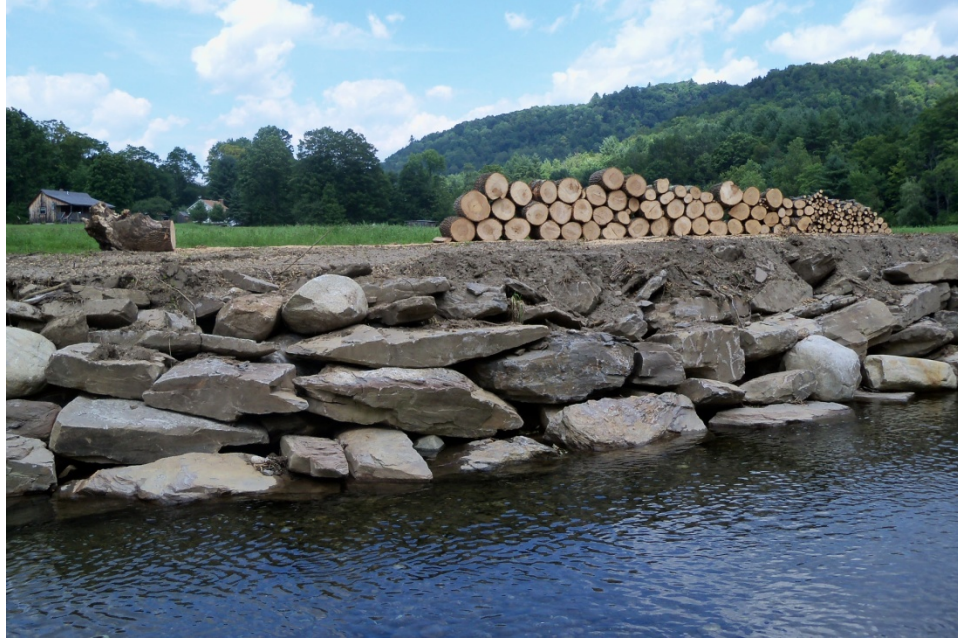
Both at the lower and upper ends of segment 19-B, the channel appears to have been pushed up against the valley wall. The channel is held in a straightened path with riprap. About 20 percent of each bank has hard bank armoring (i.e. concrete) or riprap. In areas where riprap is not present, bank erosion is common. Nearly half of the west bank has buffers less than 25 feet. About 35 percent of the east bank has buffers in the range of 0-25 feet; however, the dominant buffer width on that side is greater than 100 feet. Figure 4.16 shows an area of bank, where trees were recently cut down and the bank was stabilized with riprap.

**Figure 4.16** Newly installed riprap with trees cut along the bank in segment R19-B

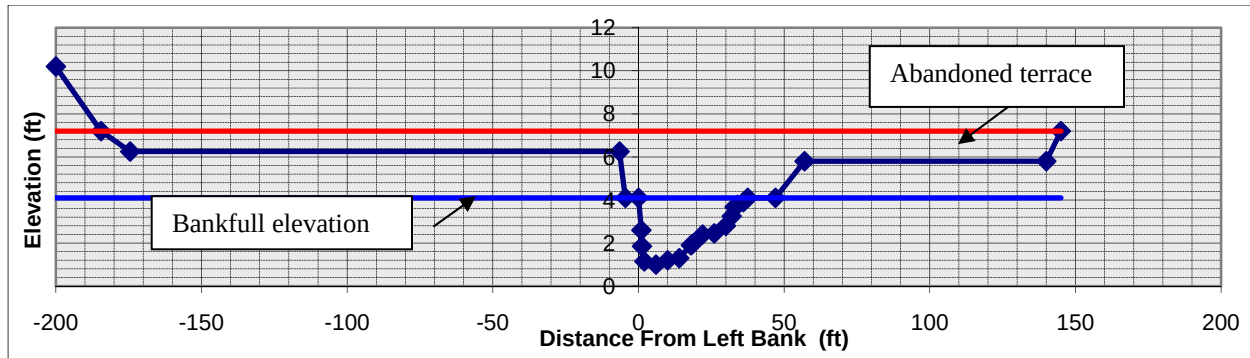
Segment R21-A is 0.8 miles in length. Approximately 55 percent of the channel length has been straightened, primarily for agricultural purposes. The channel has incised historically as shown in the graph of the cross section below (Figure 4.21). The new bankfull elevation (depth where the water overtops the banks and spills out into the floodplain) is currently about two feet lower than the abandoned terrace (i.e. former floodplain before the channel incised). In this case, the channel is moving from the widening stage into the stabilizing stage of the channel evolution model. A very narrow juvenile floodplain (bankfull bench) is starting to develop on the right (west) bank. A bankfull bench, a flat area along the channel, forms at the elevation of the *bankfull discharge*. A bankfull discharge occurs about once every one to two years and is responsible for shaping river channels. The red line in the graph below shows the width of the floodprone area (an area whose extent is at an elevation twice the bankfull elevation) that would be accessed during a large flood event. The floodprone width of the cross section from R21-A is about 330 feet. The difference in the elevation of the abandoned terrace and the bankfull elevation is also illustrated in Figure 4.22.

**Figure 4.21** Channel cross section for segment R21-A (graph is vertically exaggerated for illustration purposes)

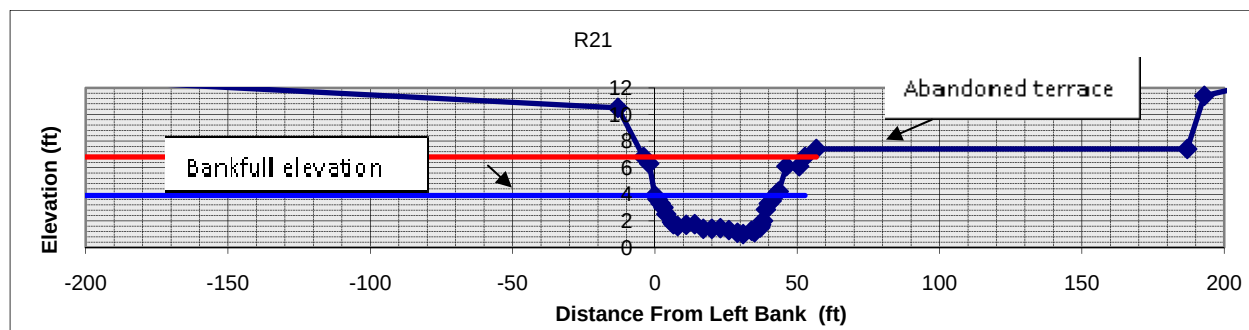
Segment R2I-B is a short segment of just over 1,000 feet in length near the West Fairlee/Vershire town line. Floodplain access is poor within this segment. As shown in Figure 4.23, the abandoned terrace is about 3.5 feet higher than bankfull. The floodprone width of this “F” channel is only 57 feet, and is much narrower than the floodprone width of the “C” channel shown in Figure 4.21. The channel in R2I-B is just starting to go through a widening process. Trees on the bank and riprap are preventing the channel from widening further. There is virtually no floodplain available at a bankfull discharge, and the sediment is transported through rather than being deposited on the floodplain. The overall geomorphic condition of segment R2I-B is “fair”.

**Figure 4.23** Channel cross section for segment R2I-A (graph is vertically exaggerated for illustration purposes)

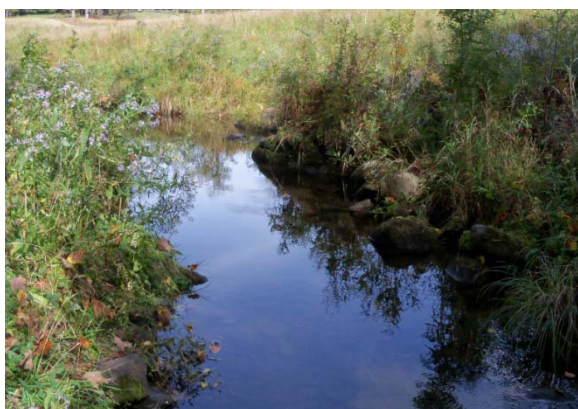
A full Phase 2 assessment of the most upstream portion of R16T2.05 (segment E) could not be completed because of lack of landowner permission. Segment E is about 1,500 feet in length. Riprap is evident along both sides of the channel at the downstream end; the lower 230 feet of the segment has been straightened (Figure 4.40). The upper 550 feet of the segment has also been straightened, and what appears to be an old mill building is located along the east bank in the most upstream part of the segment (Figure 4.41). The channel in most of this segment flows through a horse pasture with nearly 75 percent of the channel length having buffers less than 25 feet in width.

**Figure 4.40** Straightened channel in R16T2.05-E

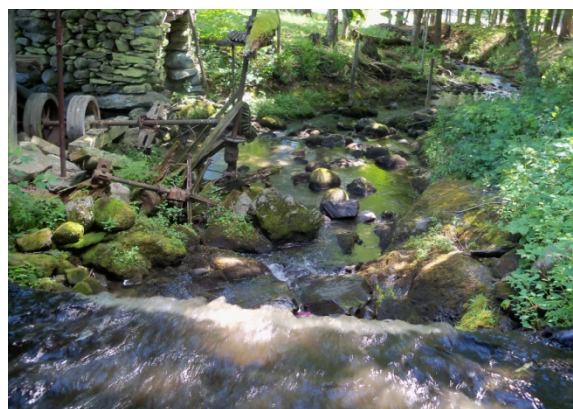
**Figure 4.41** Old mill building on east bank

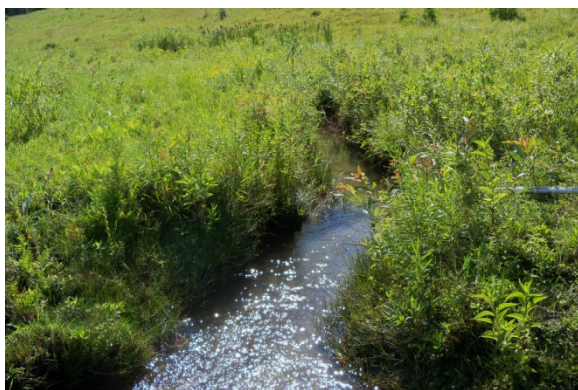
The most downstream segment, R16T2.06-A, starts at Marsh Hill Road and goes upstream about one-half mile through a horse pasture with buffers less than 25 feet along the entire length (Figure 4.42). This segment likely was a wetland historically that has been altered for agricultural use. The dominant bedform is riffle-pool, although there are some areas with plane bed features that lack defined pools. The dominant bed substrate is gravel. Silt and clay are cohesive bank material on the lower bank, while the upper bank is non-cohesive and consists primarily of sand. The channel has a reference and existing stream type of “E”, but lacks the high sinuosity that is typical of this type of channel. The channel currently has a straightened planform either due to active head cuts (Figure 4.43) or historic and present channel management practices, such as straightening and armoring or dredging. Six active head cuts were mapped during the Phase 2 assessment, which is a sign of active incision. The overall geomorphic condition is at the low end of the “fair” range. In addition to having extreme active incision through the presence of numerous head cuts, the channel is actively widening due to lack of floodplain access. There is bank erosion along 60 percent of both banks. Horses are adding to the bank erosion, by causing localized disturbance at animal fords (Figures 4.44 and 4.45).

**Figure 4.42** Low sinuosity in segment R16T2.06-A

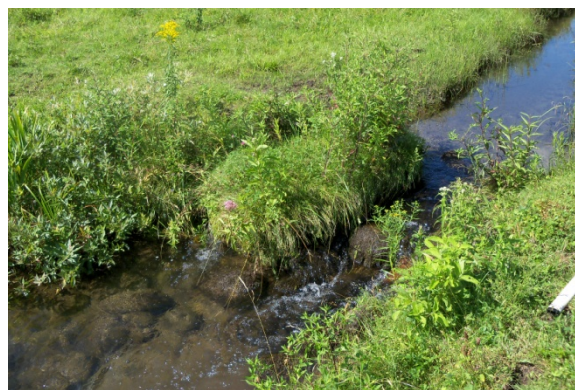
**Figure 4.43** Head cut or knickpoint

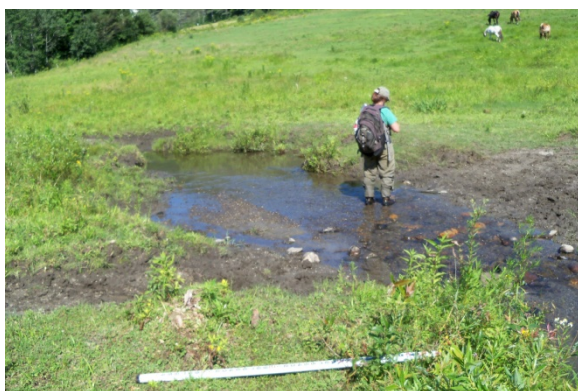
**Figure 4.44** Disturbed soil at animal ford

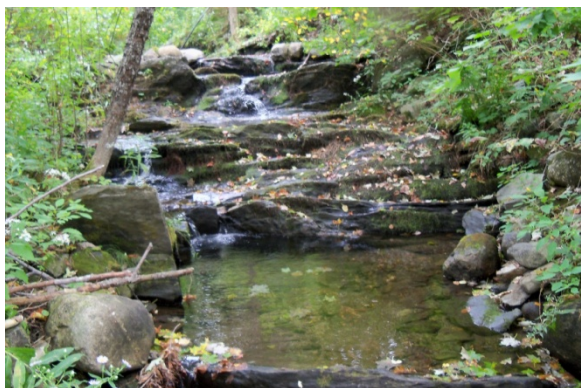
**Figure 4.48** Waterfall in R16T2.06-C

The habitat condition of R16T2.06-C is also “good”, although the score is at the low end of the range. All of habitat parameters scored in the good category with the exception of connectivity. The waterfall and the Godfrey Road culvert are likely an obstruction for some aquatic species. The Godfrey Road culvert is discussed in further detail in sections 4.5 and 6.2. In general, the water depth in segment C is shallow. There are frequent pools, but none of the pools exceeded two feet in depth at the time of the assessment.

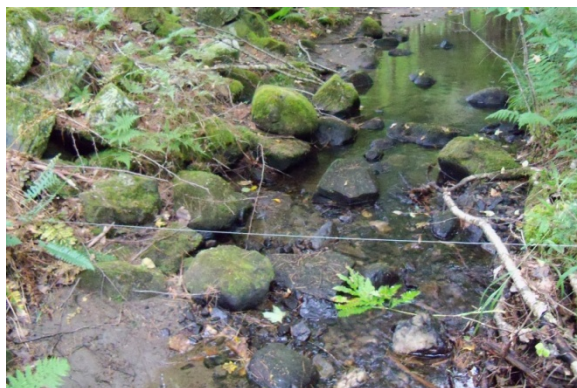
**Figure 4.49** Typical channel in R16T2.06-C

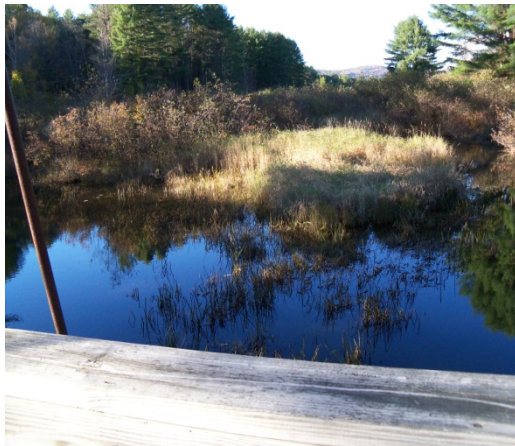
**Figure 4.51** Wetland upstream of Lake Fairlee

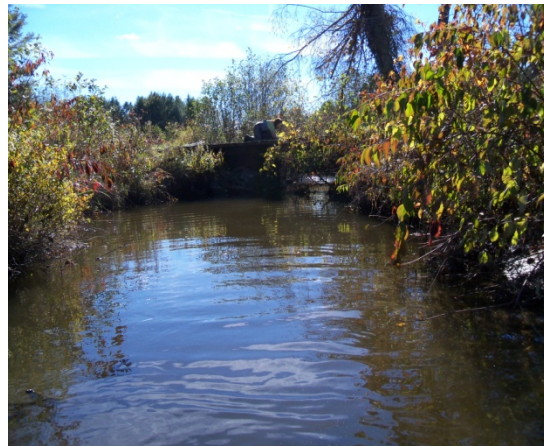
**Figure 4.52** Impounded channel below farm bridge

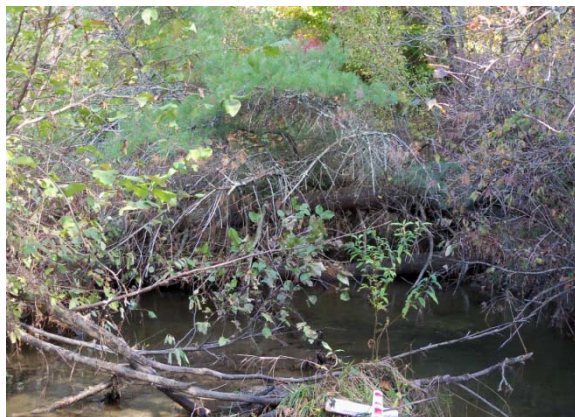
The habitat condition for Reach R16T2.03S1.01-B is “good”. The dominant buffer width within the reach is over 100 feet on the east side and 51-100 feet on the west side. Buffers less than 25 feet are subdominant and occur in the area immediately downstream of the Cross Road Trail (Figure 4.53). The presence of frequent pools with a variety of depths and surface area are offering suitable depth cover for fish and other aquatic species. Pools with depths greater than three feet are common within segment B. There are a number of low flow and high flow refuge areas, where aquatic species can retreat during stressful conditions. Large woody debris cover is excellent (Figure 4.54), and there are many undercut banks.

**Figure 4.54** Large woody debris cover

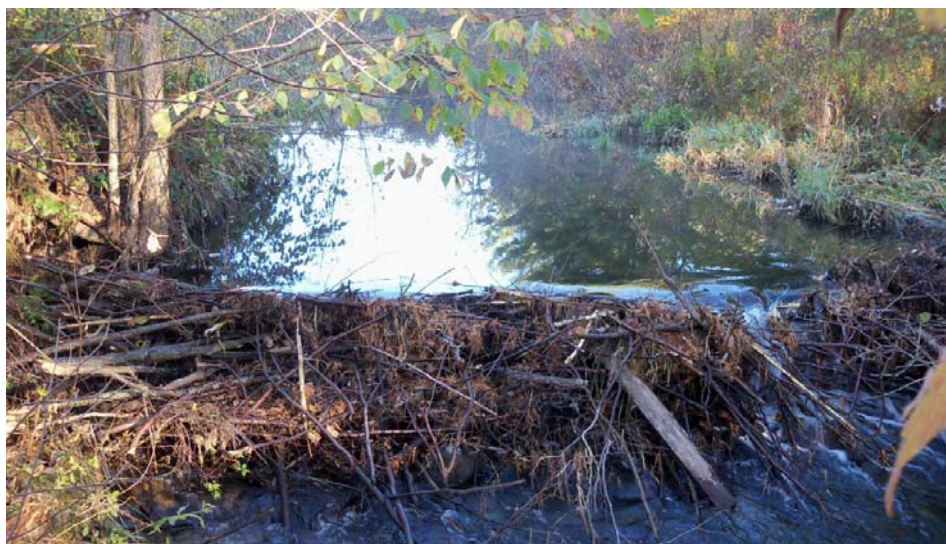
The most upstream segment in R16T2.03S1.01-C starts above the Cross Rivendell Trail Bridge and continues about 1,000 feet upstream. The channel is impounded by a beaver dam at the downstream end of the segment (Figure 4.55). Riparian buffers are narrow in segment C along the west bank with a dominant buffer width of 0-25 feet. The east bank, however, is forested and the dominant buffer width is greater than 100 feet. There is a short area in the middle of the segment adjacent to a crop field, where the buffer is 51 to 100 feet. Crop is the dominant land use within the western corridor, while forest is dominant in the eastern corridor.

**Figure 4.55** Beaver dam impounding flow in reach R16T2.03S1.01-C of Middle Brook

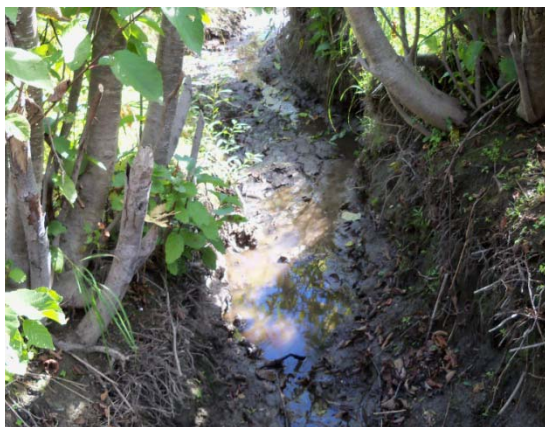
**Figure 4.57** Incised drainage swale

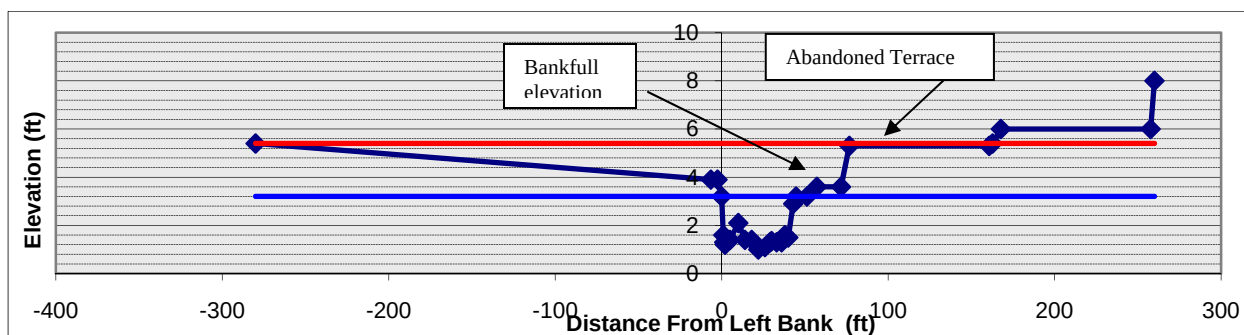
The most downstream segment (R18T3.01-A) has a reference and existing stream type of “C”. The segment is about 1,700 feet in length. The dominant bed substrate is cobble, and bedform is riffle-pool. The channel flows through a very broad valley, and has moderate to high sinuosity. As shown in the graph of a cross section (Figure 4.63), there is a well defined abandoned terrace on the right (west side) of the channel, which may be the recently abandoned floodplain. If this is the case, the channel has historically incised by 2.5 feet (or the *bankfull channel depth*). Historic channel incision has led to extreme planform adjustment and considerable widening and aggradation. The geomorphic condition is “poor”. The channel has started to build a juvenile floodplain at a lower elevation than the abandoned terrace.

**Figure 4.63** Graph of channel cross section for segment R18T3.01-A  
(The graph is vertically exaggerated for illustration purposes.)

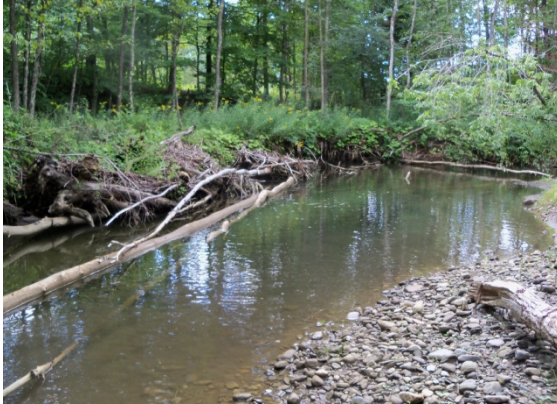
**Figure 4.64** Large pool providing habitat for fish

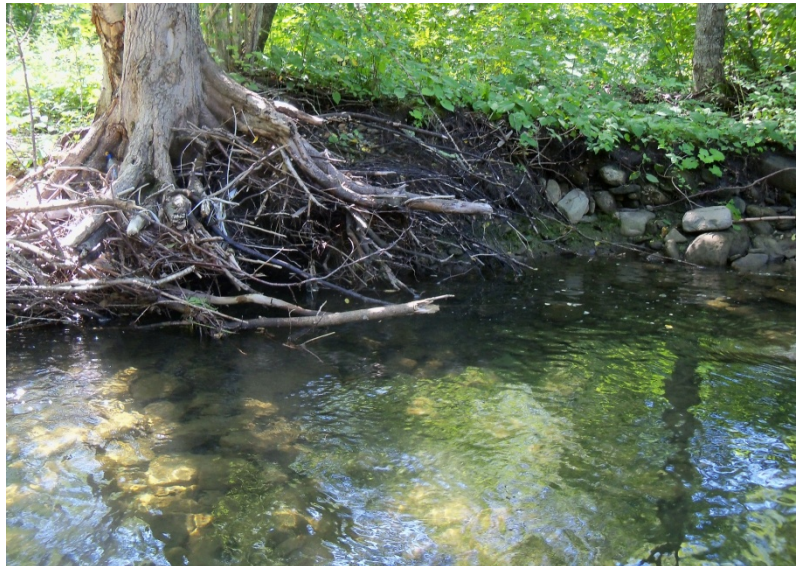
Despite the active geomorphic adjustment, the habitat scored at the high end of the “fair” range. The habitat parameter Scour and Deposition Features was mixed in terms of scoring. Scour (pool habitat) was ranked high, while deposition (bars) was ranked low. The frequency and diversity of pool sizes are providing excellent deep water habitat cover for fish. Boulders and large woody debris in the pools are contributing to pool cover (Figure 4.64). Large depositional features, such as mid channel bars, are present in the channel (Figure 4.65). Fine deposition in the channel may clog the voids between cobbles and coarse gravel, thereby impairing spawning habitat for trout, shelter for young trout, and habitat for aquatic insects. The dominant buffer width is greater than 100 feet on both sides, and trees on the near bank are providing organic material that is an important source of food for aquatic insects and other aquatic species. There are numerous undercut banks with suitable water depths to provide bank cover for fish (4.66).

**Figure 4.66** Tree root is providing a stable undercut bank

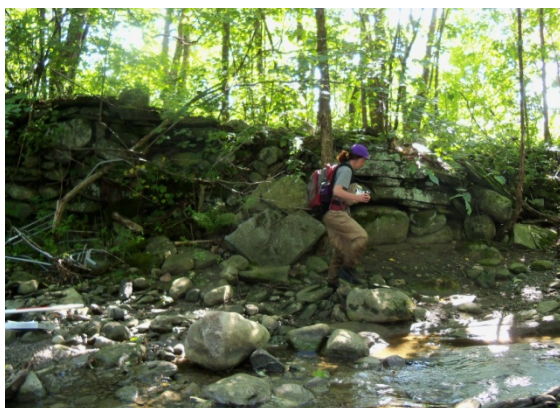
**Figure 4.67** Rock wall or old abutment on east bank

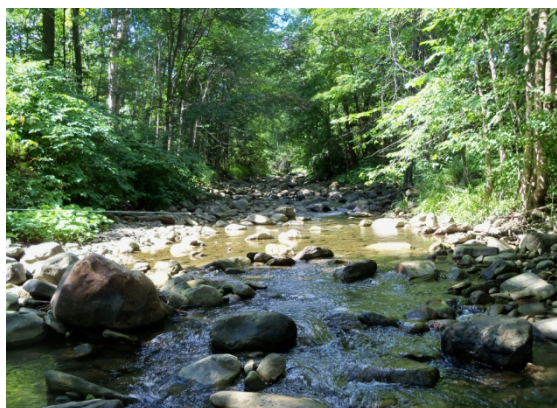
Segment B on the lowest reach of Schoolhouse Brook begins just downstream of the Route 113 crossing and continues upstream 625 feet. The segment has been extensively straightened and there is large rock or hard bank armoring present along 245 feet of the west bank and 155 feet of the east bank. There is some evidence of berms along the east bank that are likely from windrowing. The channel was likely dredged following a major flood event and the material was placed along the east bank to protect adjacent yards and buildings off of Route 113. The channel is encroached upon by Back Street on the west bank. A rock wall or old abutment is also located on the east bank (Figure 4.67). Back Street sits high above the channel, and it is possible that there was some placement of fill on the west bank that is associated with the residential development. The channel has incised resulting in a stream type departure from a reference “C” channel to a “B” channel with reduced floodplain. The geomorphic condition is “fair”. The channel is in the incised stage of the channel evolution model, and appears to be locked in place by large boulders along the bank toe and berms. There are very few depositional features in segment B; the channel has become a sediment transport reach because of the straightened planform (Figure 4.68). There are two channel spanning ledge grade control areas that guard against future channel incision.

**Figure 4.68** Straightened planform

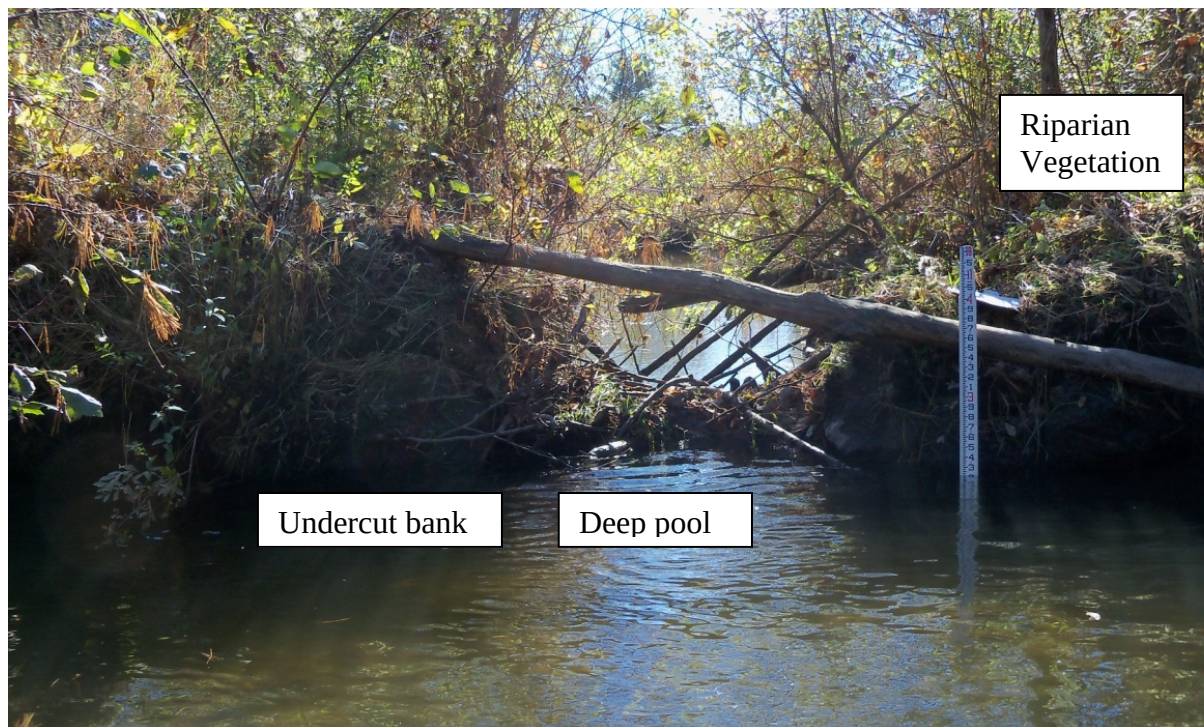
**Figure 4.72.** Segment RI6T2.03SI.01-B on Middle Brook had high quality habitat including excellent woody debris cover, deep pools, undercut banks, and trees in the buffer.

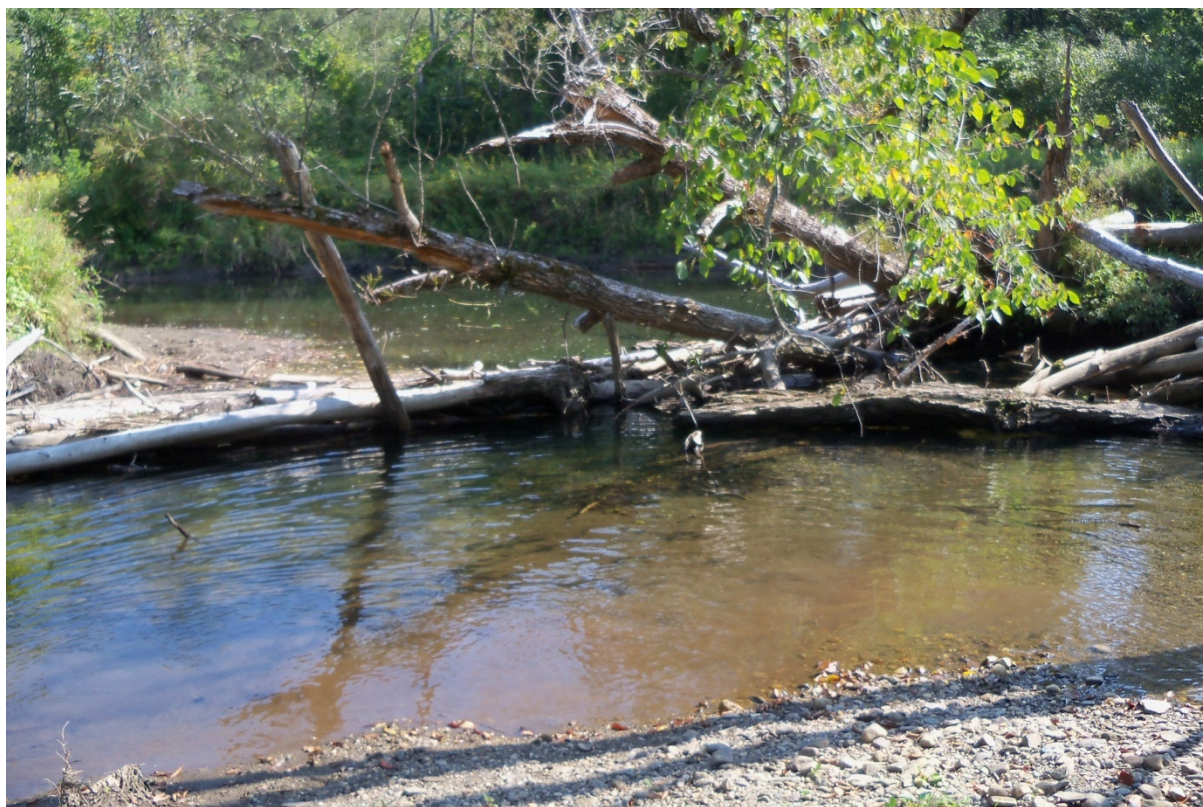
**Figure 4.73.** Large woody debris creating cover in Reach 17

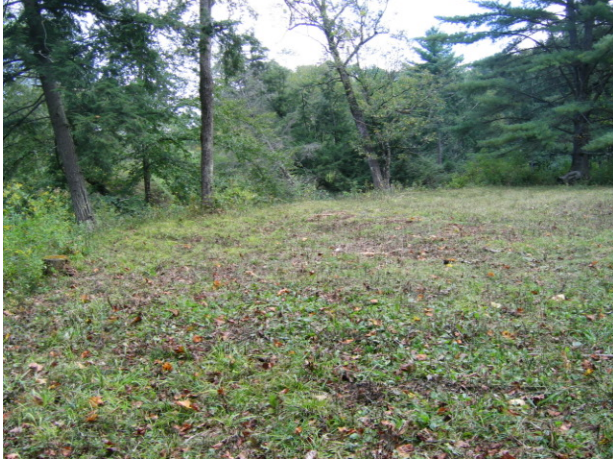
Project #1- Establish no mow zone

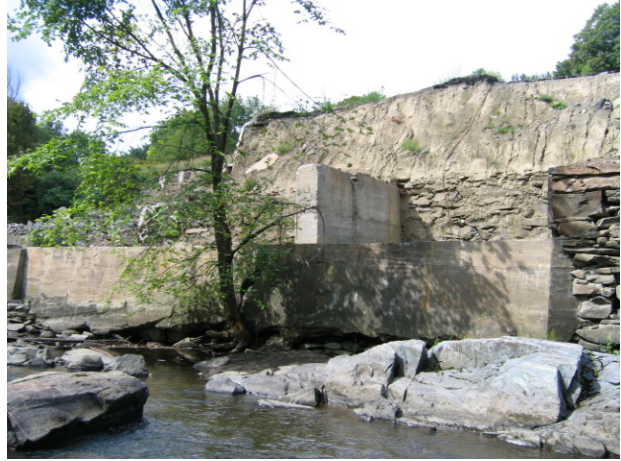
Project #2 – Improve floodplain access

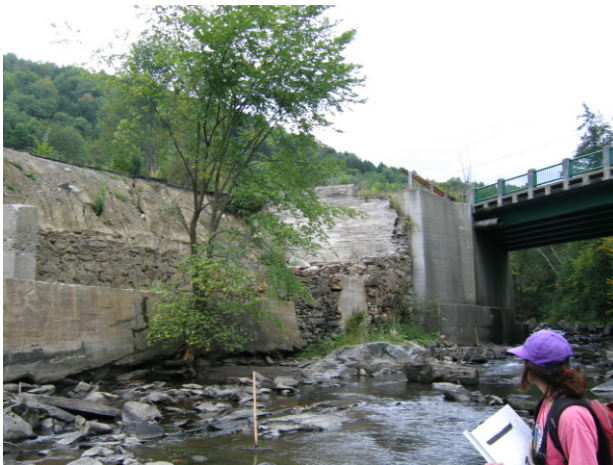
Project #3- Stormwater management

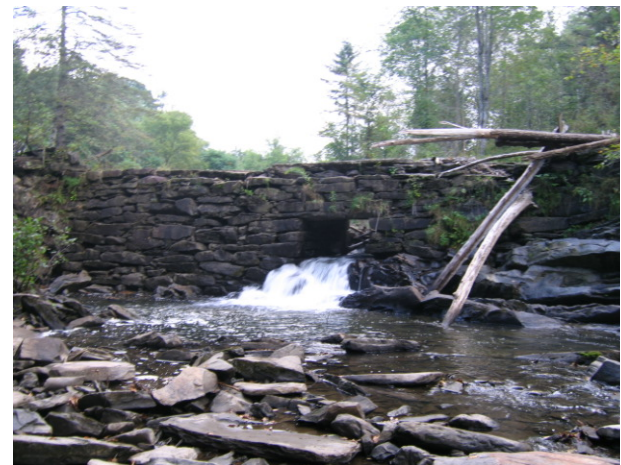
Project #4- Alternatives analysis: dam removal

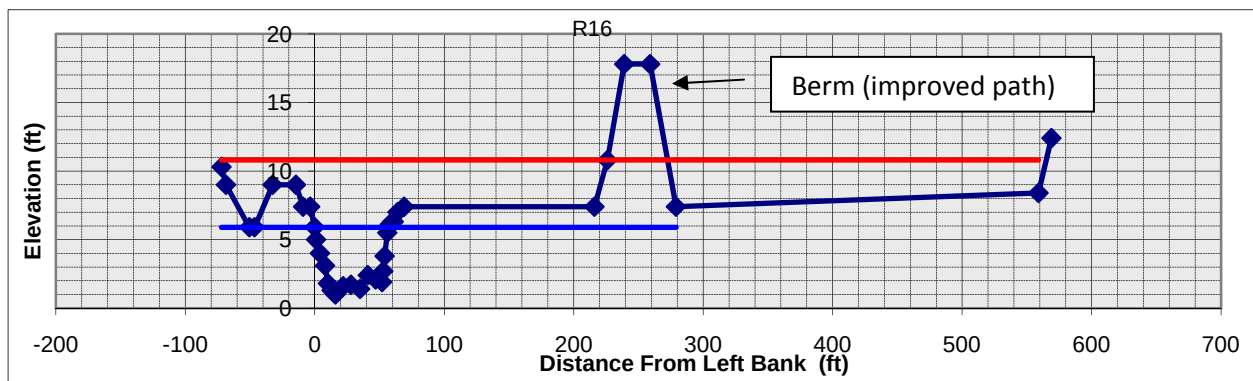
Project #5- Alternatives analysis: berm removal

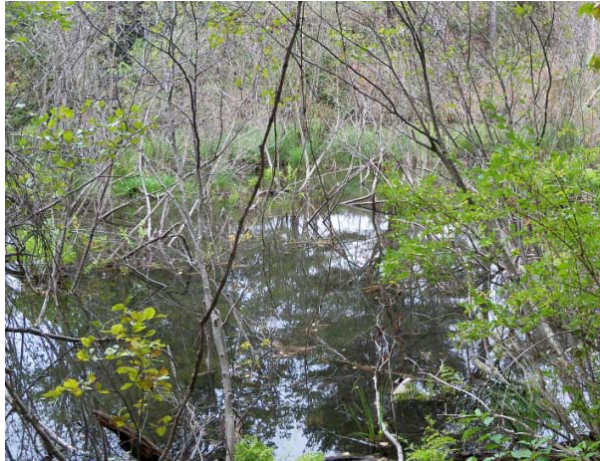
Project #6- Conservation Easement

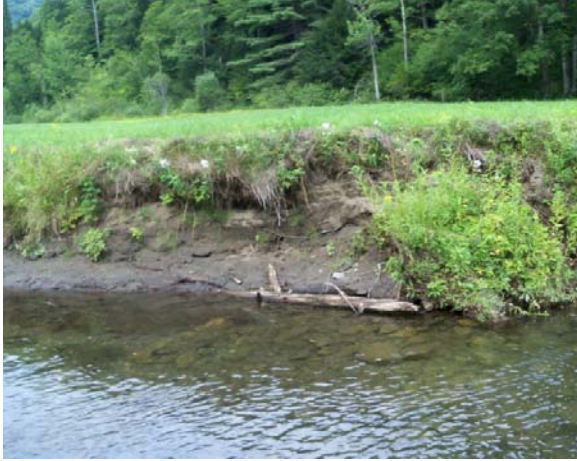
Project #1- Protect river corridor and plant

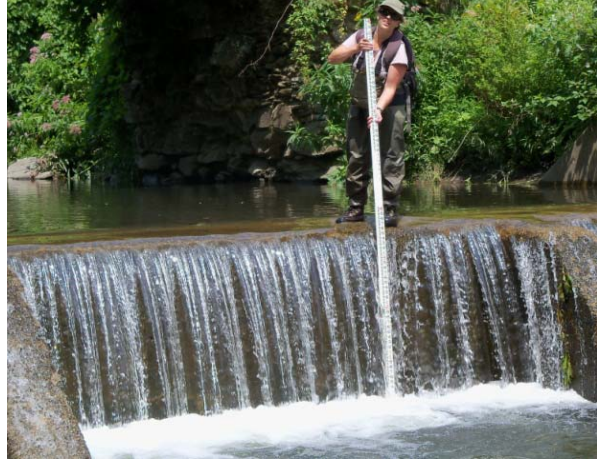
Project #4- Alternatives analysis: dam removal

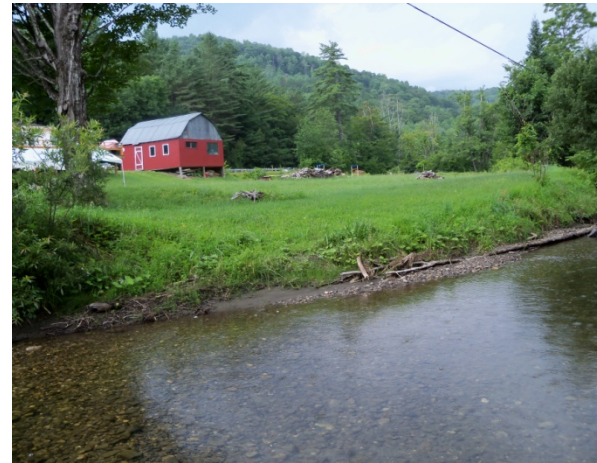
Project #6- Streamside plantings

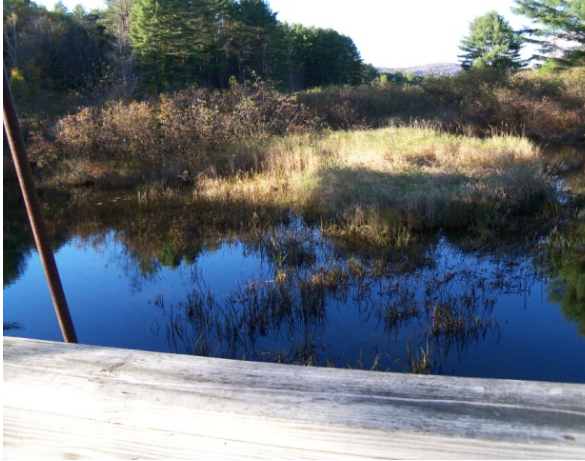
Project #1- Protect wetlands river corridor

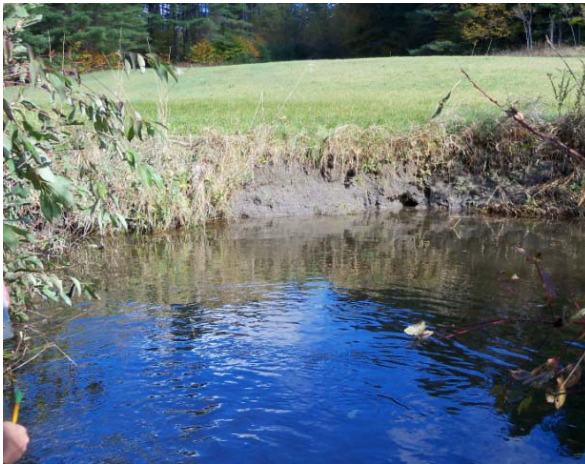
Project #3- Protect corridor and plant

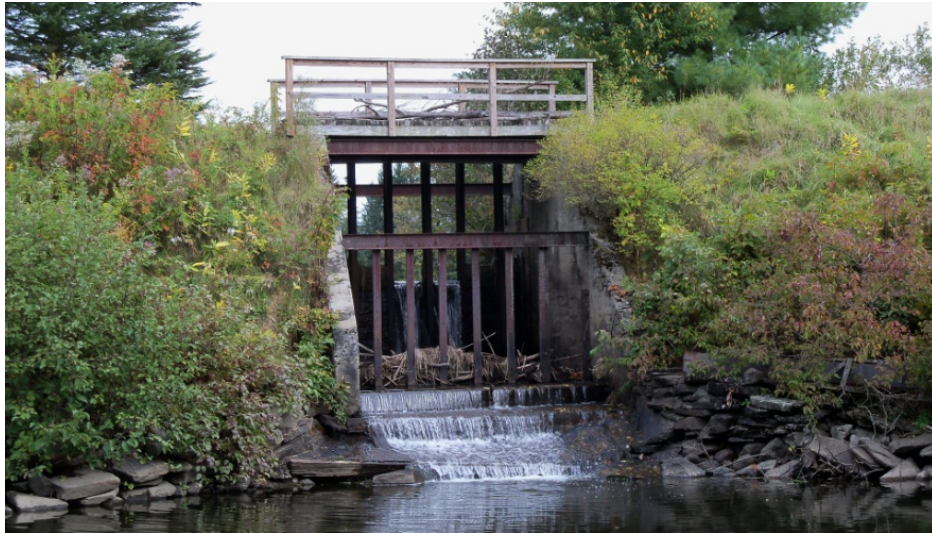
Project #8- Alternatives analysis: dam removal

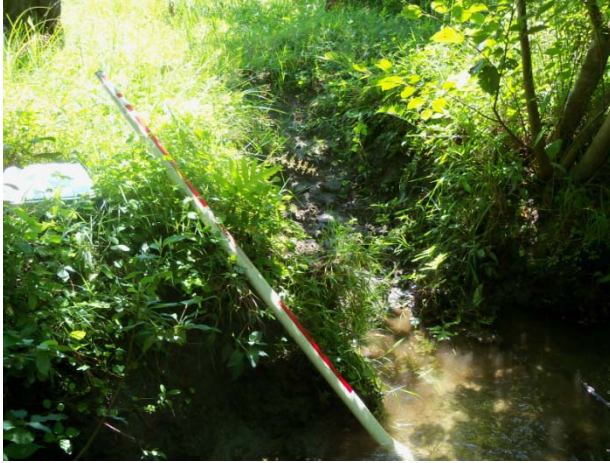
Project #1- Livestock exclusion & corridor protection    Project #2 – Trash Clean up

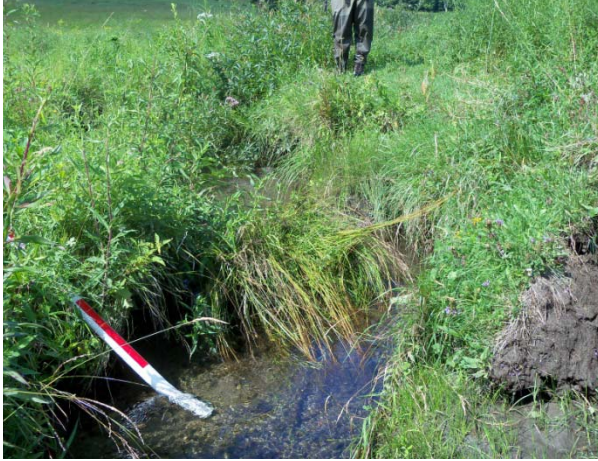
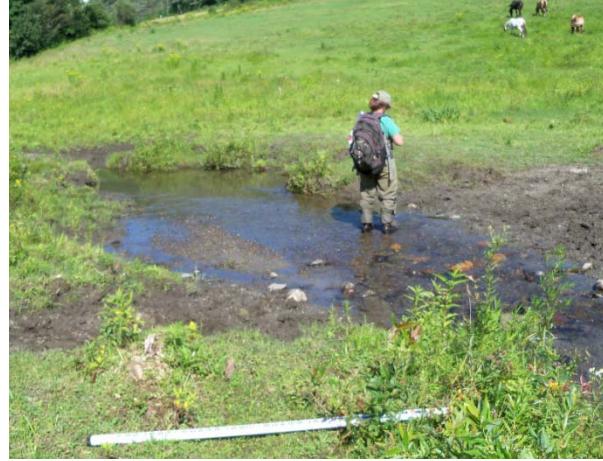
Project #4- Alternatives analysis: habitat & geomorphic stability/live stock exclusion/plantings
