Ompompanoosuc River Corridor Plan

Thetford to Norwich, Vermont

January 10, 2014

Bear Creek Environmental, LLC
149 State Street, Suite 3
Montpelier, Vermont 05602

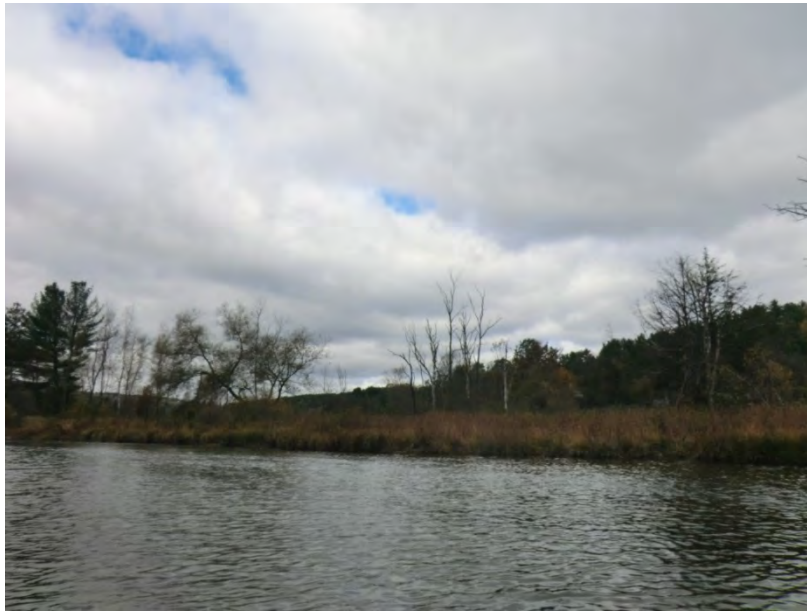
Figure 5.3. Extensive wetlands in R03-A.

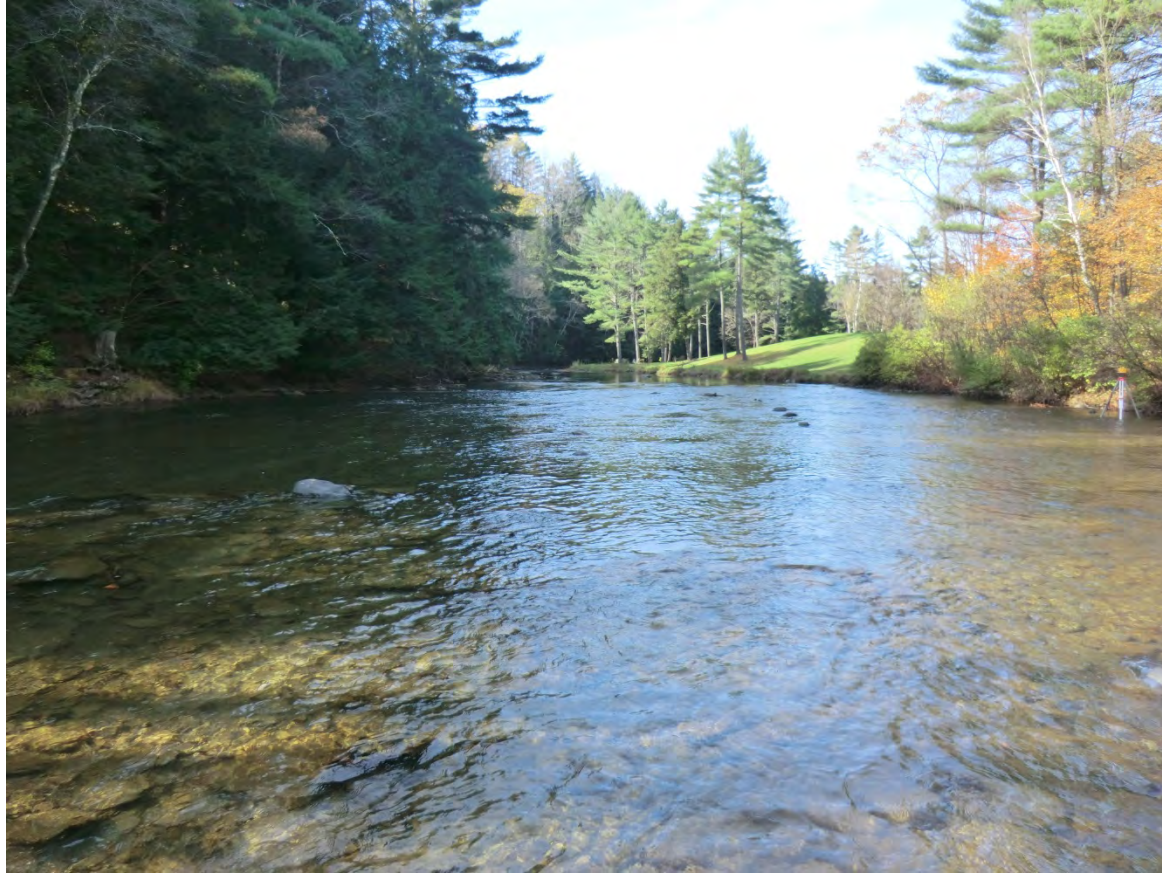
Figure 5.6. Typical channel in R04-A.

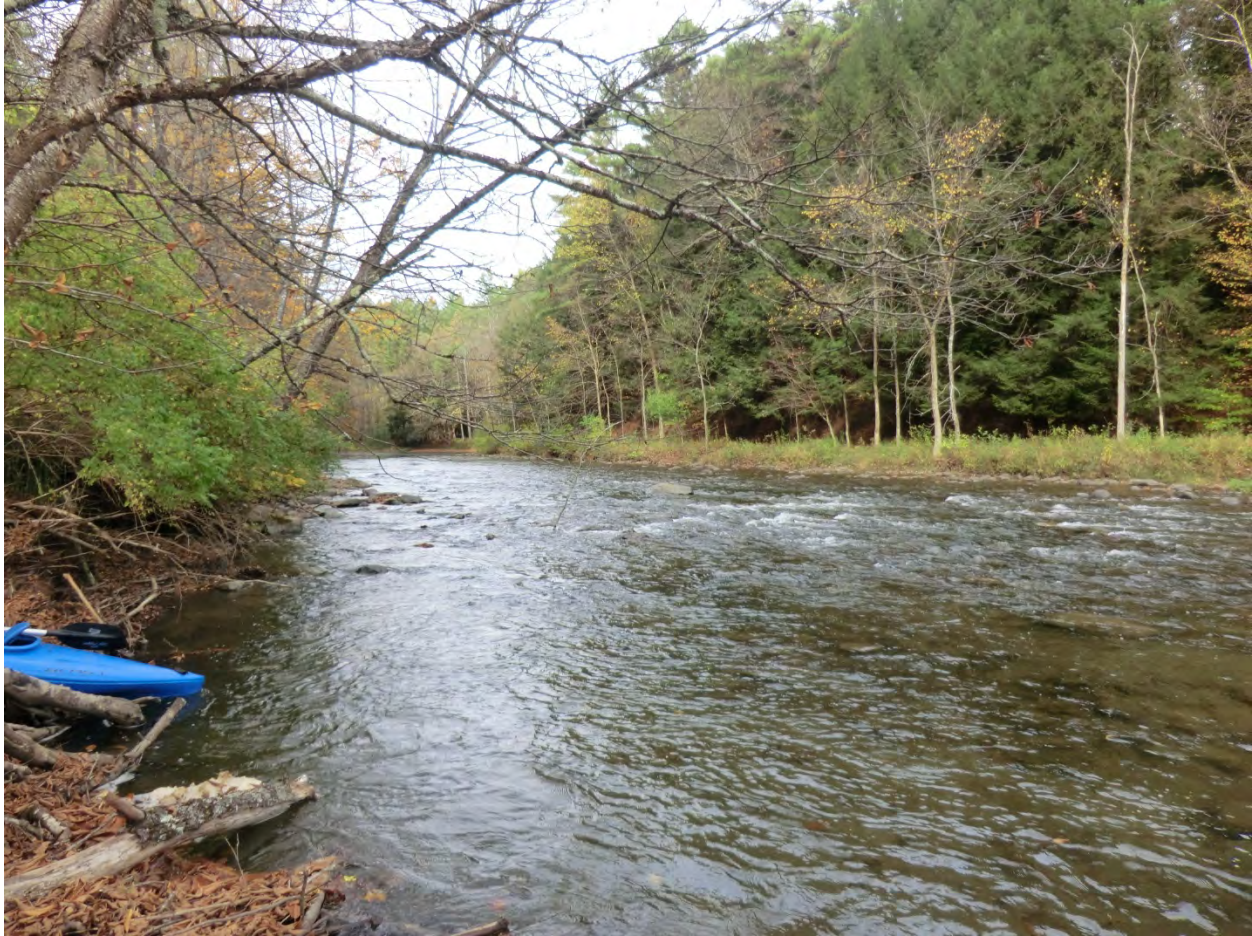
Segment R04-B begins as the valley type changes from Narrow to Semi-confined and continues upstream 1,400 feet until the valley widens again. This segment is located in a forested area with a wetland to the west of the channel. R04-B is in **good** geomorphic condition with aggradation, widening, and planform adjustment all as minor processes occurring. Extreme **historic incision** has occurred here, which may be a result of the reduction in flows from the Union Village Dam and upstream channel straightening; however, the channel appears to have stabilized. The segment is in **good** habitat condition and has excellent bank and buffer vegetation. A wetland was seen in the western corridor. Figure 5.7 shows a typical view in R04-B.

Figure 5.7. Excellent bank and buffer vegetation in R04-B.

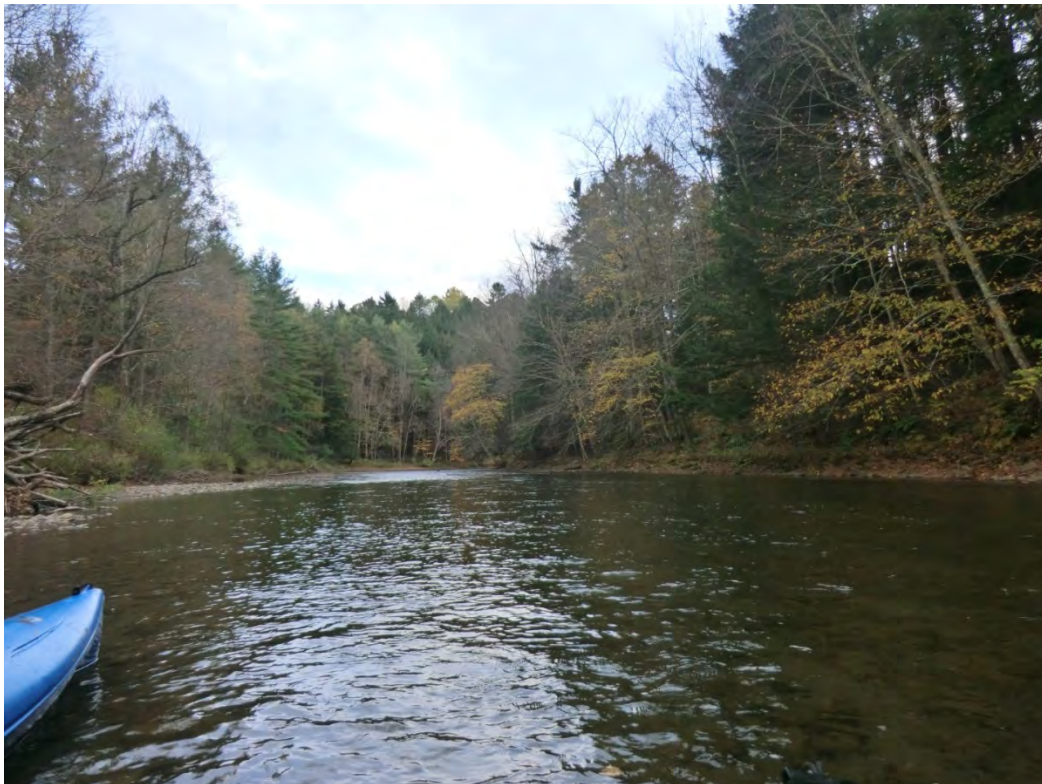
Figure 5.9. Relatively undisturbed forested area at downstream end of R05.

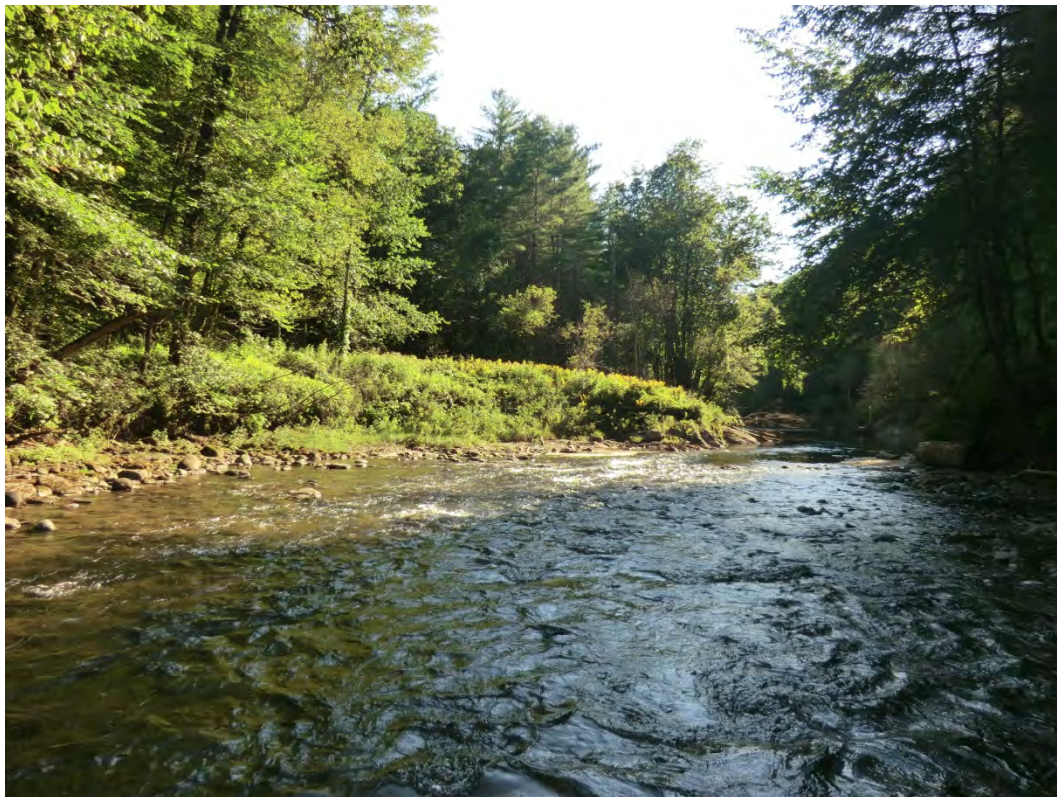
Segment R08-C is in **fair** geomorphic condition with major **historic incision**, which has not led to a stream type departure. Major **widening** is occurring as the river responds to the incision. This segment is in **fair** habitat condition (higher end of category) as a result of some areas of reduced buffer widths and poor bank vegetation and erosion on the banks.

Figure 5.16. Typical channel in R08-C shows generally good bank and buffer vegetation.

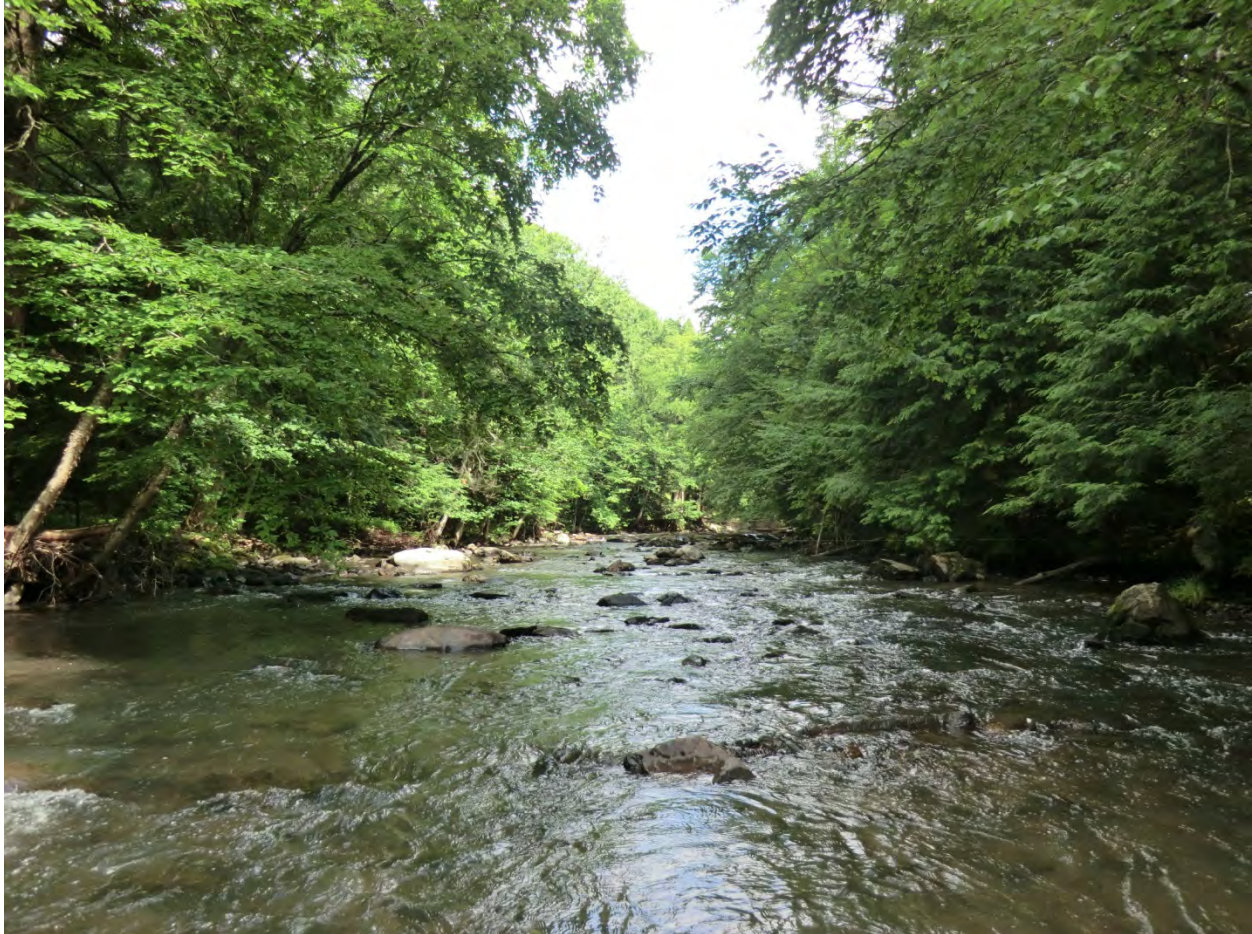
Figure 5.35. R14-C is stable and has good bank vegetation.

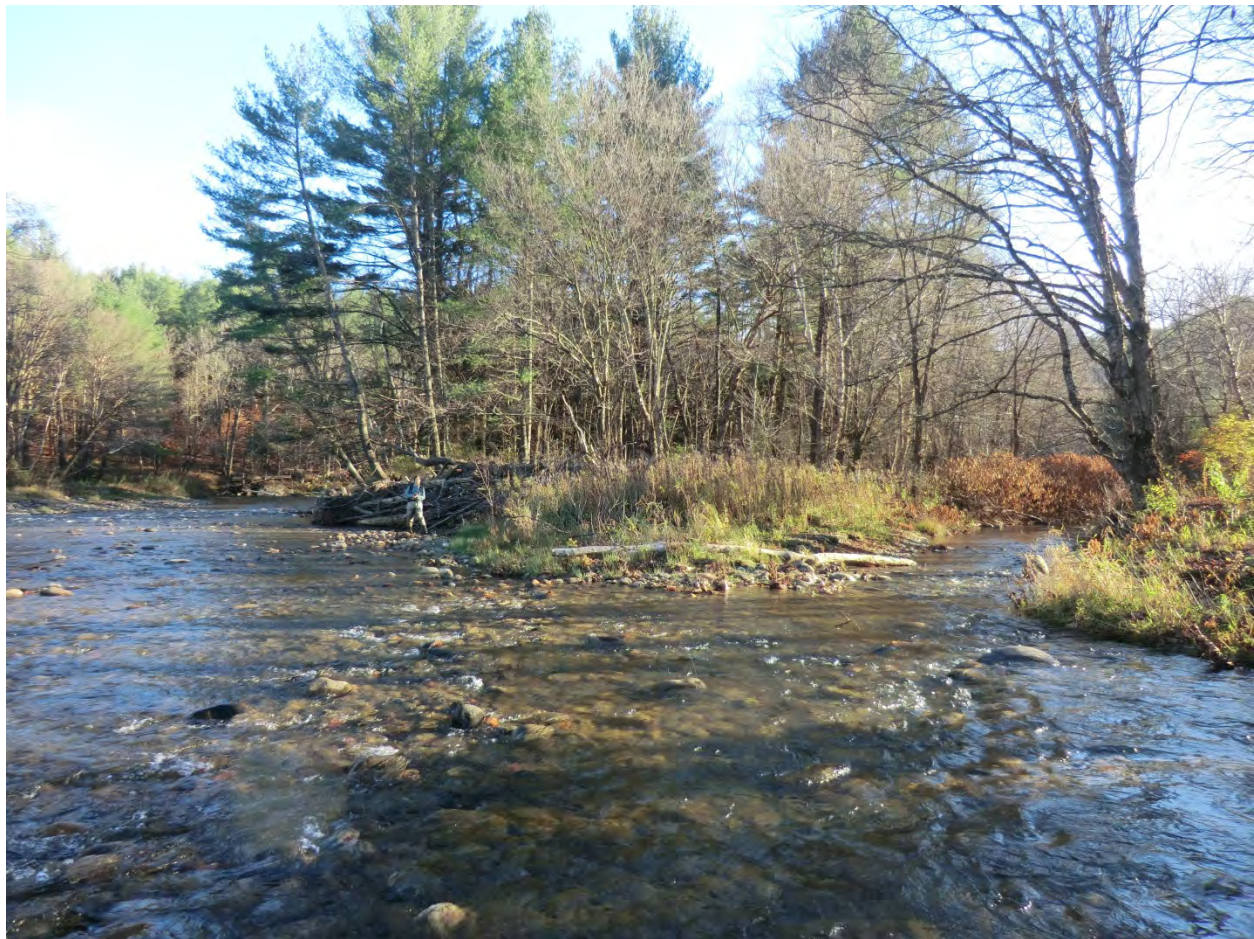
Figure 5.39. Channel splits around an island in M01-C.

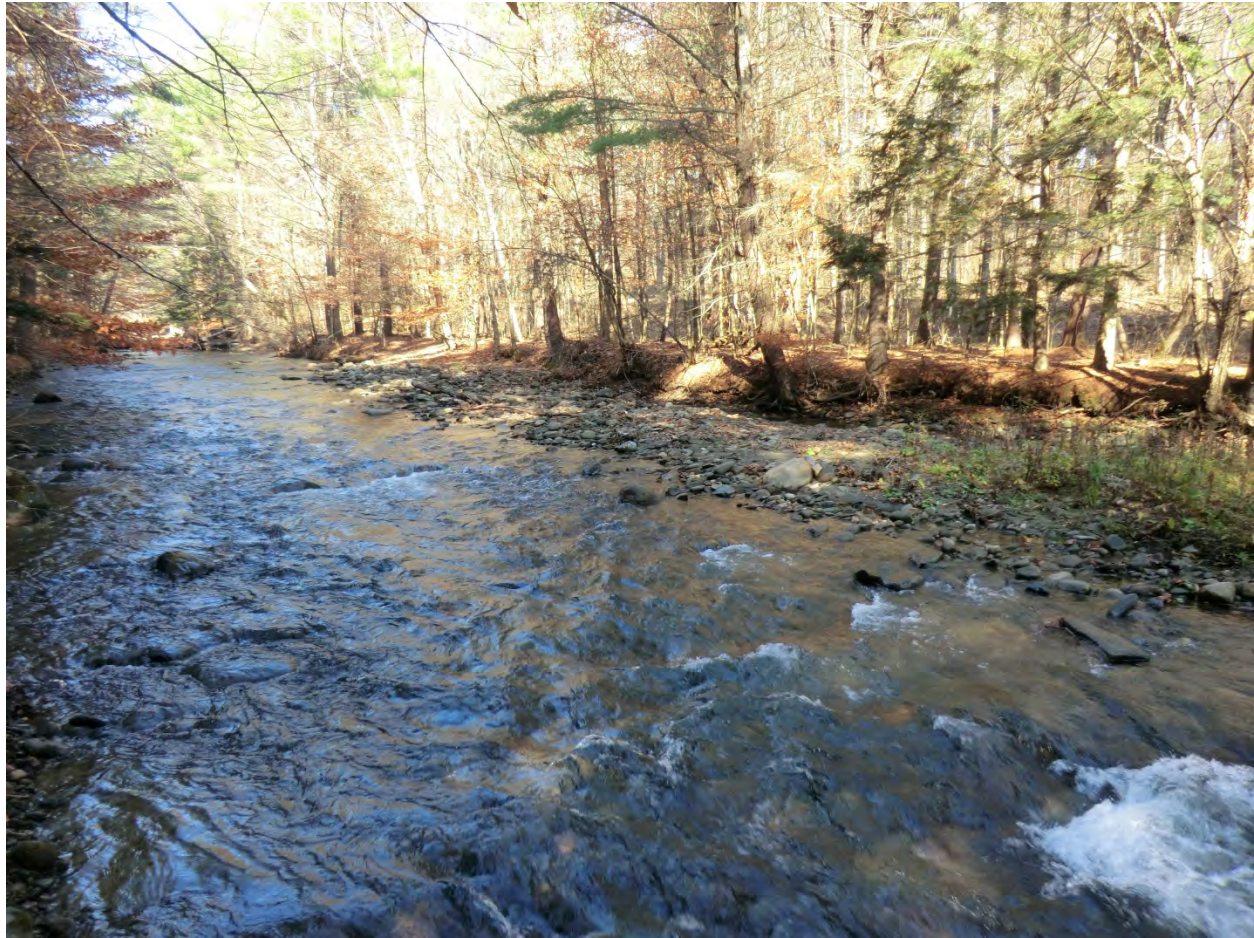
Figure 5.43. M01-G has excellent bank and buffer vegetation.

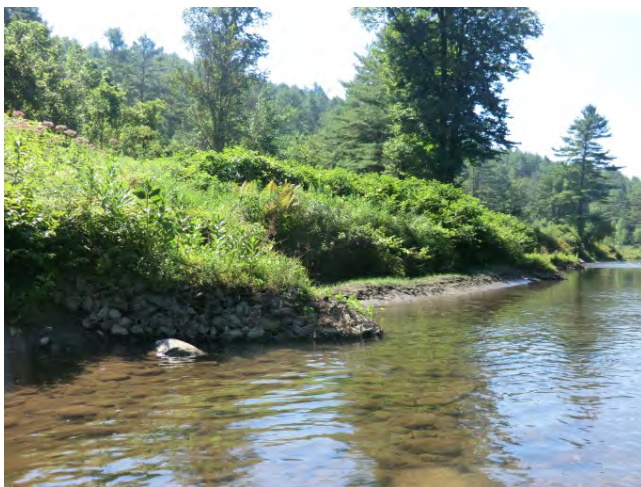
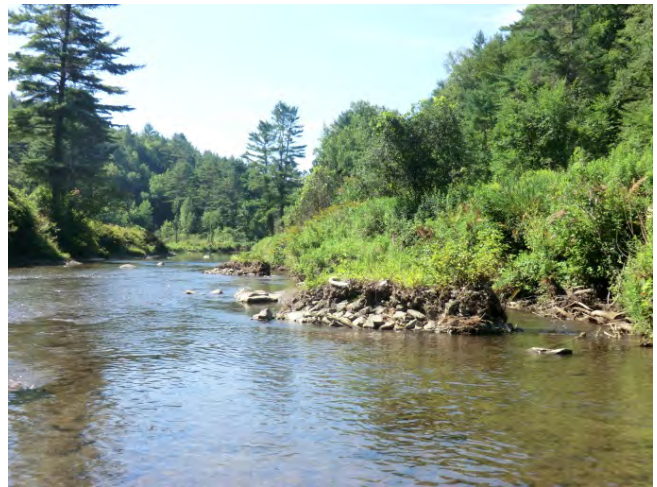
Project #1 – Alternatives Analysis for the Removal of Gabions, R08-B

Project # Segment	Type of Project	Site Description Including Stressors and Constraints	Project or Strategy Description	Technical Feasibility and Priority	Other Social Benefits	Potential Partners/Programs
Project #1 R08-B	Active Restoration	Several old gabions on both sides of the channel are causing erosion and sediment buildup. Gabions have been outflanked in some locations and in time will likely collapse on their own. They are currently providing habitat in some locations.	Alternatives Analysis for the removal of the gabions	Low Priority; ACOE not interested in moving forward with a project at this time	Improved habitat, water quality, and geomorphic stability	US Army Corps of Engineers, TCC, VANR, Town of Thetford ERP, CRWC
Project #2 R09	Passive Restoration	Area along western bank lacks adequate buffer width. Canopy cover is reduced. Limited access here.	Natural Regeneration of Vegetation	Low Priority	Improved habitat and water quality	US Army Corps of Engineers, TCC, VANR, Town of Thetford

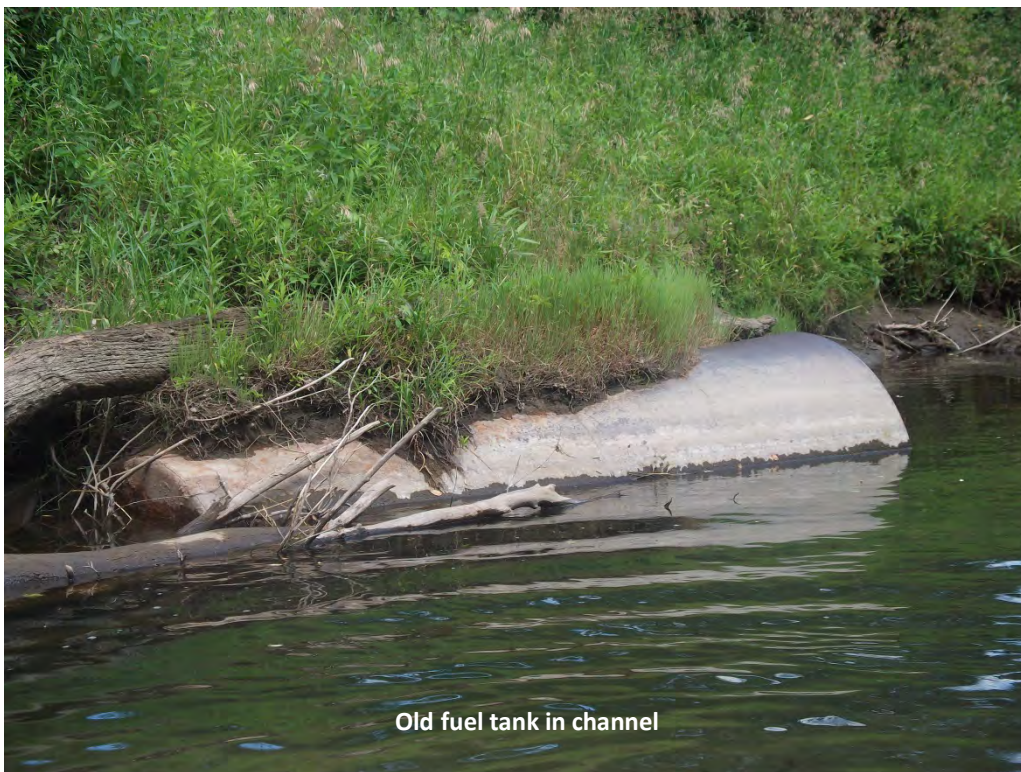
Project #1 – Stream Clean-Up, R11-A

Project # Segment	Type of Project	Site Description Including Stressors and Constraints	Project or Strategy Description	Technical Feasibility and Priority	Other Social Benefits	Potential Partners/ Programs
Project #1 R11-A	Stream Clean-Up	Old fuel tank is in the river near the left bank. Area is difficult to access with machinery. Possibly dislodge tank by hand and float downstream to a more accessible location.	Remove Fuel Tank	Low Priority	Improved water quality	US Army Corps of Engineers, TCC, VANR, Town of Thetford ERP

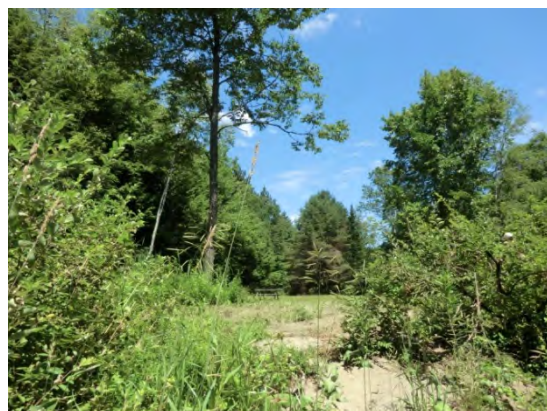
Project #8 – Streamside Plantings

Project #8 R13	Passive Restoration	Area along western bank does not have adequate buffer.	Streamside Plantings	Low Priority	Improved habitat and water quality	Landowners, TCC, VANR, Town of Thetford TFS, CRWC

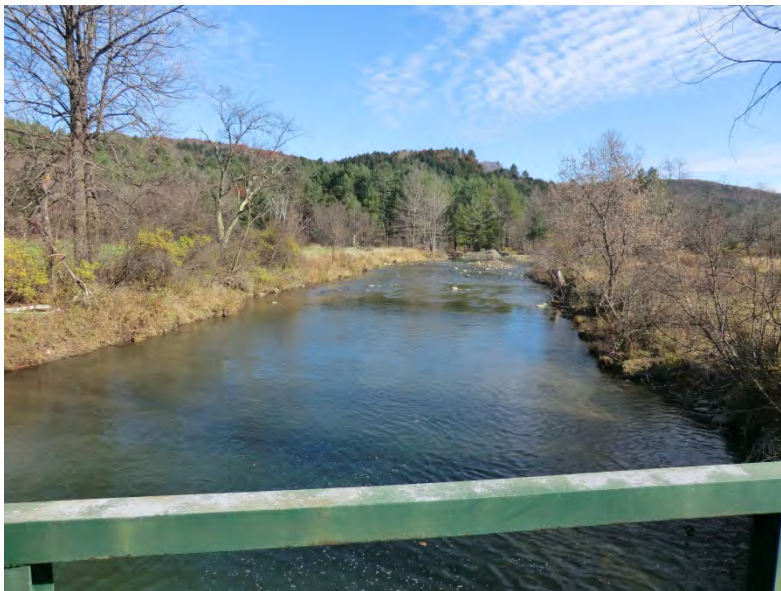
Project #1 – Streamside Plantings, M01-F

Project # Segment	Type of Project	Site Description Including Stressors and Constraints	Project or Strategy Description	Technical Feasibility and Priority	Other Social Benefits	Potential Partners/Programs
Project #1 M01-F	Passive Restoration	Area along northern bank has inadequate buffer. Bobolinks nest in the tall grass of the field adjacent to the river.	Buffer Improvement: Establish “no mow” zone and let buffer naturally reestablish	High Priority; ACOE has increased buffer width to about 20 feet on east side of channel south of bridge during 2013	Improved habitat and water quality	Landowner, TCC, VANR, Town of Thetford TFS, CRWC

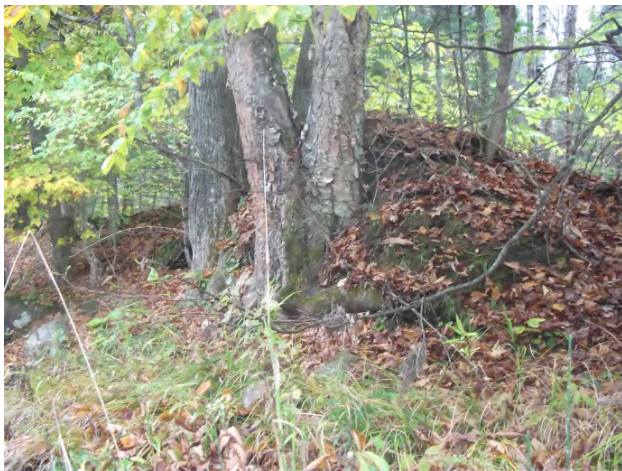
Project #1 – Berm Removal, M01-I

Project # Segment	Type of Project	Site Description Including Stressors and Constraints	Project or Strategy Description	Technical Feasibility and Priority	Other Social Benefits	Potential Partners/ Programs
Project #1 M01-I	Active Restoration	Berm along northern bank restricts floodplain access. Removal of berm may disturb wetland to the north of the channel.	Remove Berm	Low Priority; the project priority was downgraded due to access issues. In addition, the wetland may be hydraulically affected if the berm were to be removed. Project partners did not want to move forward with project at this time.	Improved geomorphic stability	Landowner, TCC, VANR, Town of Thetford ERP
Project #2 M02	Active Restoration	According to landowner, during flood events water backs up behind an old abutment near end of Ilsley Road.	Alternatives Analysis for the removal of the old abutment	Low Priority; old abutment is impacting a private landowner and removal is not likely to improve geomorphic stability. Old Abutment may be a historic structure.	Reduced flooding on private land	Landowner, TCC, VANR, Town of Thetford ERP
