Ottauquechee River Watershed Stream Geomorphic Assessment Bridgewater and Woodstock, Vermont January 29, 2013

Prepared by:
Bear Creek Environmental, LLC
297 East Bear Swamp Road
Middlesex, Vermont 05602

Prepared under contract to:
Two Rivers-Ottauquechee Regional Commission
128 King Farm Road
Woodstock, VT 05901

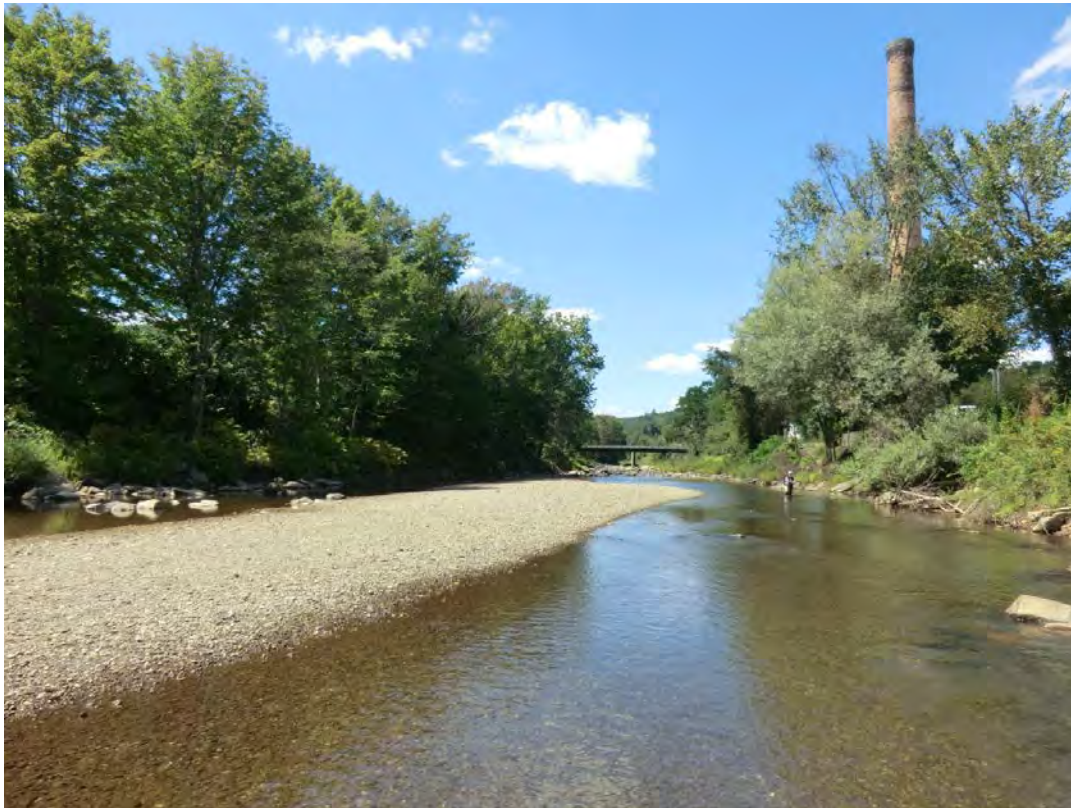
This segment is in **fair** geomorphic condition. Significant channel straightening and alteration in this segment led to **historic incision**. There is now a complete loss of floodplain access and a stream type departure. Major **aggradation** and **planform adjustment** are the dominant active adjustment processes. Natural widening is limited by rip rap on both stream banks in some locations. This segment is in **fair** habitat condition and exhibits a habitat type departure from its reference riffle-pool sequence to plane bed (See Figure 5.22). A lack of adequate buffer vegetation and an extremely incised streambed have contributed to the habitat departure.

Figure 5.22. Typical channel in M22-A exhibits high aggradation and plane bed features.

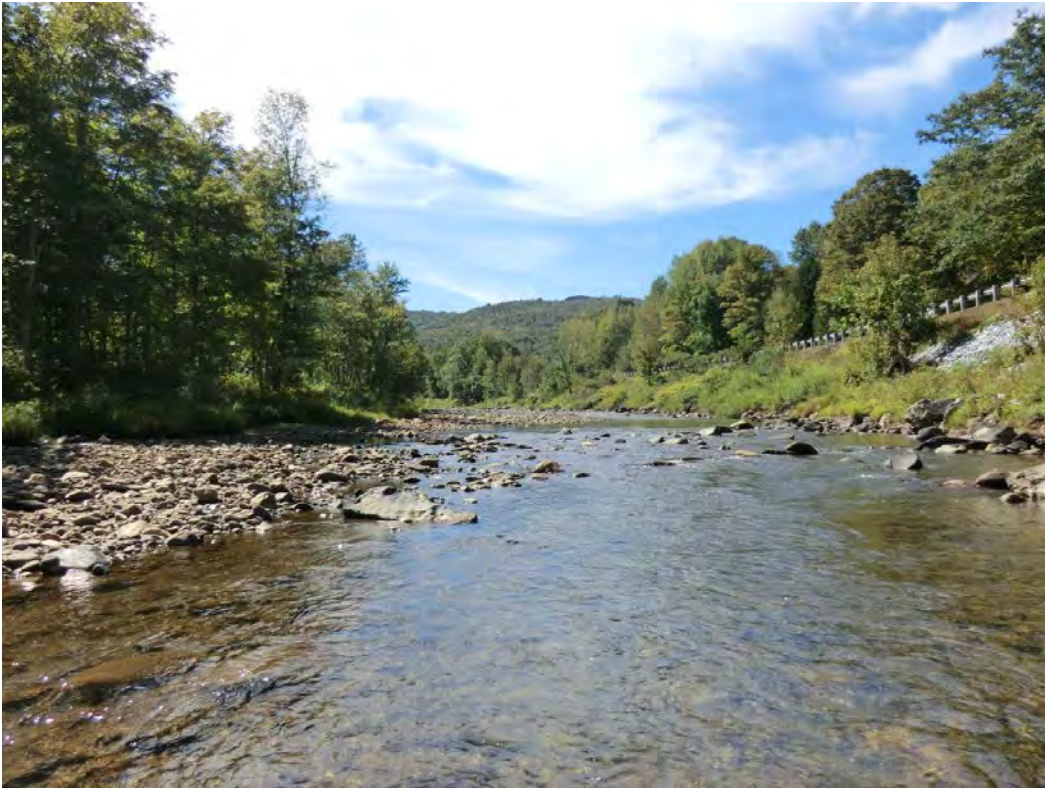
Figure 5.25. Typical channel in M23-B. Major aggradation.

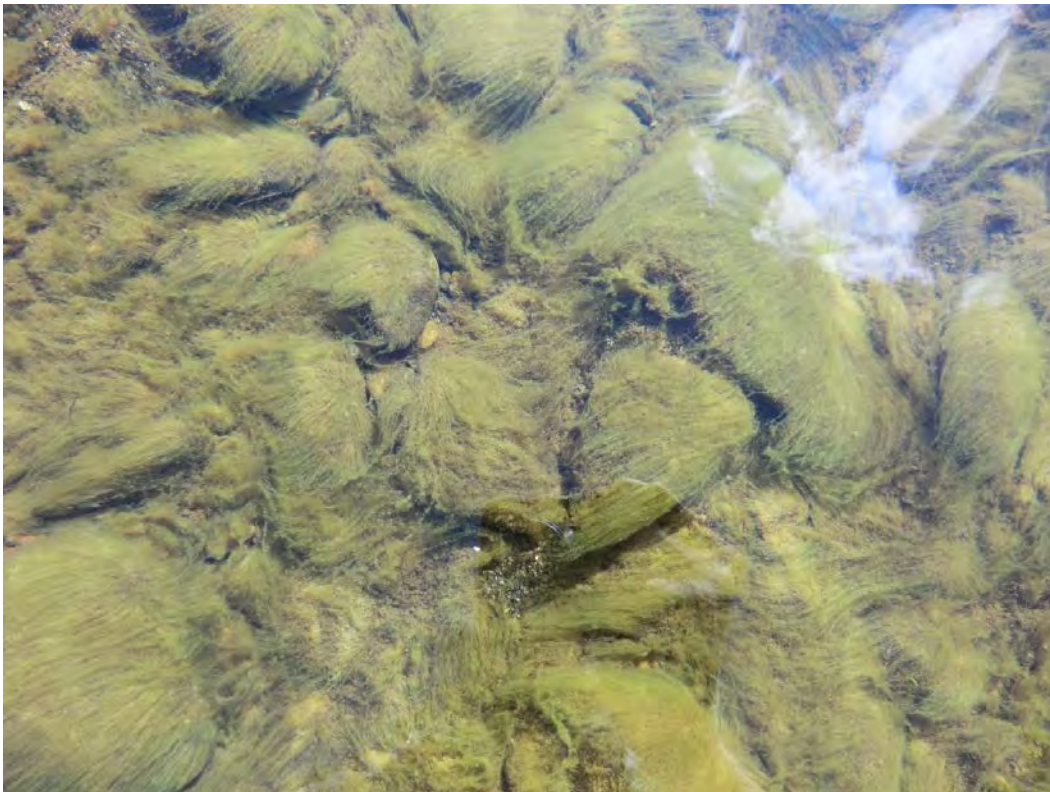
Figure 5.26. Dense algal growth seen on streambed in M23-B.

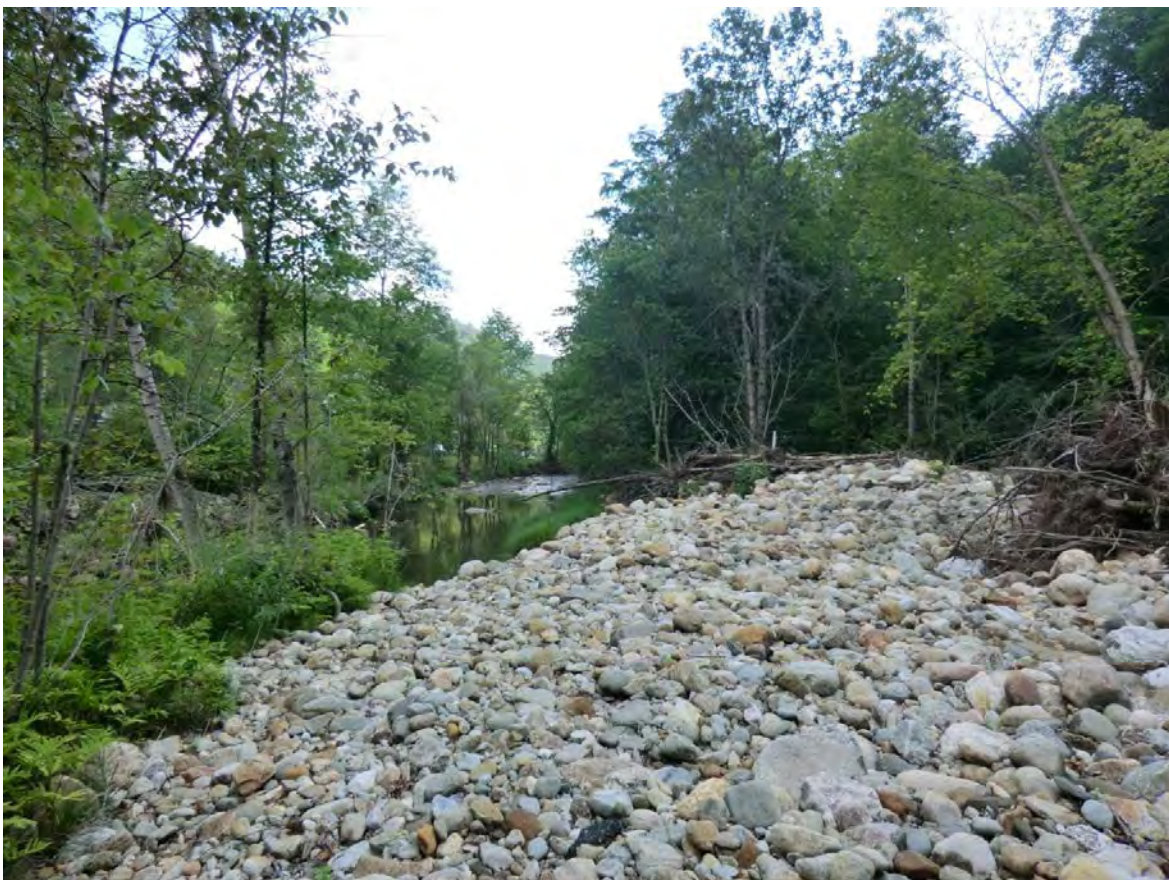
from unconfined to confined. As a result, a stream type departure is seen here. This segment is exhibiting extreme **historic incision, aggradation, widening, and planform adjustment**. Aggradation is so extreme that the islands are connected by deposition (See Figure 5.47). This segment is in **fair** habitat condition because of a lack of an adequate northern buffer and extensive bank erosion and revetments.

Figure 5.47. Islands are connected by major aggradation.

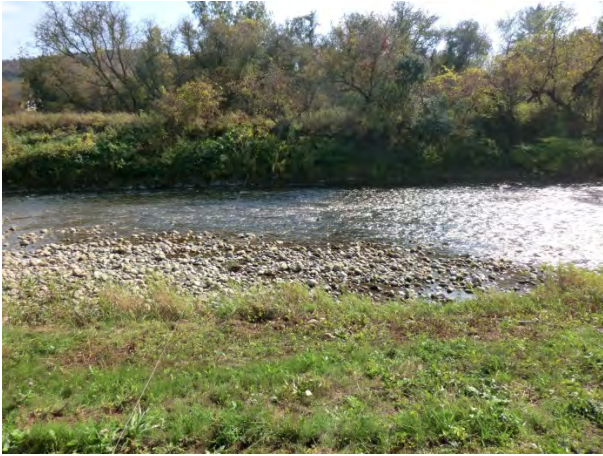
Project #1 – Protect River Corridor

Project # Segment	Type of Project	Site Description Including Stressors and Constraints	Project or Strategy Description	Technical Feasibility and Priority	Other Social Benefits	Costs	Potential Partners/Programs
Project #1 M13	Passive Restoration	Agricultural fields along river corridor are a sediment attenuation area	Protect river corridor through easement	High Priority	Improved habitat and water quality	Cost of easement	Landowners, TRORC, VANR, Town of Woodstock RCE
Project #2 M13	Passive Restoration	Agricultural fields along channel lack adequate buffer along northern bank	Streamside plantings	High Priority	Improved habitat and water quality	Cost of plantings	Landowners, TRORC, VANR, Town of Woodstock CREP, TFS, WHIP, CRWC
Project #3 M13	Passive Restoration	Area along agricultural fields that has newly planted trees	Supplement existing plantings as needed	Low Priority	Improved habitat and water quality	Cost of plantings	Landowners, TRORC, VANR, Town of Woodstock TFS, CRWC

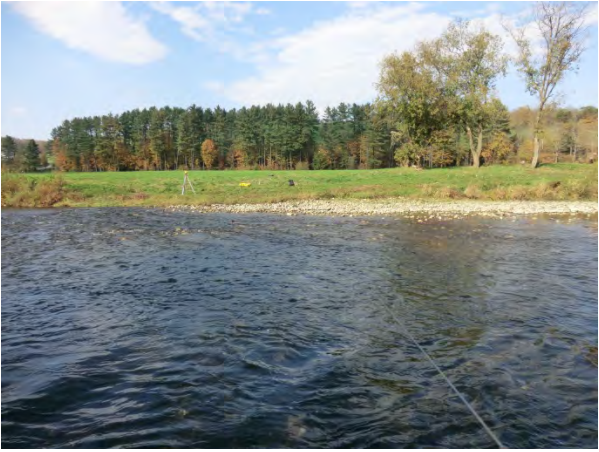
Project #2 – Streamside Plantings

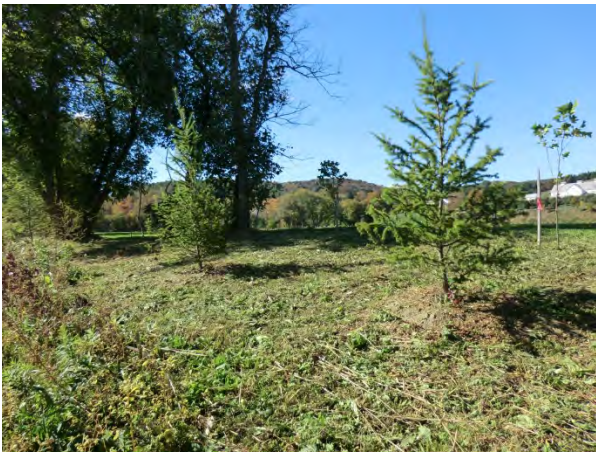
Project #3 – Supplement Existing Plantings

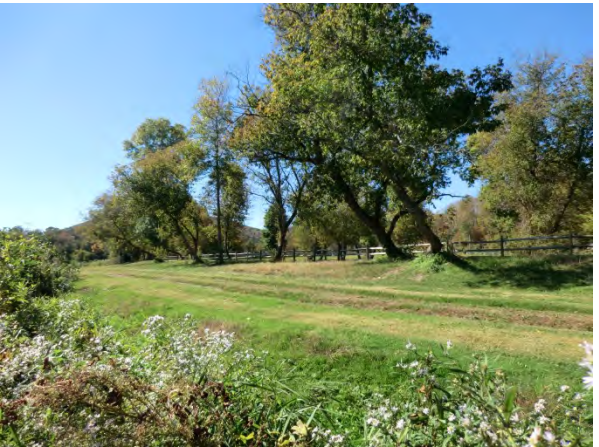
Project #4 – Natural Buffer Regeneration

Project #4 M13	Passive Restoration	Area along fence that does not have adequate buffer	Allow vegetation to naturally regenerate over time	Moderate Priority	Improved habitat and water quality	None	Landowners
Project #5 M13	Passive Restoration	Southern bank along agricultural field lacks adequate buffer	Streamside plantings	High Priority	Improved habitat and water quality	Cost of plantings	Landowners, TRORC, VANR, Town of Woodstock CREP, TFS, WHIP, CRWC
Project #6 M15	Passive Restoration	Residential areas in Woodstock Village where buffer is not adequate	Streamside plantings	Low Priority	Improved habitat and water quality	Cost of plantings	Landowners, TRORC, VANR, Village of Woodstock TFS, CRWC

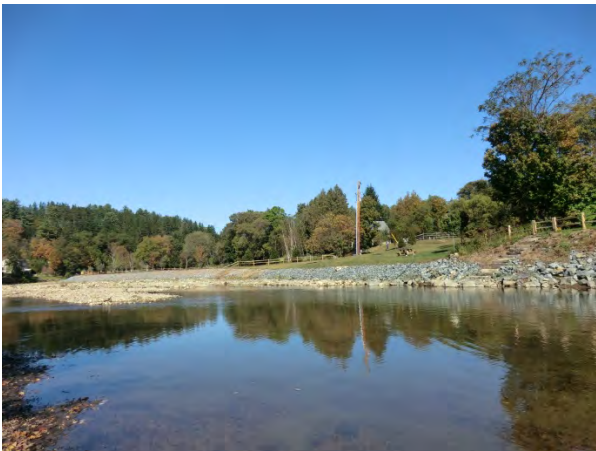
Project #6 – Streamside Plantings in Woodstock

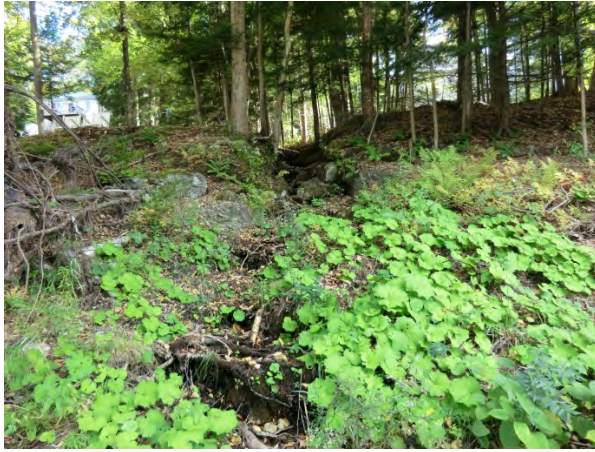
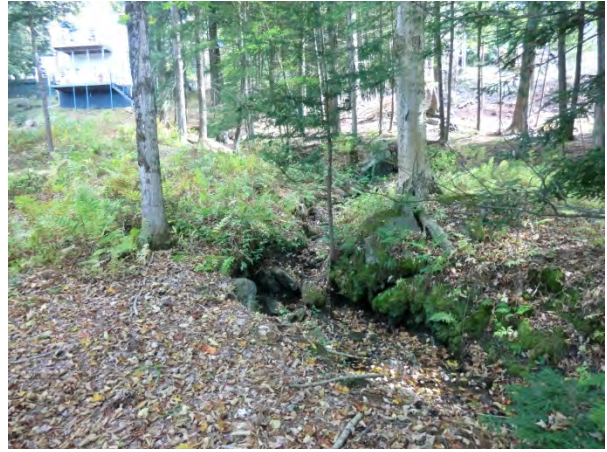
Project #1 – Stormwater Management and Gully Remediation

Project # Segment	Type of Project	Site Description Including Stressors and Constraints	Project or Strategy Description	Technical Feasibility and Priority	Other Social Benefits	Costs	Potential Partners/Programs
Project #1 M16	Stormwater Management	Two gullies have formed likely from stormwater runoff from College Hill Road.	Evaluate stormwater management practices. Remediation of gullies through stormwater management.	Moderate Priority	Improved water quality	Unknown	Landowners, TRORC, VANR, Town of Woodstock ERP
Project #2 M17	Passive Restoration	Tree farm located in northern and southern river corridor. Some areas have floodplain access.	Protect river corridor through easement	Moderate Priority	Improved habitat and water quality	Cost of easement	Landowners, TRORC, VANR, Town of Woodstock RCE
Project #3 M17	Passive Restoration	Rip rapped area along parking lot is lacking adequate bank vegetation.	Streamside plantings with live stakes in rip rap	Low Priority	Improved habitat and water quality	Cost of plantings	Landowner, TRORC, ANR, Town of Woodstock TFS, CRWC

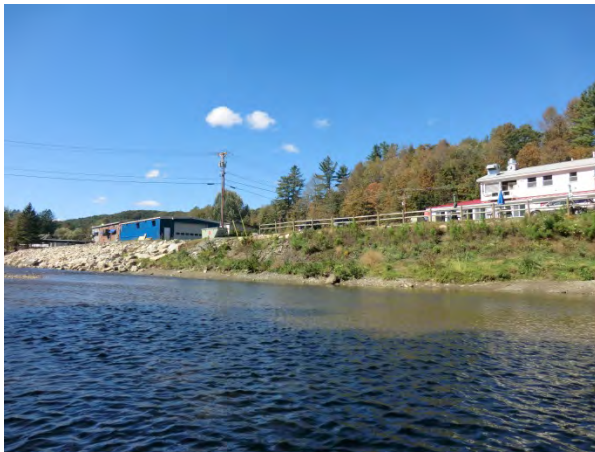
Project #3 – Live Stakes in Rip Rap

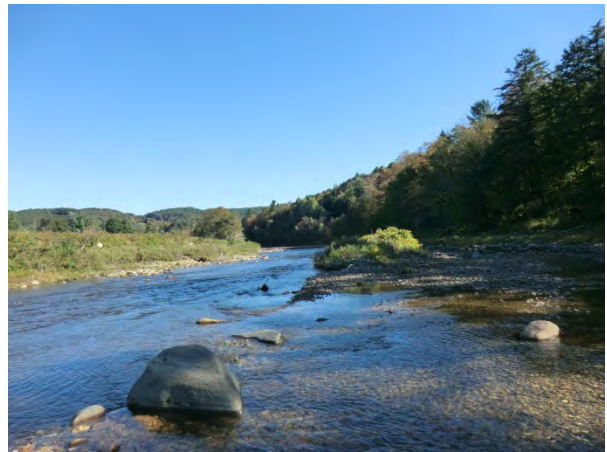
Project #4 – Streamside Plantings (left)

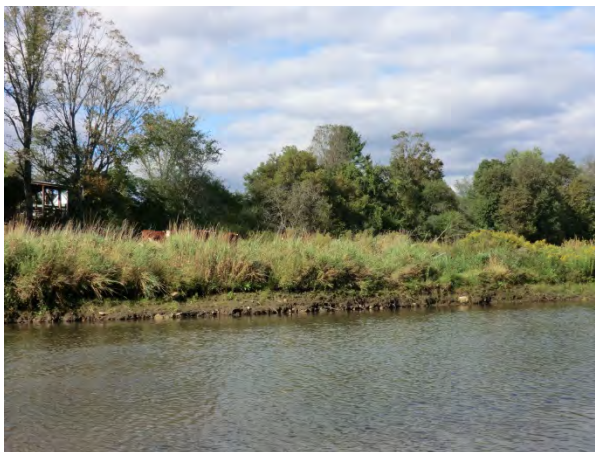
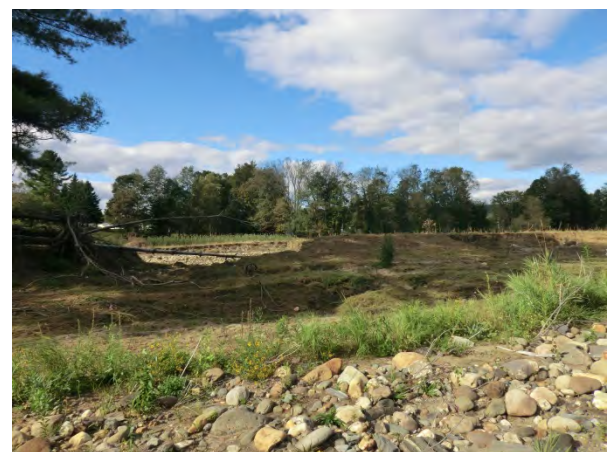
Project #5 – Streamside Plantings and Protect River Corridor

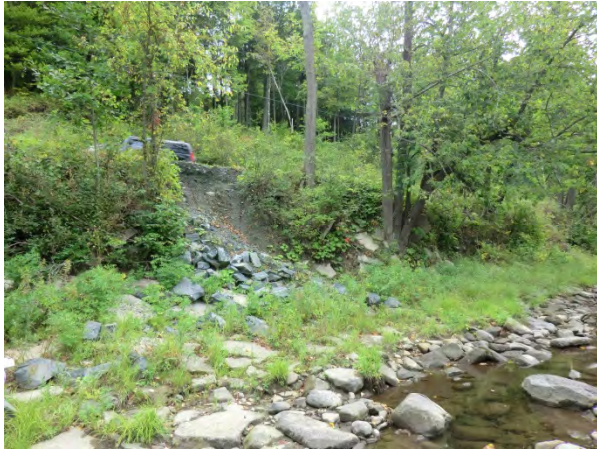
Project #2 – Riverside Park Road

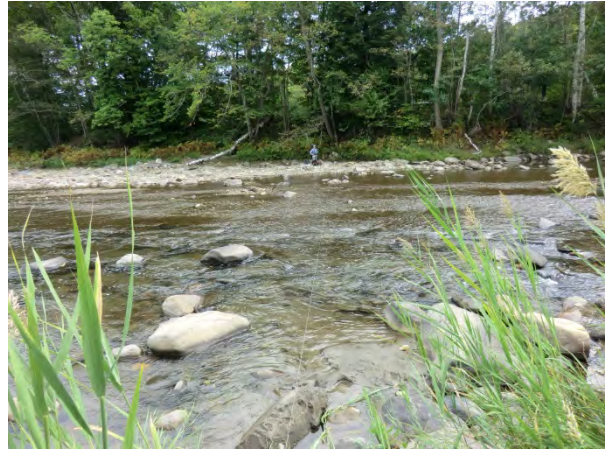
Project #3 – Protect River Corridor

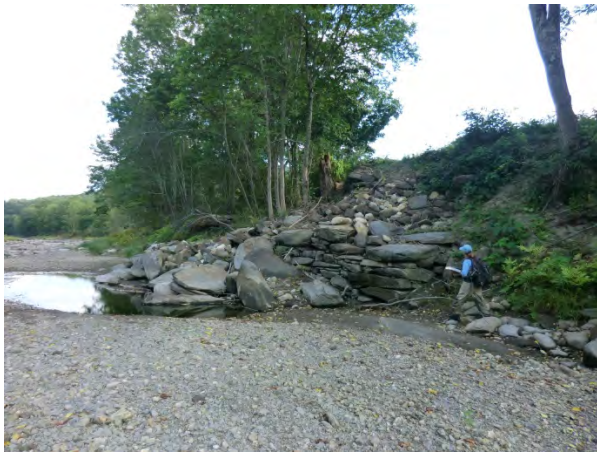
Project #4 – Investigate Abutment Removal

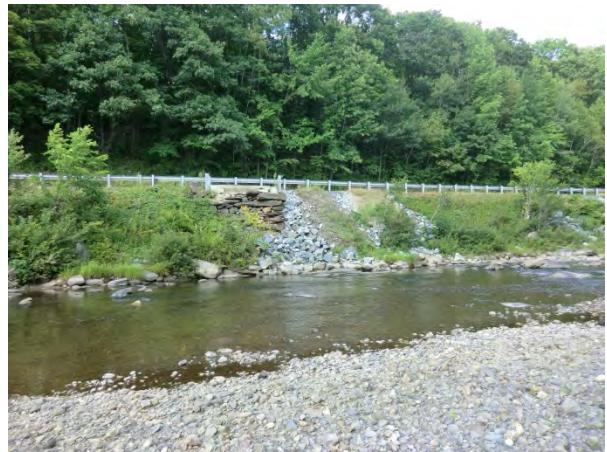
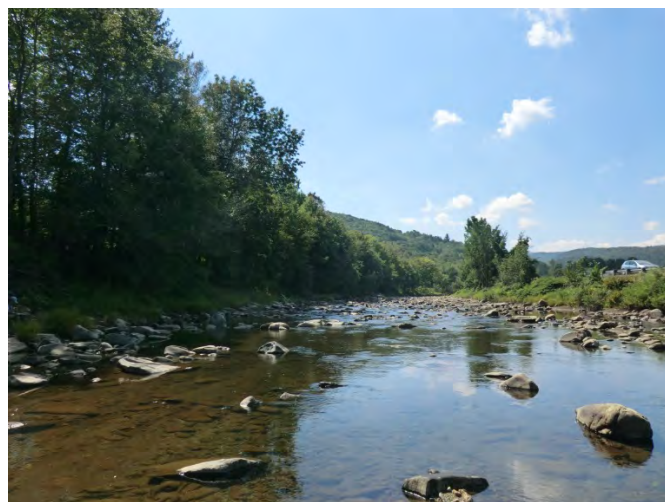
Project #5 – Protect River Corridor (left)

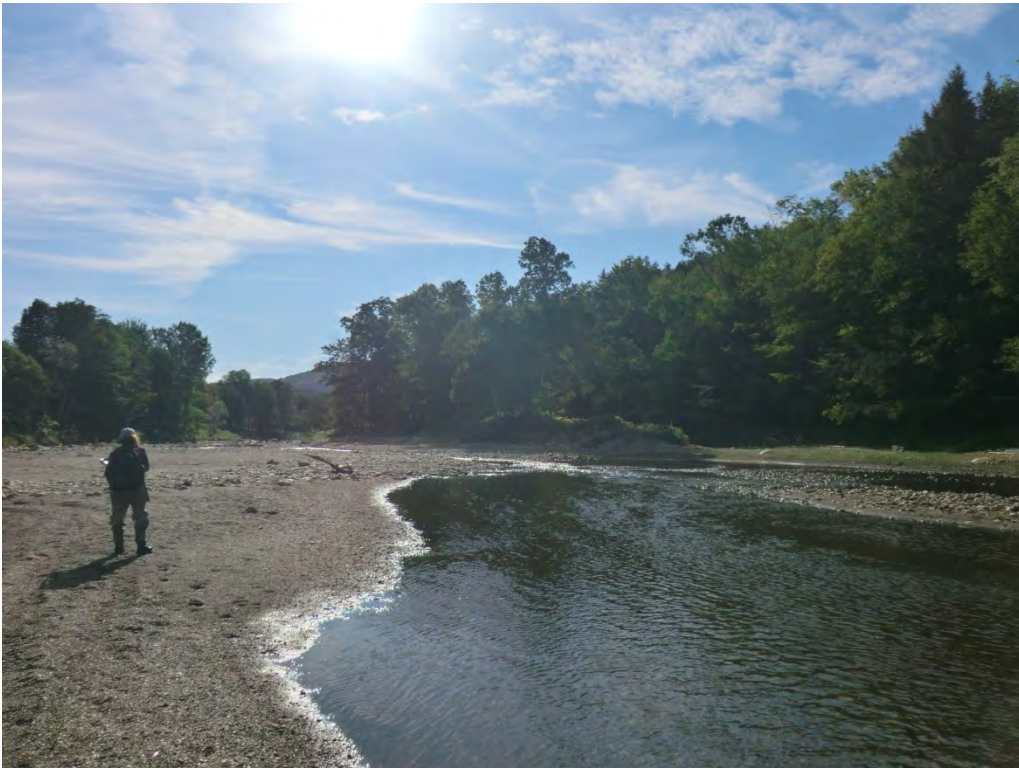
Project #3 – Protect River Corridor (right)

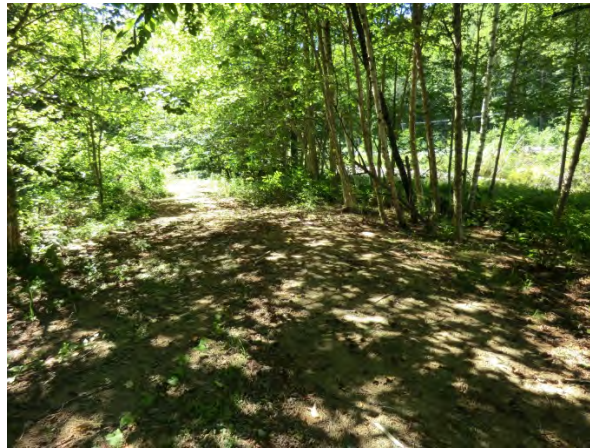
Standish Road in River Corridor

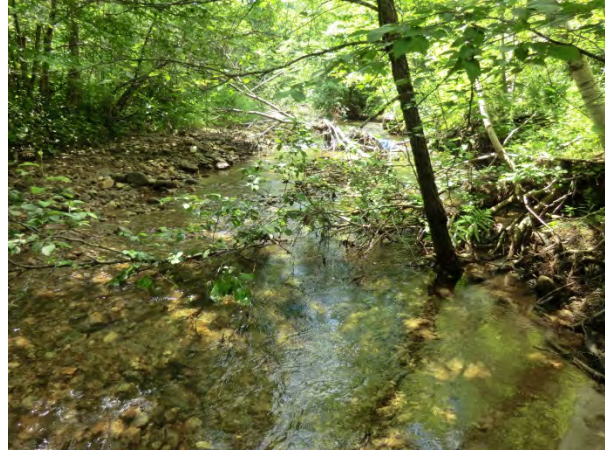
Project #10 – Protect River Corridor

Project #10 M28T5.01-B	Passive Restoration	Forested river corridor contains wetland, good floodplain access	Protect river corridor through easement	High Priority	Improved habitat and water quality	Cost of easement	Landowner, TRORC, VANR, Town of Bridgewater RCE, WRP
Project #11 M28T5.01-C	Active/ Passive Restoration	Windrow/berm section along Route 100A limits floodplain access. Poor bank and buffer vegetation.	Alternatives analysis for the removal of the windrow/berm and streamside plantings	High Priority	Improved habitat, water quality, and geomorphic stability	Cost of analysis and possible windrow removal and plantings	Landowners, TRORC, VANR, Town of Bridgewater ERP, TFS, CRWC
