# Brewster River River Corridor Plan

July 31, 2015

Fitzgerald Environmental Associates, LLC.  
18 Severance Green, Suite 203  
Colchester, VT 05446

**Lamoille County Planning Commission**  
PO Box 1637  
52 Portland Street, Second Floor  
Morrisville, VT 05661

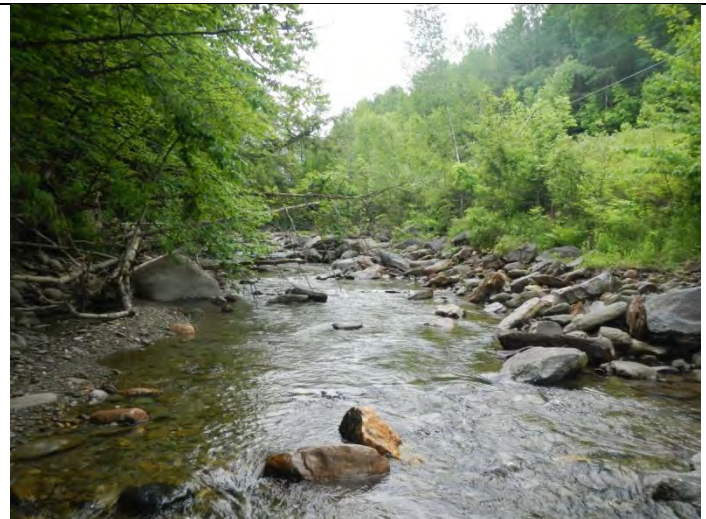
Typical incised B-type geometry

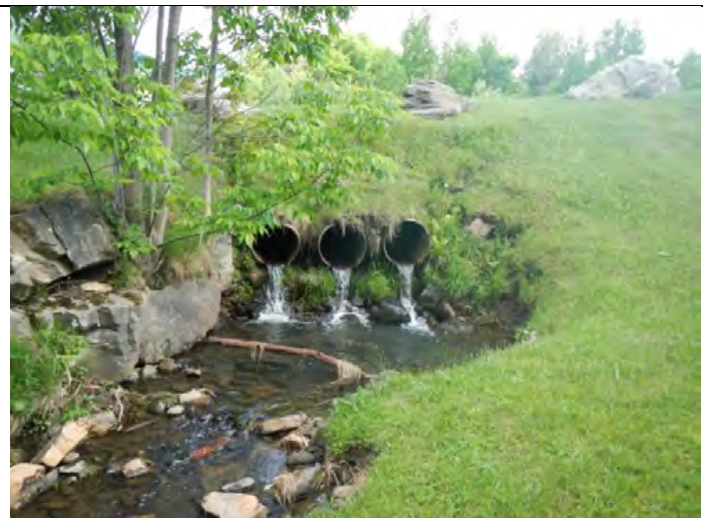
Outlet of the trout pond

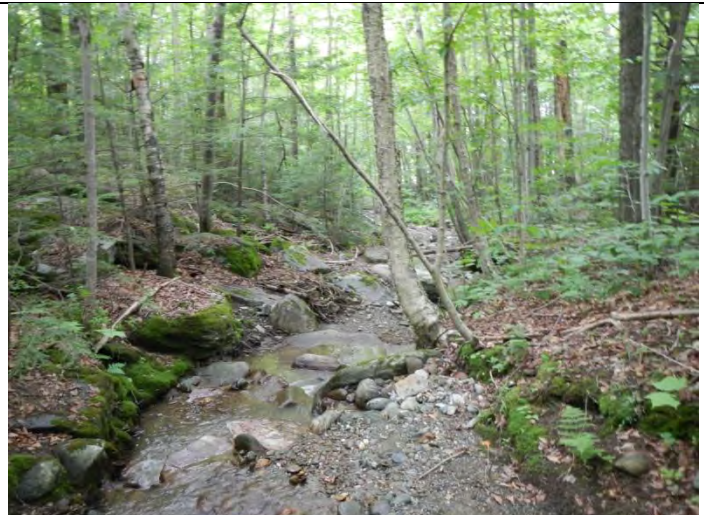
Increase gravel moving through reach

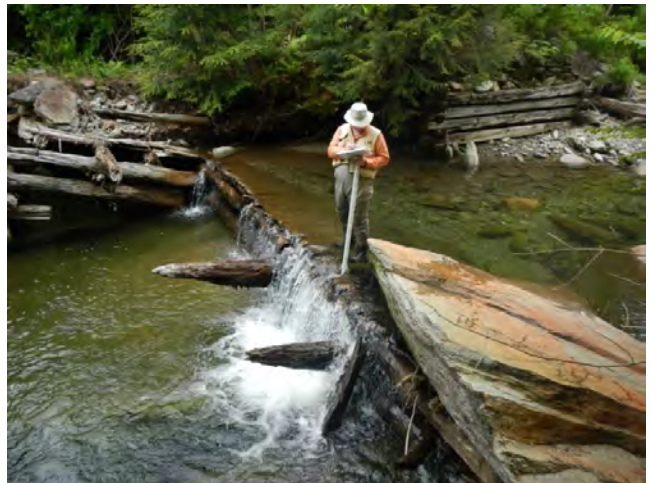
- Segments with numerous or large natural grade controls: M07.A, T7S4.03, and T7S4.02.01
- Segments with man-made grade controls:
  - Weirs: M14, T7S1.02, T7S4.03, and T7S4.02.01
  - Dam: M14, T7.01, and T7.S1.01 (Figures 15 and 16)

**Figure 15:** Partially breached timber crib dam on T7.01.

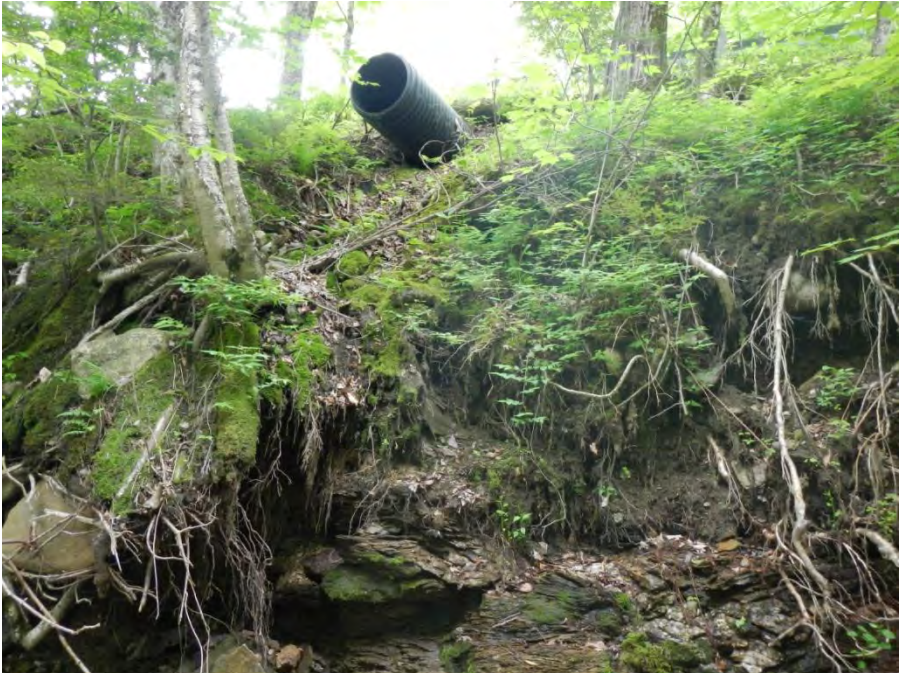
- High road density in subwatersheds draining to reaches M05, M07, M11, M14, T7.01, T7S1.02, and T7S4.03 (Figure 18)
- Very high road density in subwatersheds draining to reaches M12, M13, and T7S1.01
- Stormwater inputs from developed areas and roads in M09, M12.B, M14, T7.01, T7S1.01, T7S1.02, T7S4.02.01, and T7S4.03 (Figure 19)

**Figure 19:** Stormwater input from Desjardins Road to reach T7.01.

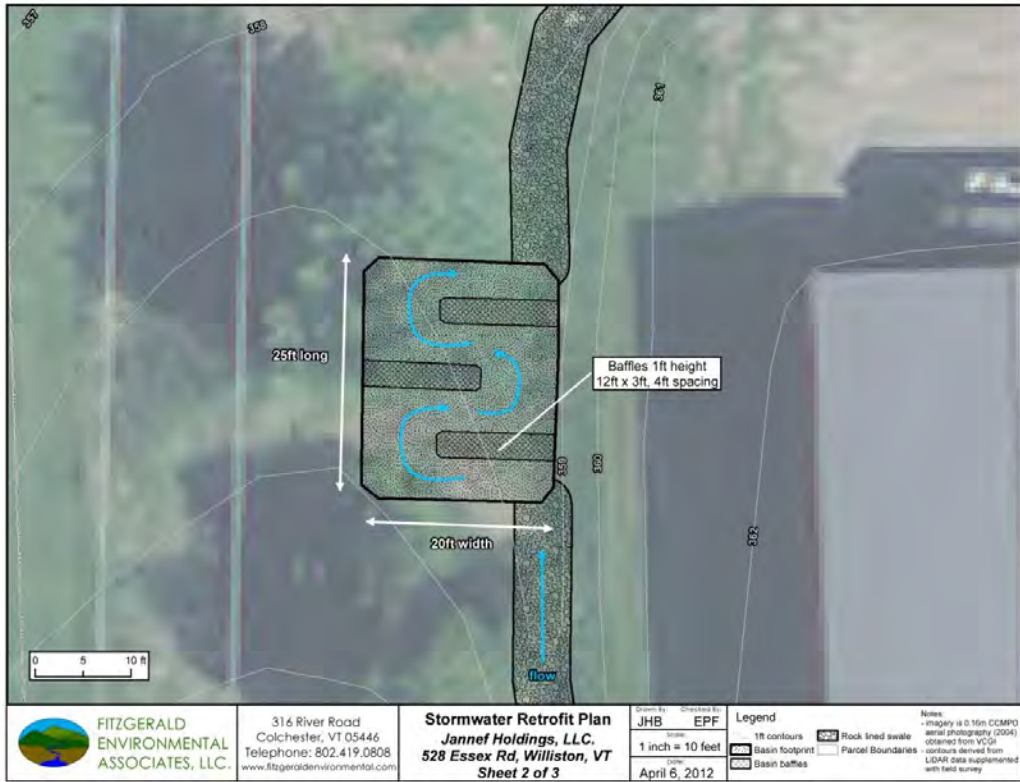
**Figure 22:** Example of baffled sediment basin.

Sediment basins would require frequent maintenance by the Town. This could be completed by hand by shoveling out captured sediment, or by a mini-excavator and dump truck. Maintenance would likely be required every 2-3 years, although check dam installation would reduce maintenance frequency.
