Upper Winooski

Class Three and Four Road Erosion Assessment

March 24, 2014

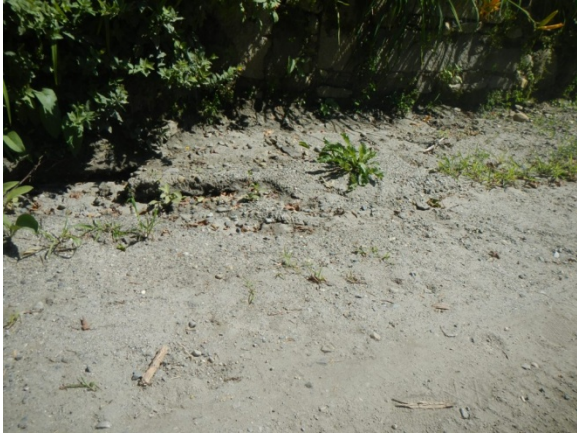
Photo 3

Erosion site 2

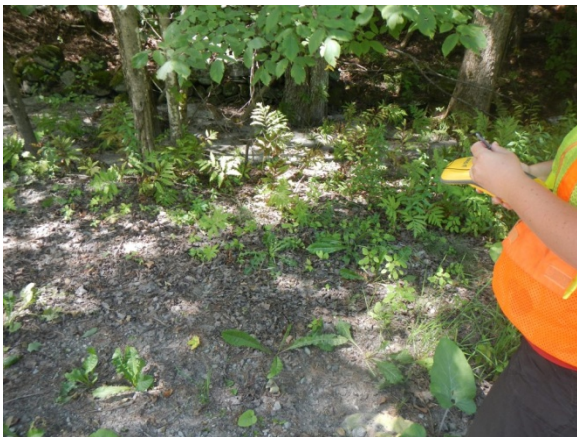
Photo 3

Erosion site 3 -

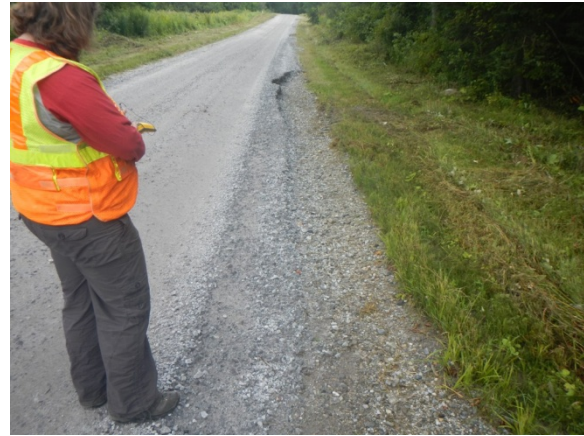
Photo 4

Erosion site 4

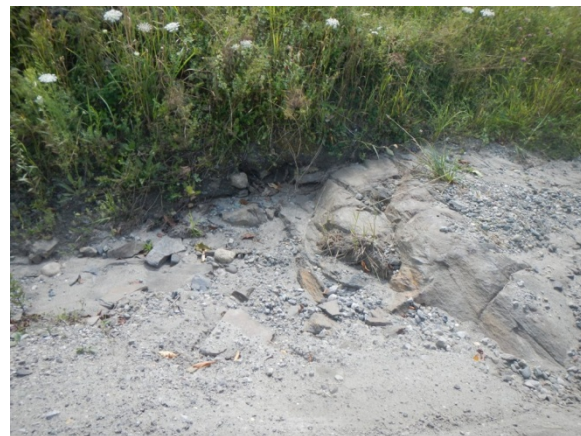
Photo 2

Site 5 –

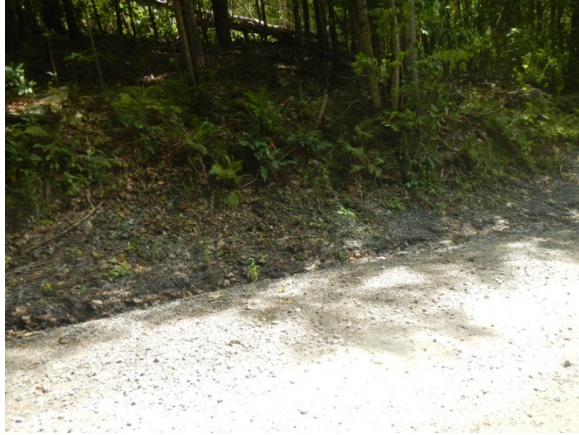
Photo 3

Erosion site 6

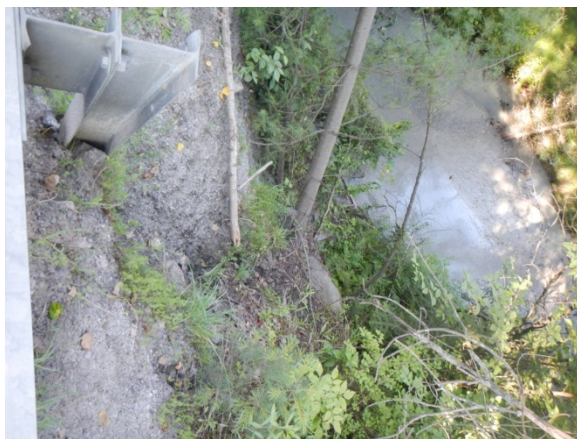
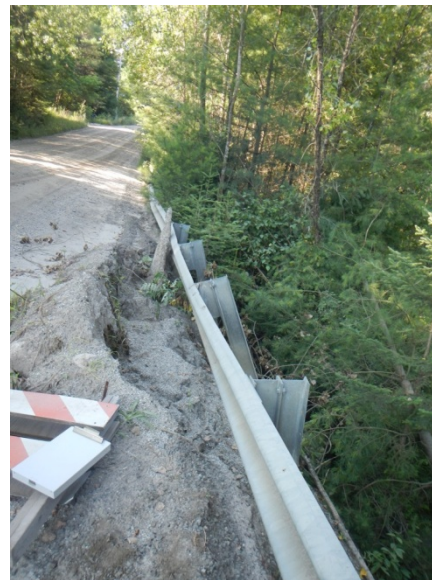
Erosion site 2

Location – Slump location on roadway shoulder near outlet of culvert on Country Club 0.5 miles South of US Route 2 in Plainfield, VT.

- Gather slump slope information
- Calculate stone needed for slop stabilization
- Price of replacement culvert
