Lamoille County Road Erosion Assessment

A project funded by the Vermont Watershed Grants Program and conducted by the Lamoille County Planning Commission with assistance from Watershed Consulting Associates, LLC.

February 2014

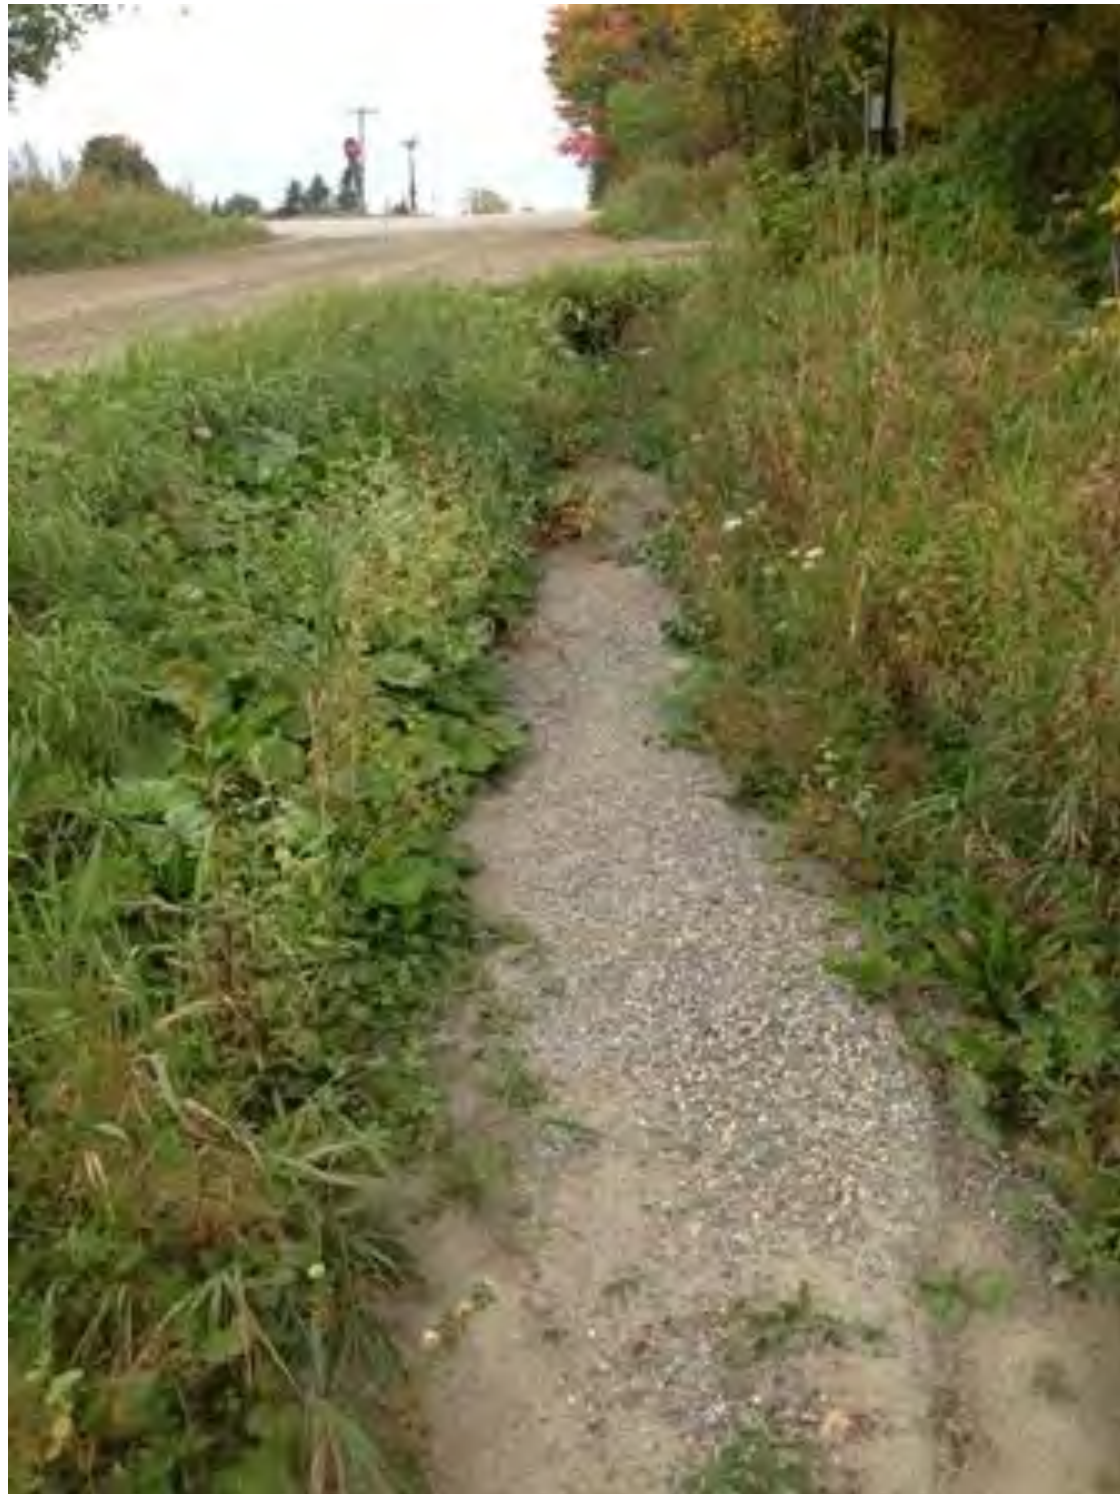
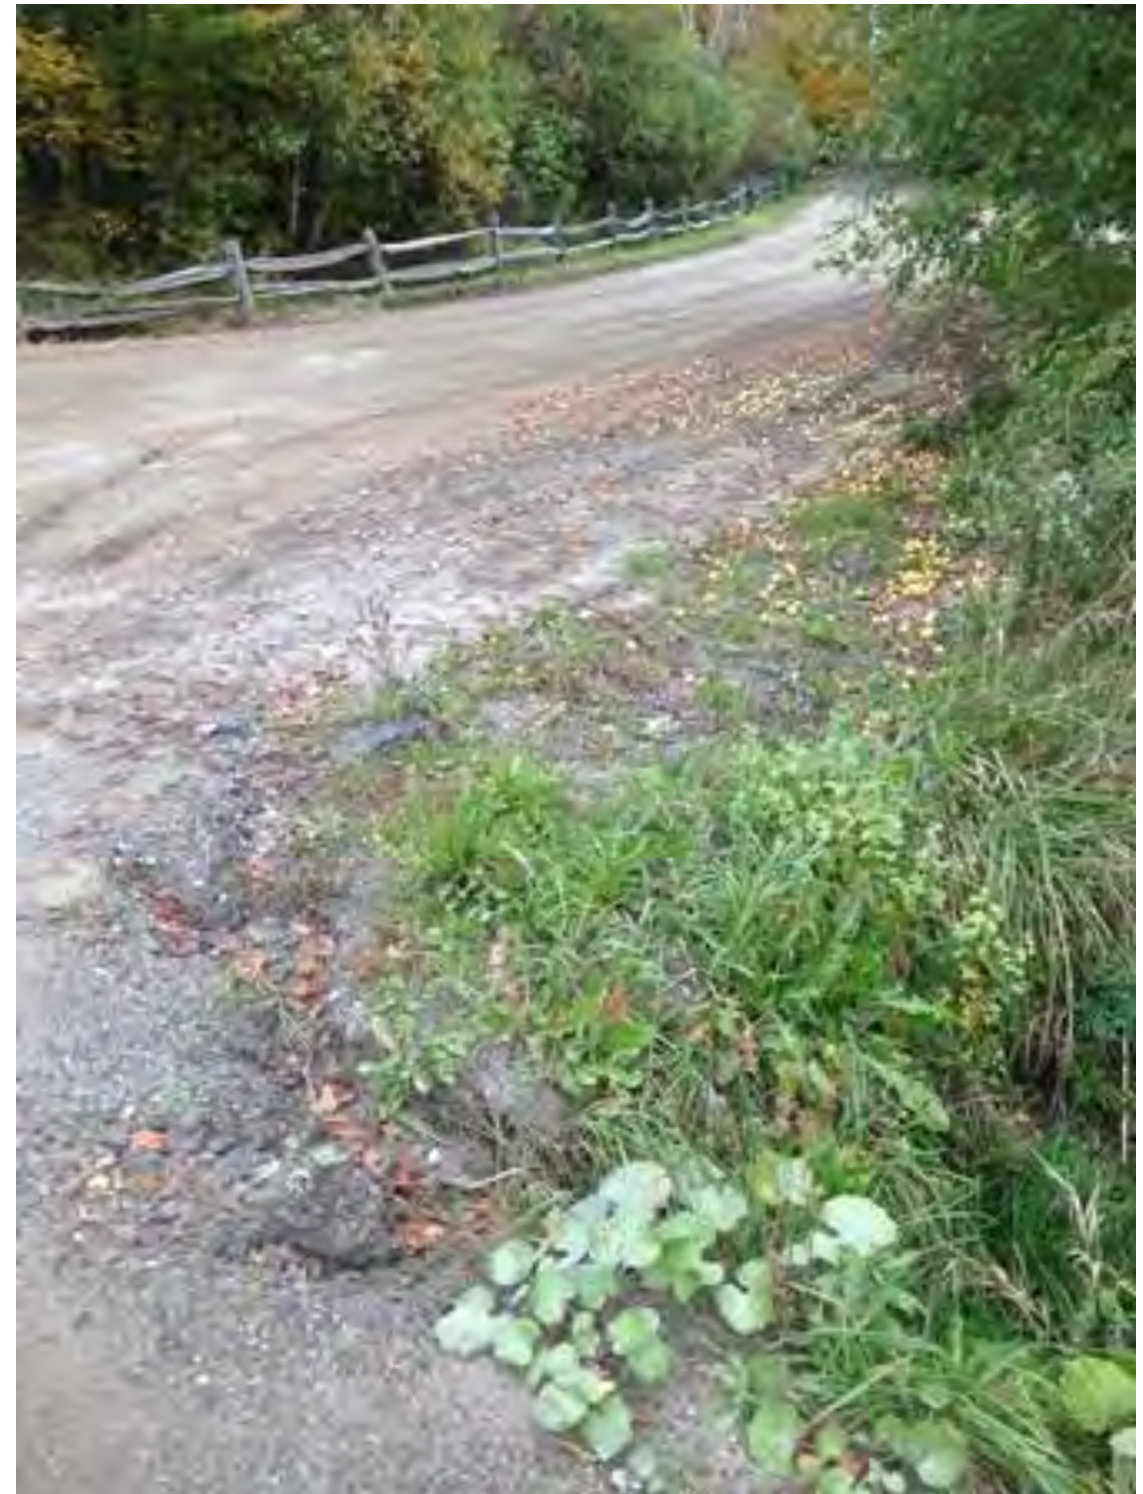
TAN4

no erosion noted
at mapped site

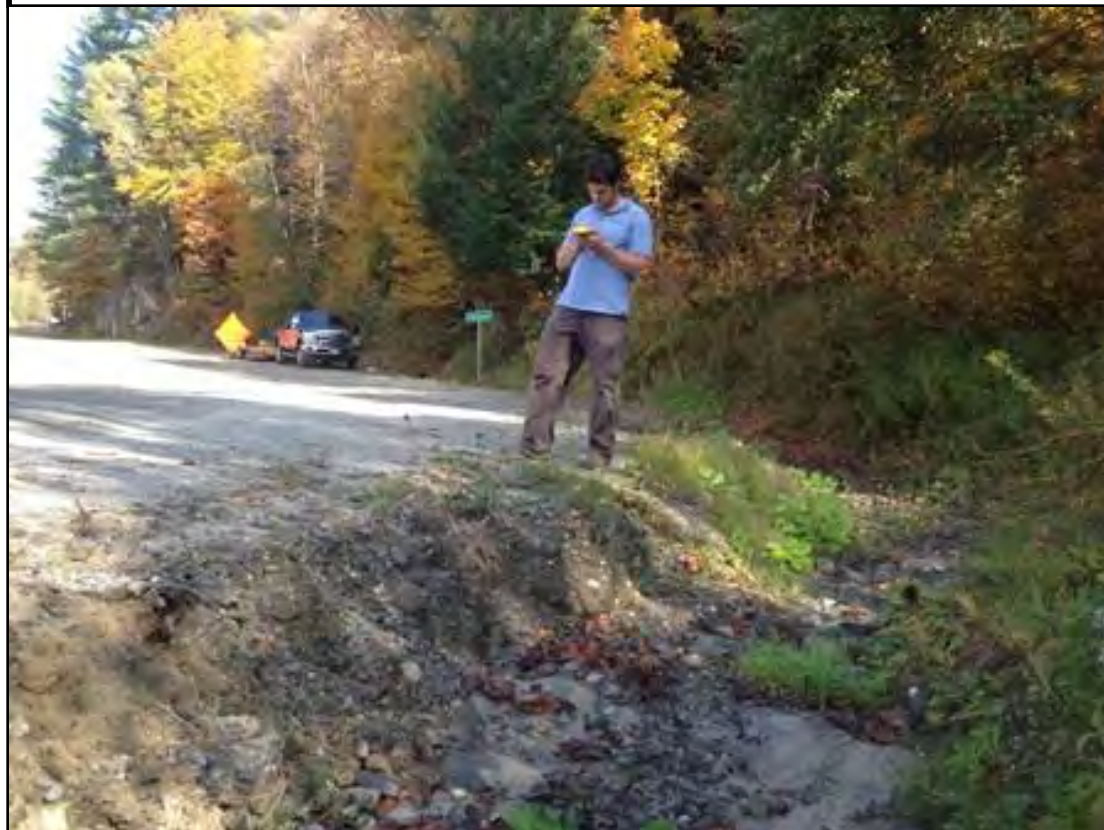
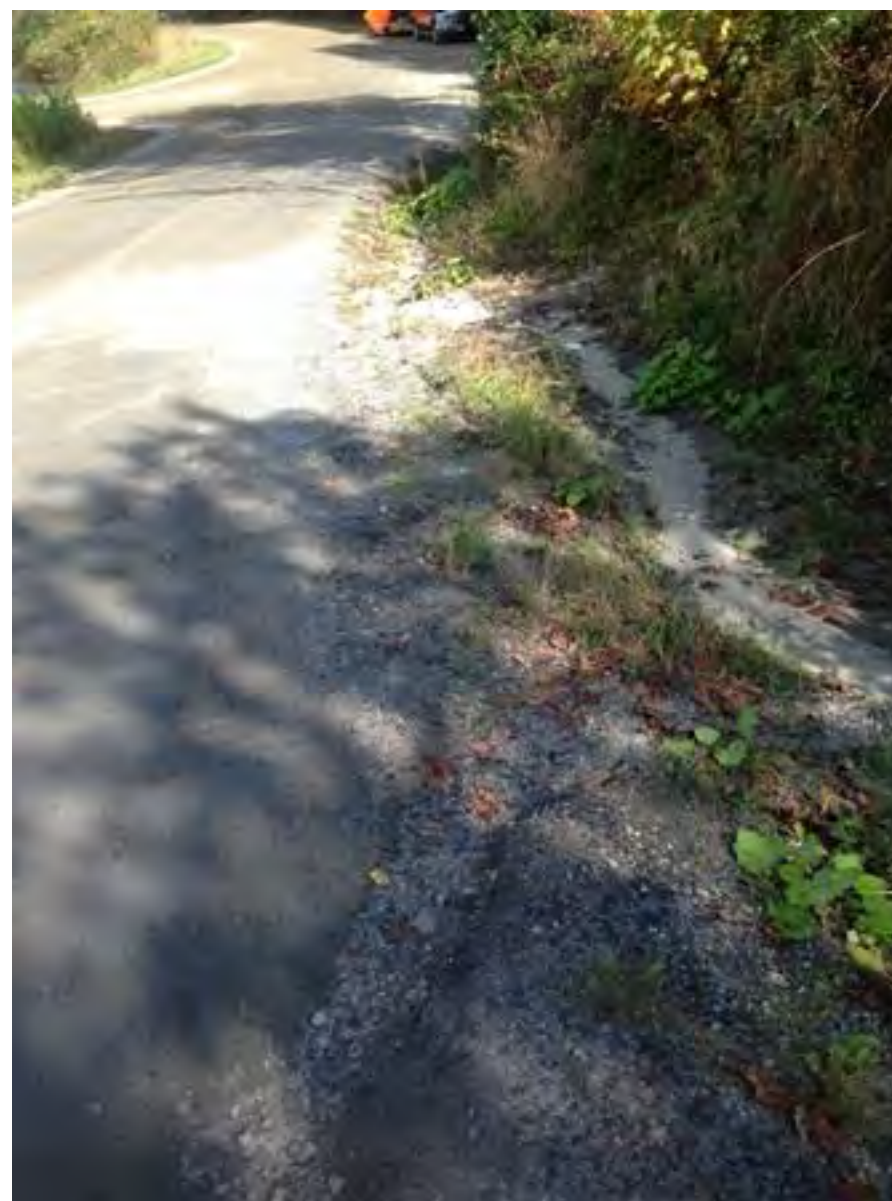
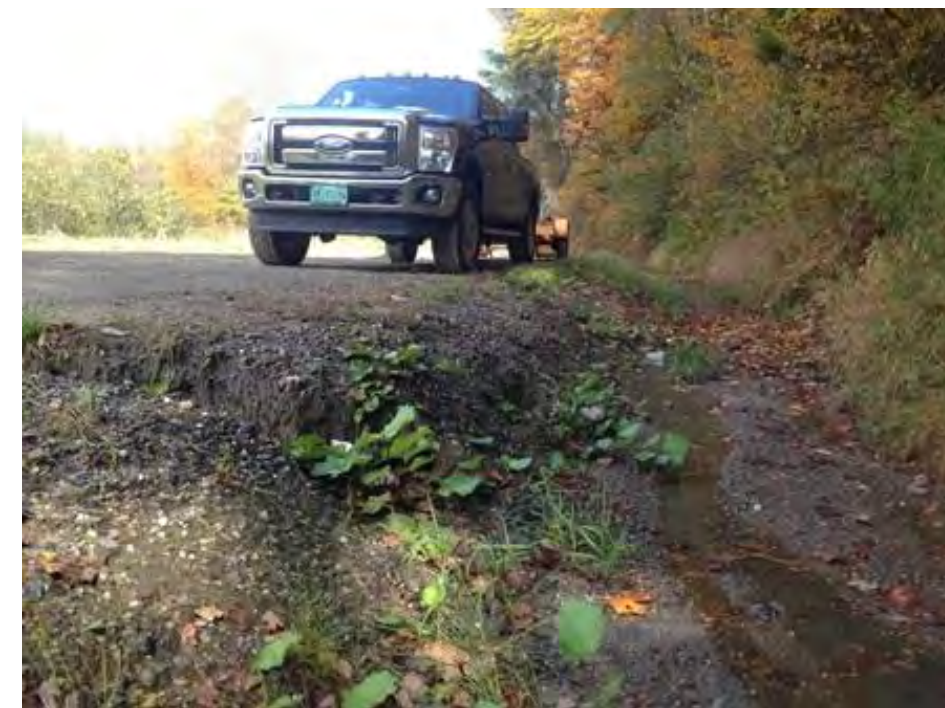
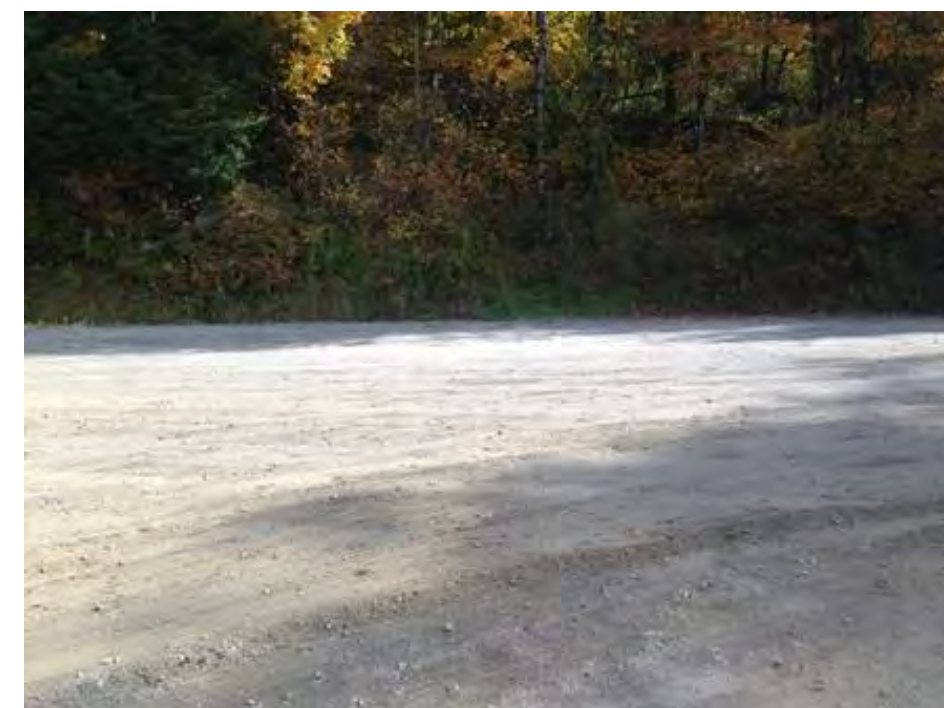
EM1

Incision is occurring in roadside swale and sediment is being deposited in stream. Armor swale and create stone spreader

DETAIL G

**2,560 CF of Type II stone
150 CF of crushed stone**

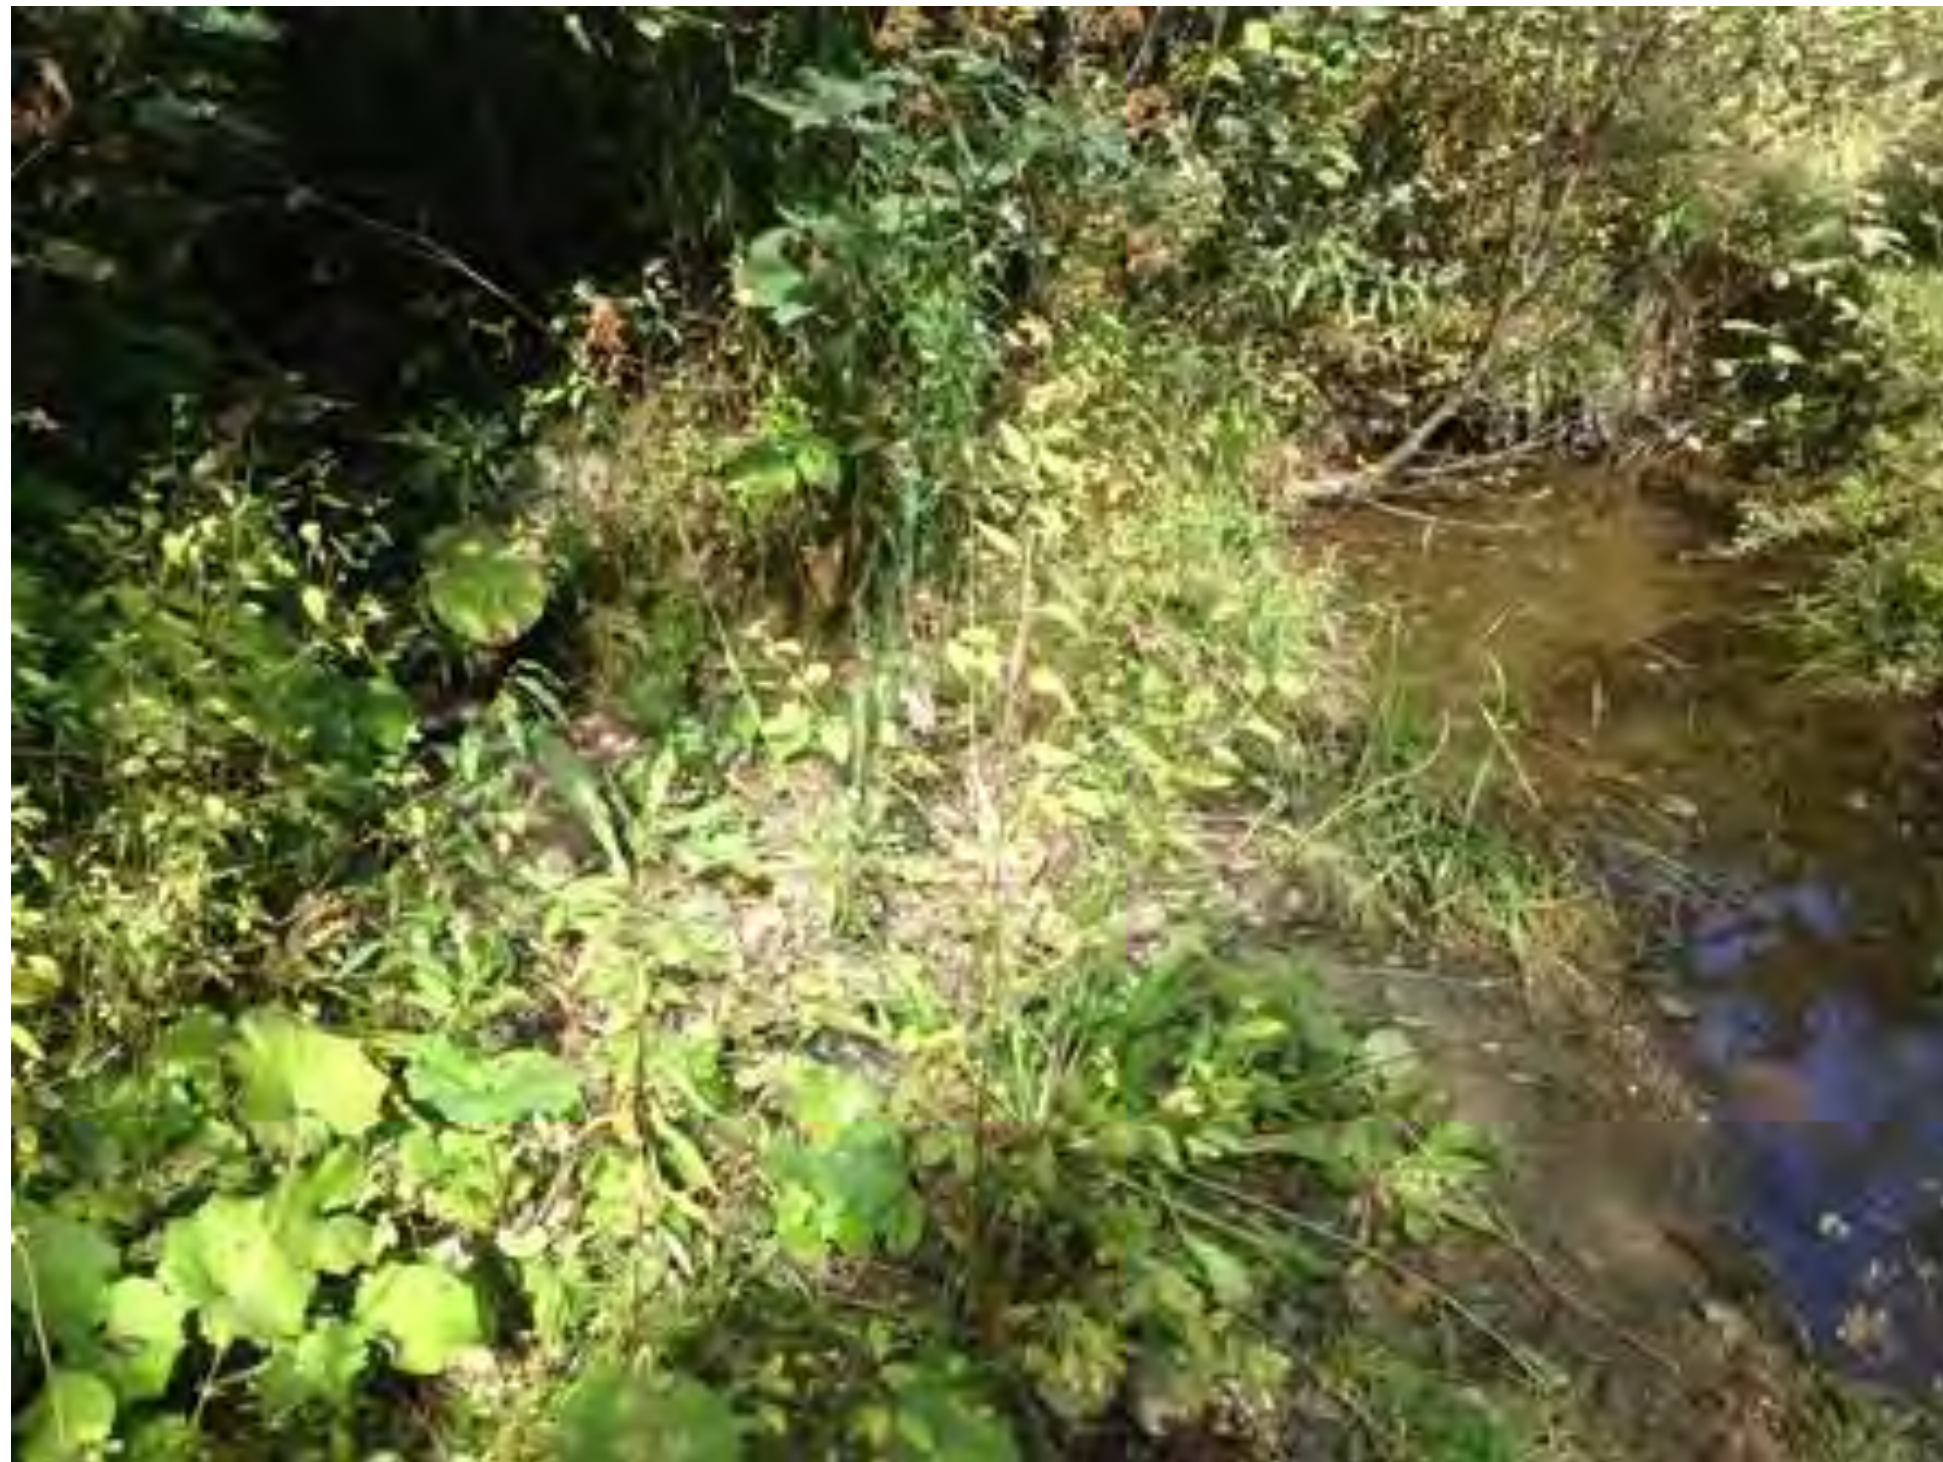
SM4

SM4: DETAIL G
Ditch on S side of road
highly incised.

DETAIL G

4,720 CF of Type II stone
285 CF of crushed stone
