## **SUMMARY REPORT – PFAS BUILDING CLEANING INSPECTIONS FORMER CHEMFAB FACILITY – SAINT GOBAIN PERFORMANCE PLASTICS**

PROJECT NO. 280EM01070 (SMS SITE #2006-4630)

1030 Water Street, North Bennington, VT 05257

April 24, 2024

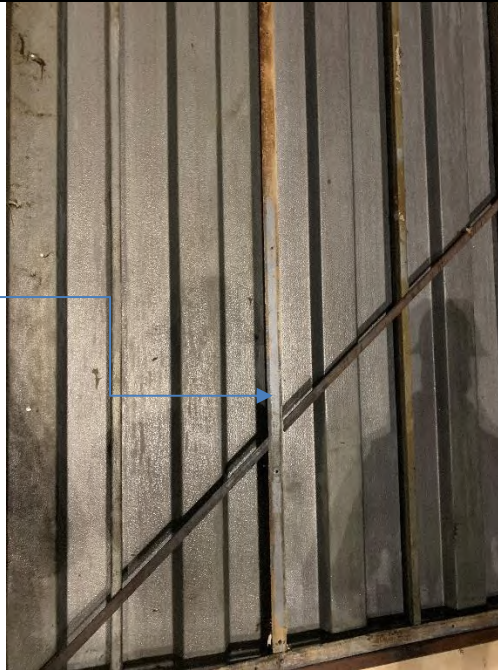
**Photograph #3**

**Description:**  
*Test section of  
pressure washer  
removal on lower  
strip of sheet metal  
walls.*

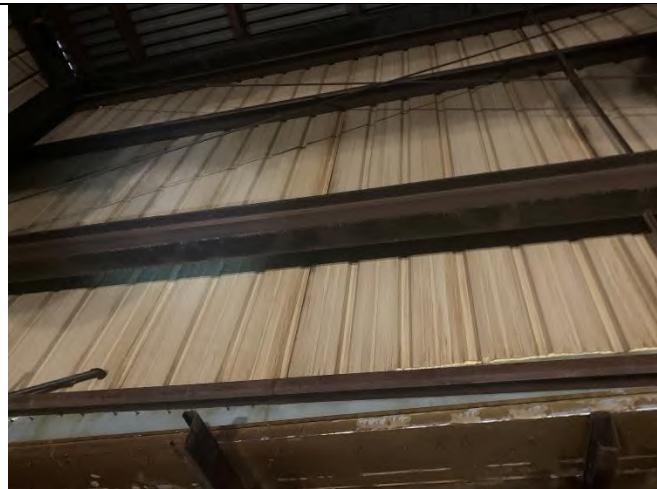
**Photograph #3**

**Description:**  
Passing photo of  
cupola III wall.

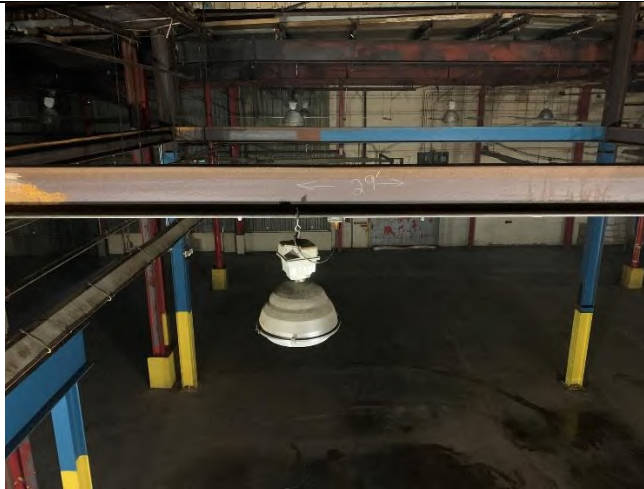
**Photograph #5**

**Description:**  
Passing support  
beam in area  
beneath cupola III.

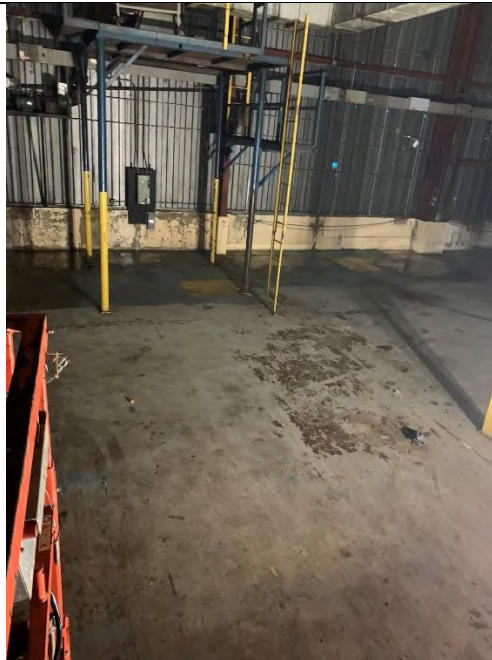
**Photograph #14**

**Description:**  
Passing floor along  
eastern wall,  
including HVAC  
catwalk area.

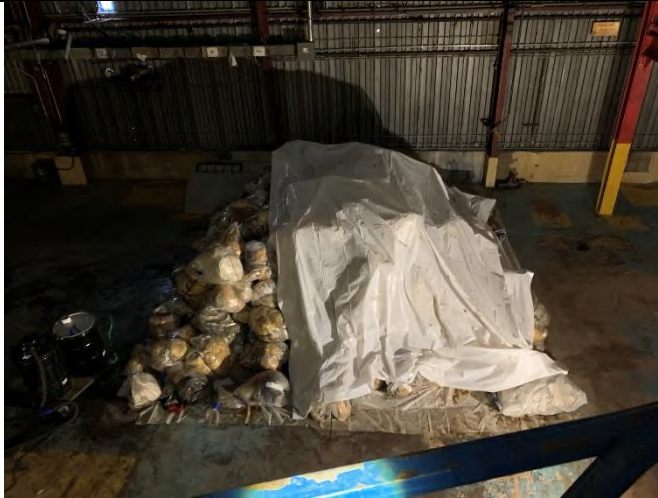
**Photograph #7**

**Description:**  
Insulation pile  
awaiting disposal.  
Contractor waiting for  
new roll offs.
