# Lower Passumpsic River Tributaries River Corridor Plan

May 1, 2014

Fitzgerald Environmental Associates, LLC.  
18 Severance Green, Suite 203  
Colchester, VT 05446

Caledonia Country Natural  
Resources Conservation District  
481 Summer Street, Suite 202  
St. Johnsbury, VT 05819

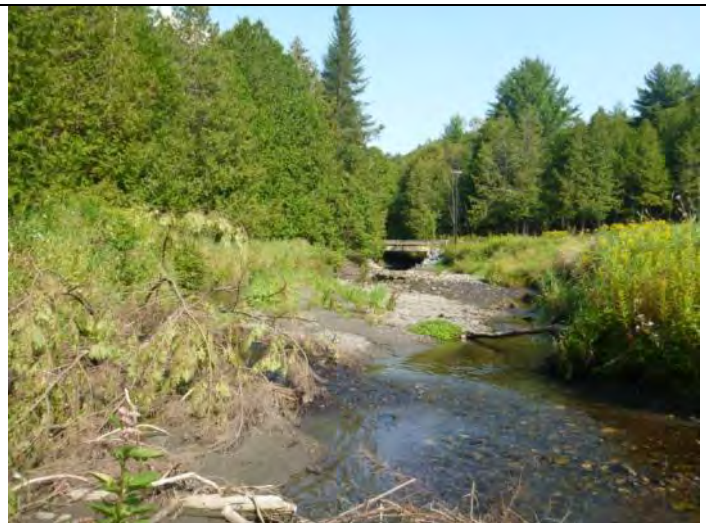
Typical channel geometry near top of reach

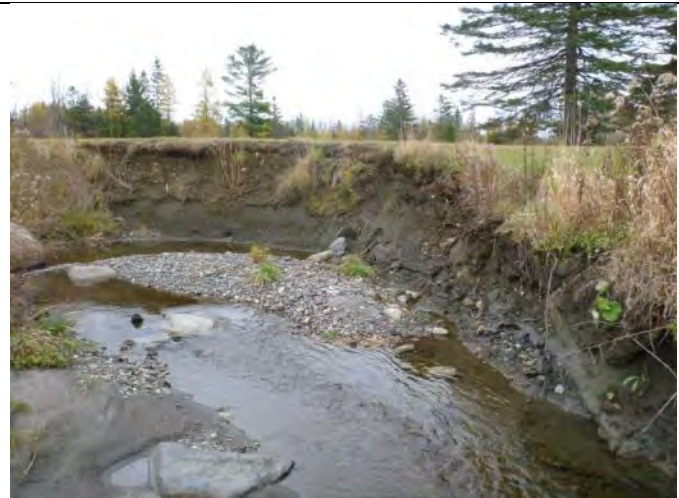
Fresh erosion and fine deposition along areas with no buffer vegetation

- #18 – Buffer Planting
- #19 – Channel and Floodplain Restoration
- #20 – Culvert Replacement

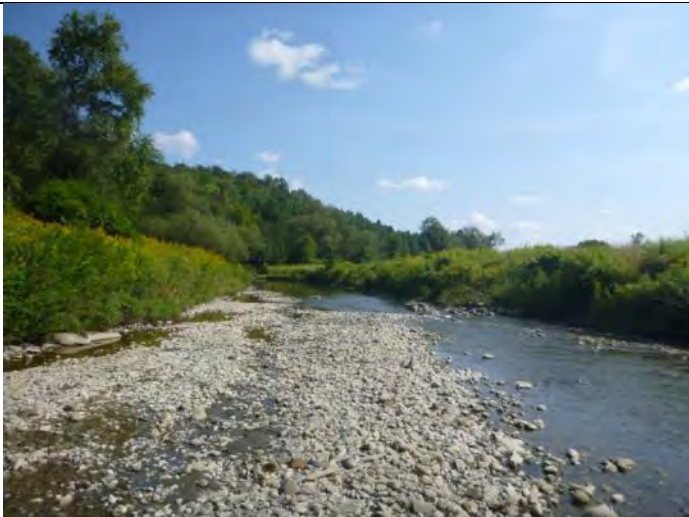
**Reach Highlights:** This reach is deeply incised and entrenched due to right bank armoring along the corn field and a typically tight left valley wall. Historic armoring and channel manipulation are limiting widening leading to downcutting and an inaccessible floodplain. Gravel deposits within the channel are unstable. Large grade control at top of reach appears to reduce upstream migration of incision. The river doesn't have much power through this reach due to the low slope and effect of dam downstream. There was some channel migration in the lower reach during the 2011 floods. This suggests that overall the reach would have a tendency to laterally migrate, but has become locked in place along the valley wall due to the severe incision.

Straightening, buffer impacts and deep incision mid-reach

- #21 – Channel and Floodplain Restoration

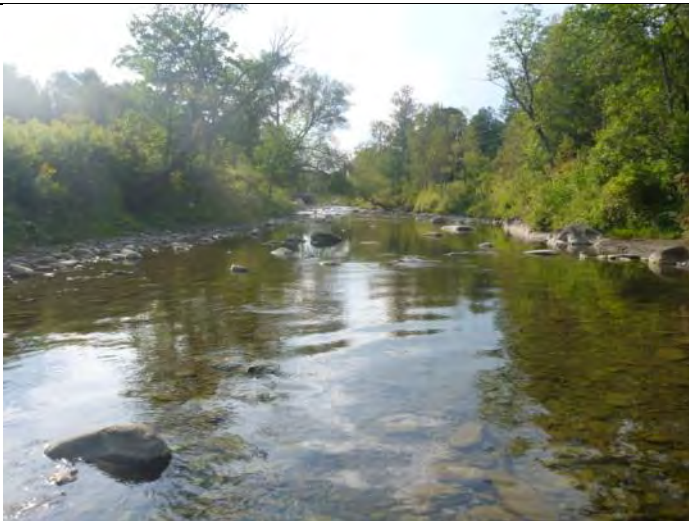
Mid-reach looking upstream - stable rocky banks and a smooth bed profile

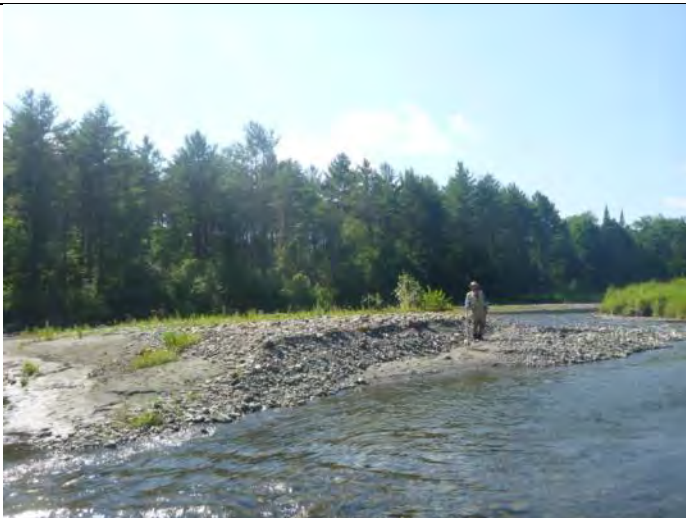
**Reach Highlights:** This reach is a major depositional area and contains a large alluvial fan. The dominant adjustment process is widening as the stream braids through large cobble and gravel deposits; these adjustments would be expected in this setting, but are exacerbated by river corridor impacts. The left bank is armored along Goss Hollow Rd and the right bank shows evidence of recent scour and erosion. The stream is highly overwidened and contains numerous diagonal bars and mid channel bars braiding flow at all levels. Access to the large forested right floodplain may eventually improve if the bed aggrades, however the house in floodplain may be at risk.

Stream braiding through large cobble and gravel bars

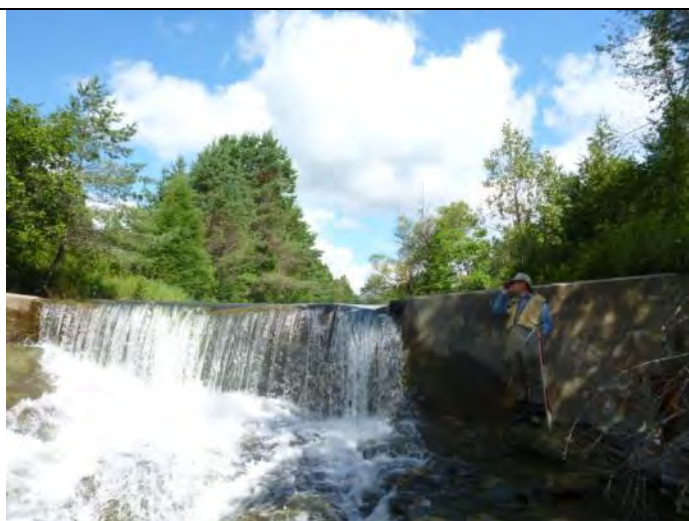
**Reach Highlights:** Degradation is the dominant process for this reach. This reach contains numerous bedrock grade controls and an abandoned USGS weir. Grade controls may have arrested historic incision, with widening likely in near future. These features trap large volumes of sediment and may increase degradation downstream. The right valley wall is tight for most of the reach and the left bank is heavily armored in several stretches along North Danville Road, limited widening and increasing degradation.

USGS weir over a bedrock grade control

- #26 – USGS Weir Removal
- #27 – Floodplain Easement for property in major flood risk location
- #28 – Bank Stabilization
- #29 – Buffer Planting

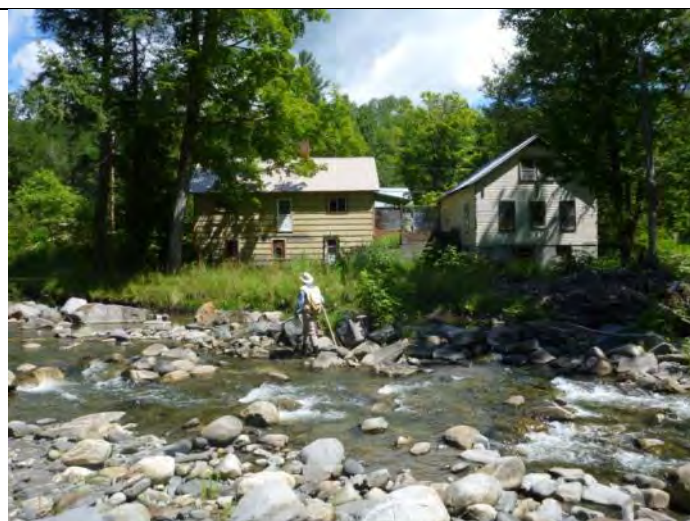
House on a low floodplain bench near active channel area

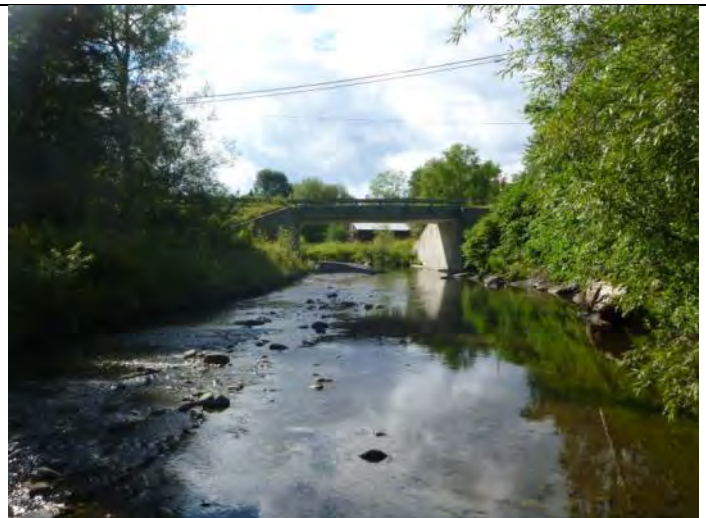
Jamieson Road bridge and backwater from dam through most of reach

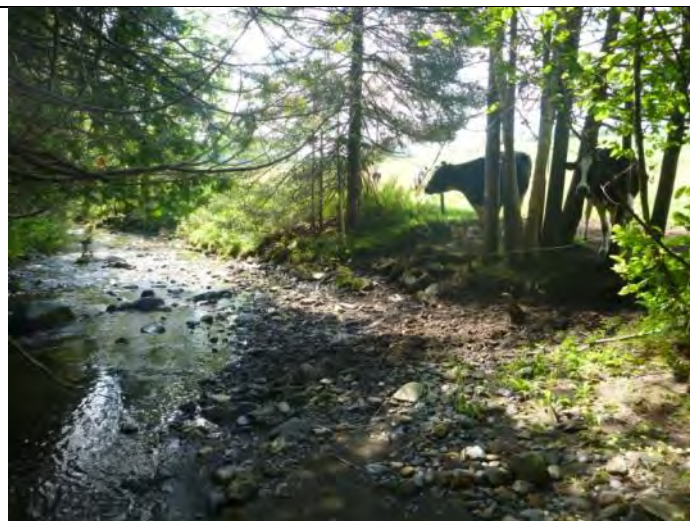
Cattle stream access and narrow forested buffer in upper reach

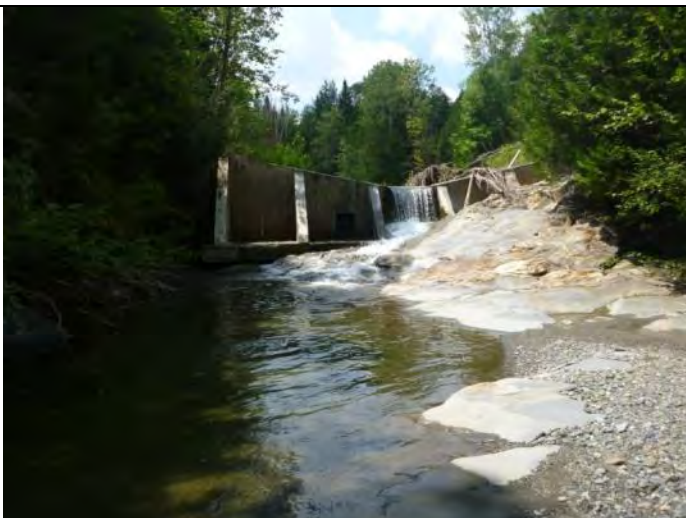
**Reach Highlights:** This reach is affected by a USGS weir for the entire length with large depositional features and lack of bankfull indicators. Administrative judgment for stream type and sensitivity. Most of the channel is occupied by a huge side bar that is several feet above bankfull. The channel is eroding the left bank for most of the reach.

USGS weir and ledge from below

- #37 – Remove USGS Weir

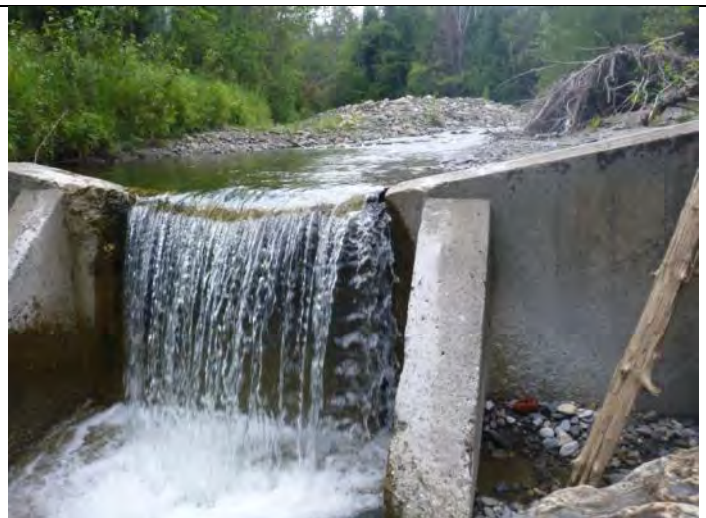
Huge cobble side bar above weir

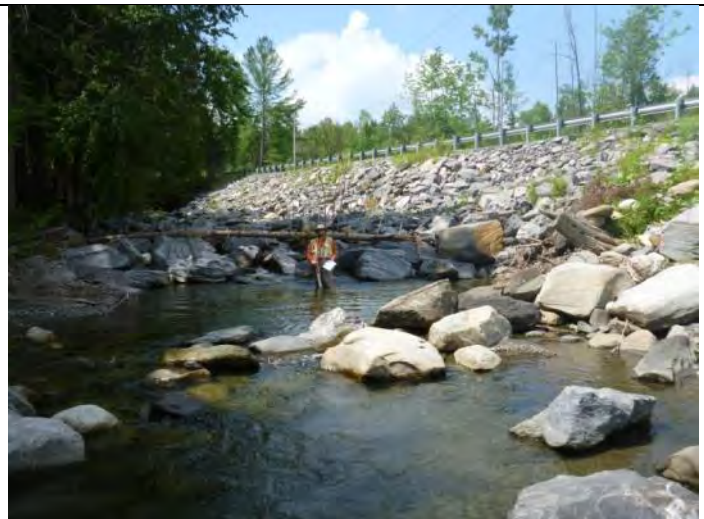
Large bed and bank armoring site in upper reach

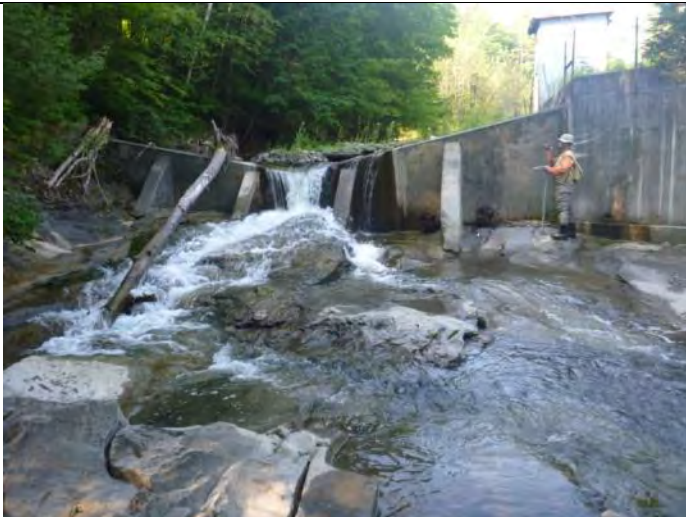
Abandoned USGS weir on a natural grade control

- #43 – Bridge Retrofit/Replacement: Roy Rd
- #44 – USGS Weir Removal

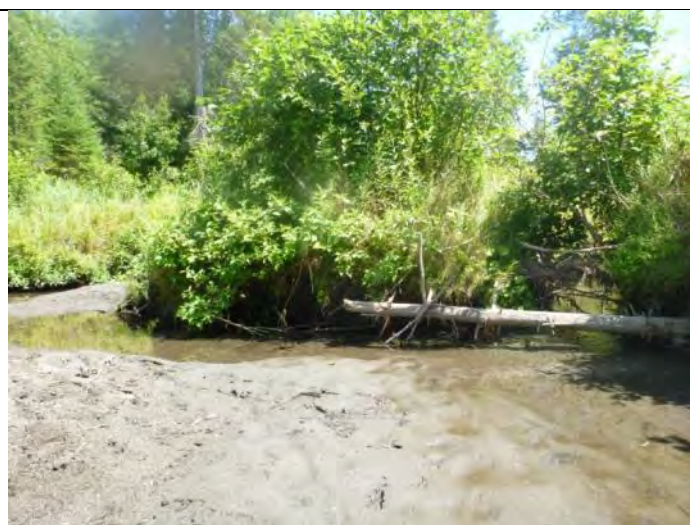
Large point bar and a recent neck cutoff through a meander bend

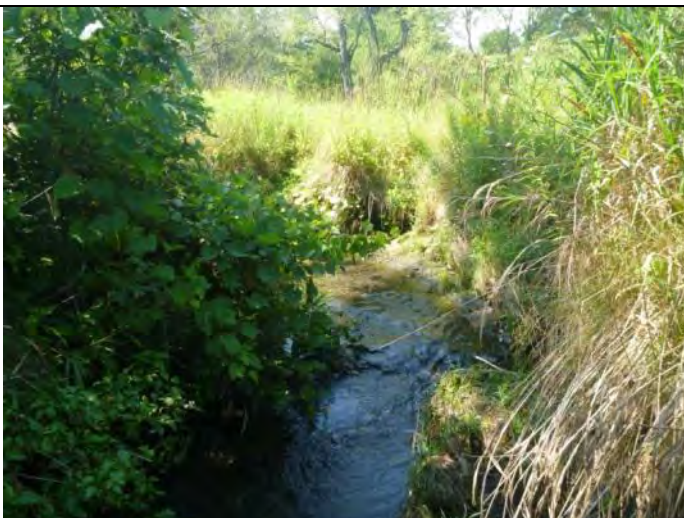
Typical incised E-type geometry

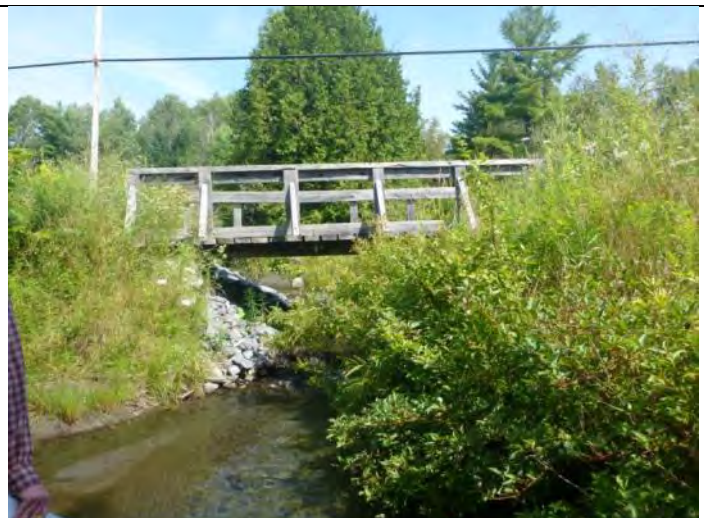
Private bridge in lower reach

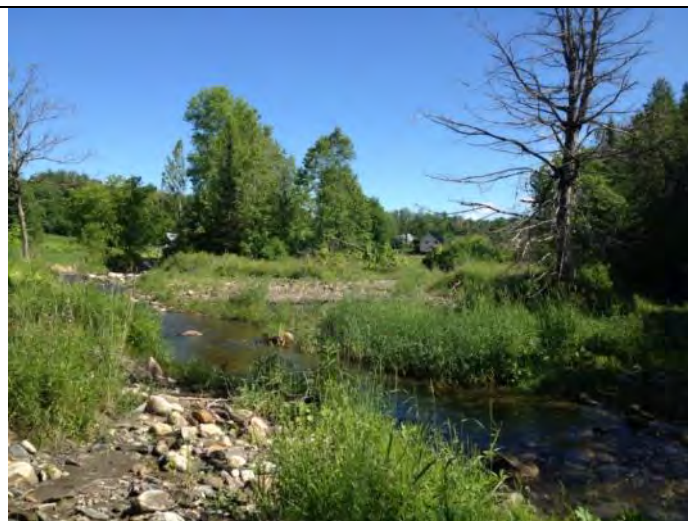
Evidence of recent floodplain access and redeveloping planform in lower reach

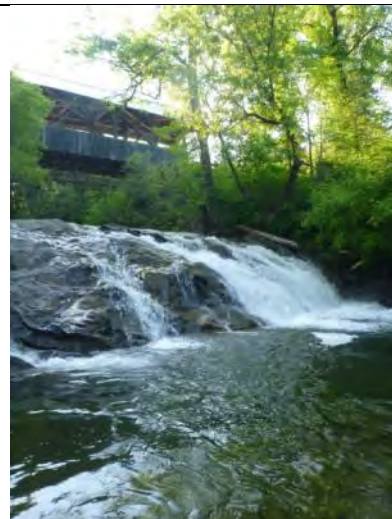
Bedrock cascade and Chamberlain Covered Bridge at top of reach

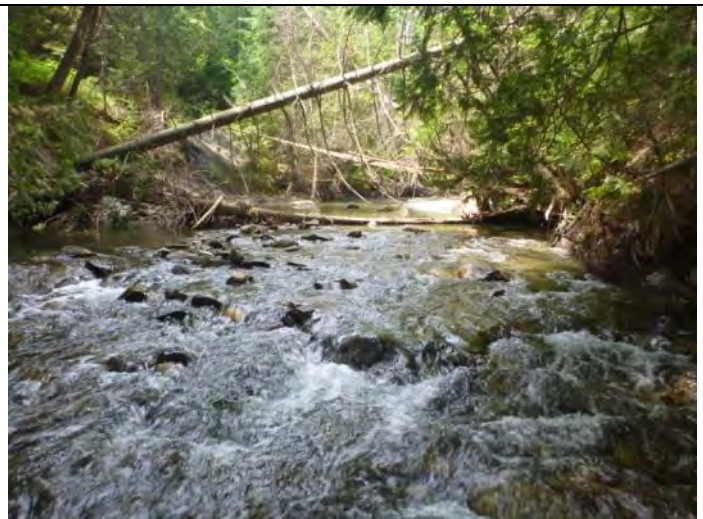
Typical reach geometry with steep banks to elevated and inaccessible floodplain, MF visible on RB

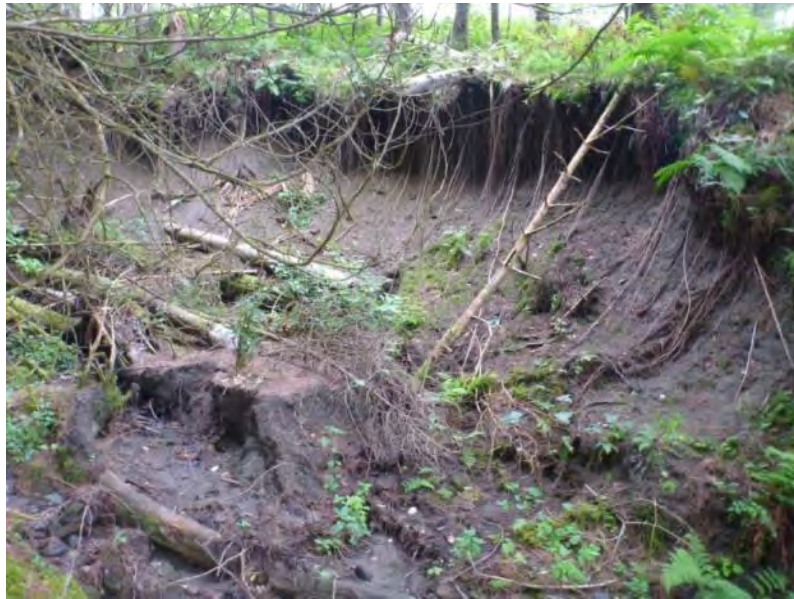
- Large gullies: T2.07 (see Figure 8) and T4.02
- Extreme mass failure density: T2.08B, T2.10, T2.11B, T3.06, T3.09, T3.10, T3.10S1.01, T3.10S1.03, T3.7S1.01A, T3.7S1.01B, T3.7S1.02, T3.7S1.05, T4.02, T4.03B (see Figure 9), T4.2S1.01, and T5.05B

**Figure 8:** Large gully on Water Andric Reach T2.07.

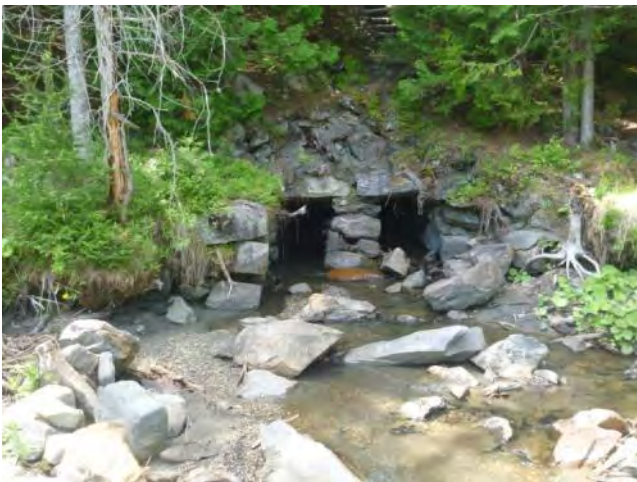
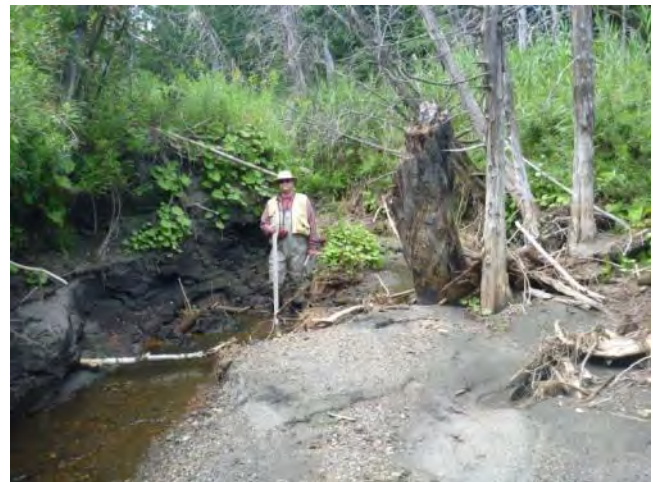
- Extreme debris jam density: All Water Andric Segments (9 segments), T3.09, T3.10, T3.10S1.01, T3.10S1.03, All Whiteman Brook segments except T3.7S1.06A (8 segments), T4.02, T4.03, T4.2S1.01, and T5.05 (Figure 10)
- Large grade controls:
  - Ledge: T3.05, T3.06, T3.10S1.03, and T5.07
  - Man-made: T3.08, T3.09, T3.10, T3.11, T3.7S1.01B, and T3.10S1.02
- Extreme undersized structures: T2.09, T3.7S1.01A, T3.7S1.06B (Figure 11), T3.7S1.07, and T5.06

**Figure 11:** Extremely undersized stone culvert (left) leading to deep deposition of fine material and channel instability (right) on Whiteman Brook segment T3.7S1.06B.

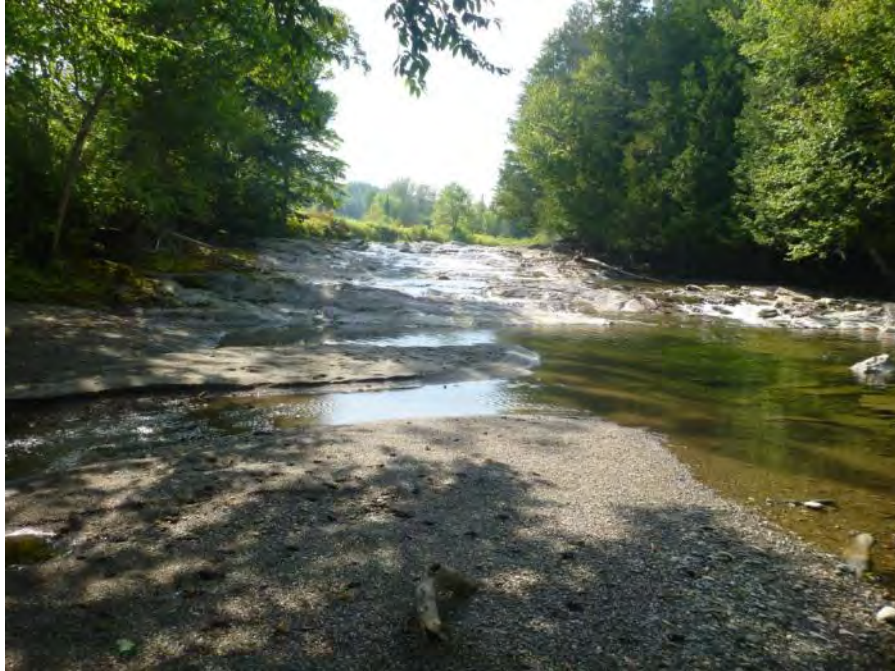
- Segments with numerous or large natural grade controls: T2.08B, T3.05, T3.06, T3.08, T3.10S1.03, T5.02, T5.05A, T5.06, and T5.07 (Figure 13)
- Segments with man-made grade controls (Figures 14 & 15)
  - Weirs: T2.12B, T3.08, T3.11, T3.10S1.02, T3.7S1.01B
  - Dam: T3.10
  - Bed Armoring: T2.09, T3.08, T3.09, T3.10S1.03

**Figure 13:** Large ledge grade control halting the progression of incision from T3.04 upstream to T3.05 on Sleepers River.

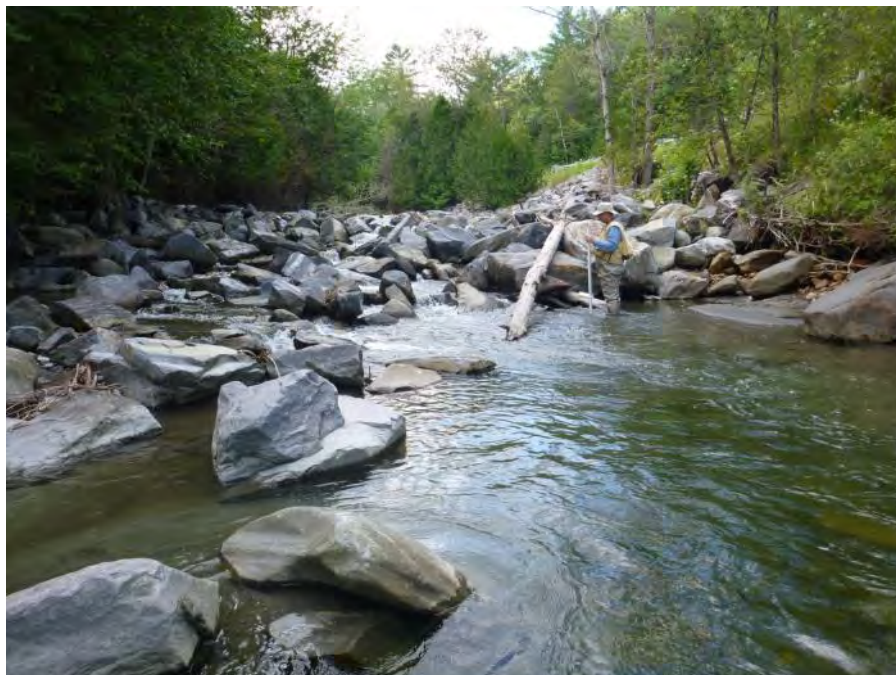
**Figure 14:** Bed armoring site on Sleepers River reach T3.08.

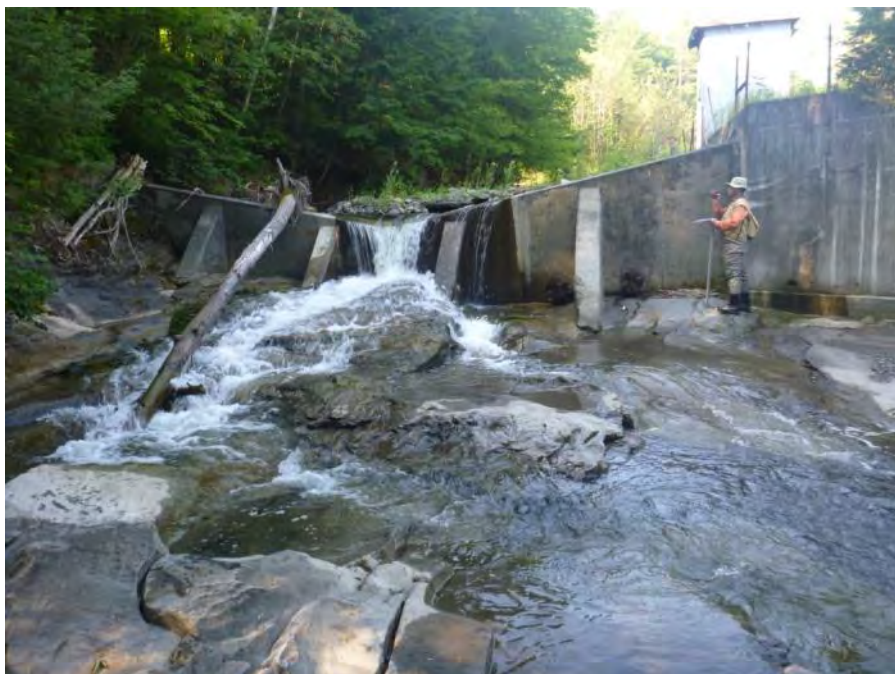
**Figure 15:** USGS weir on Whiteman Brook segment T3.7S1.01B.

| Surface Water | Phase 2 Segment ID | Reference Sediment Regime | Existing Sediment Regime | Cause of Departure |
|---|---|---|---|---|
| Whiteman Brook | T3.7S1.01B | Transport | Confined Source and Transport | Major deposition from recent flooding, active widening with mass failures |
