**River Corridor Plan for the Williams River in Rockingham,
Chester, and Andover, Vermont**

September 29, 2016

Fitzgerald Environmental Associates, LLC.
18 Severance Green, Suite 203
Colchester, VT 05446

**Windham County Natural Resources
Conservation District**
28 Vernon Street
Brattleboro, VT, 05301

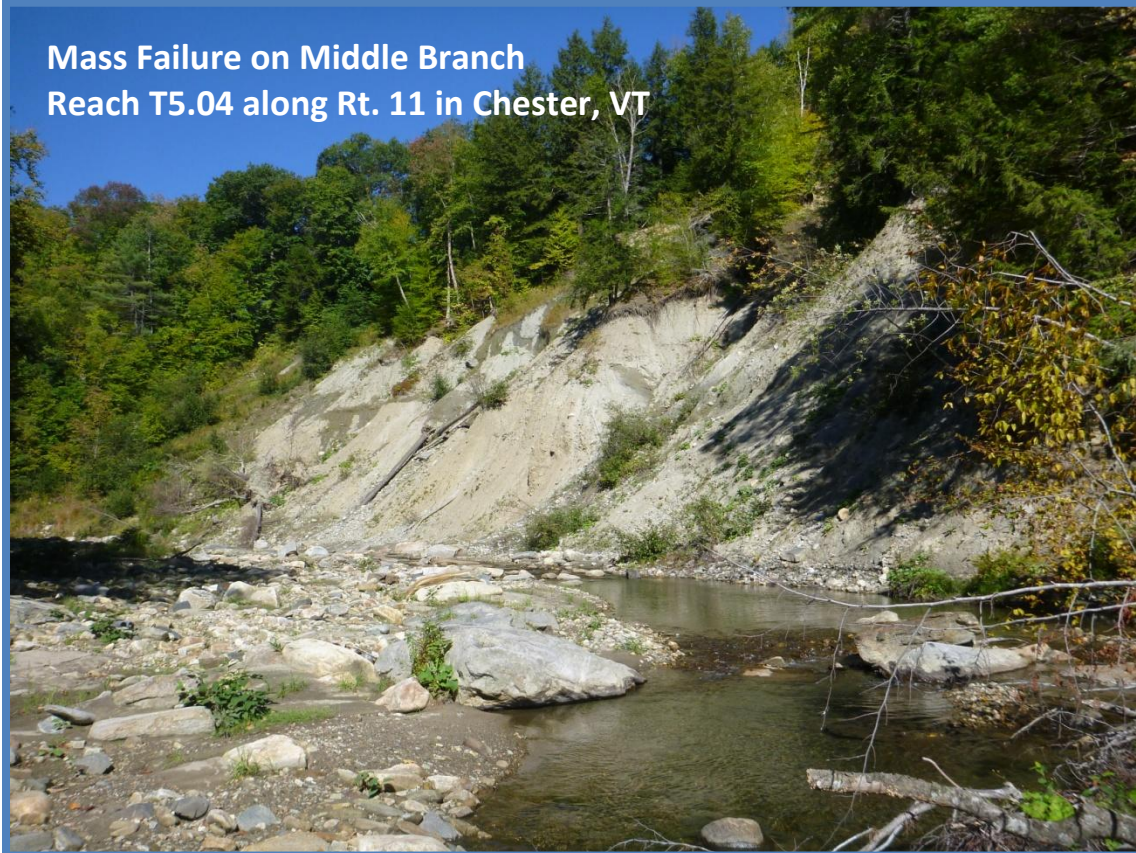
**Mass Failure on Middle Branch
Reach T5.04 along Rt. 11 in Chester, VT**

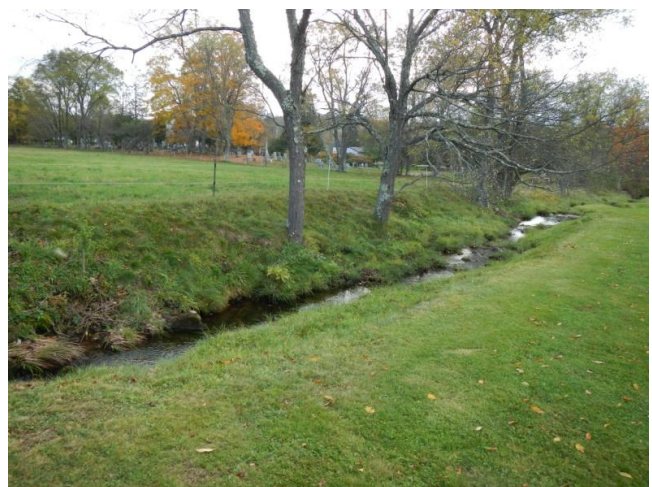
Segment T7.01-B of Trebo Brook

- Trebo Brook (T7.01.A-T7.01.B)
 - Segment A was not assessed since it was heavily influenced by a beaver complex. Segment B is deeply incised from historic straightening and bank armor. The bed had no major features and appears to be continuing to incise.

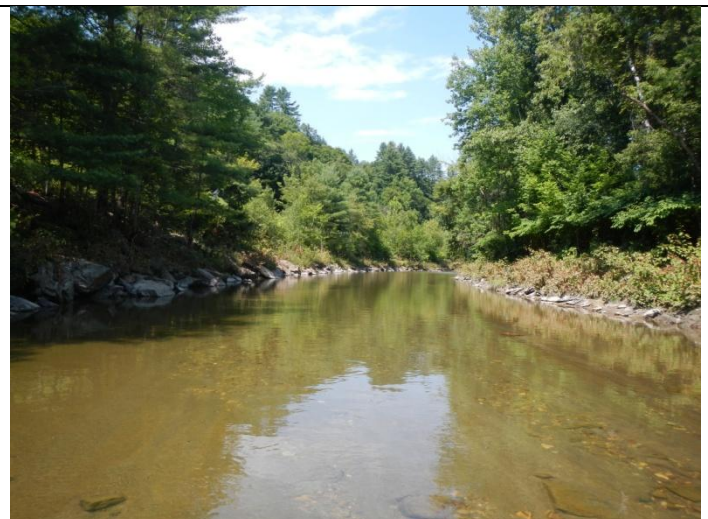
Banks straightened and armored for long sections

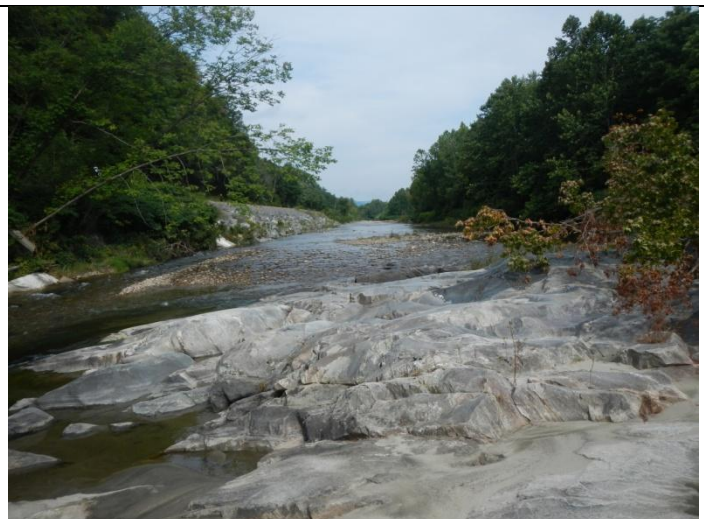
Bedrock outcroppings provided sediment storage

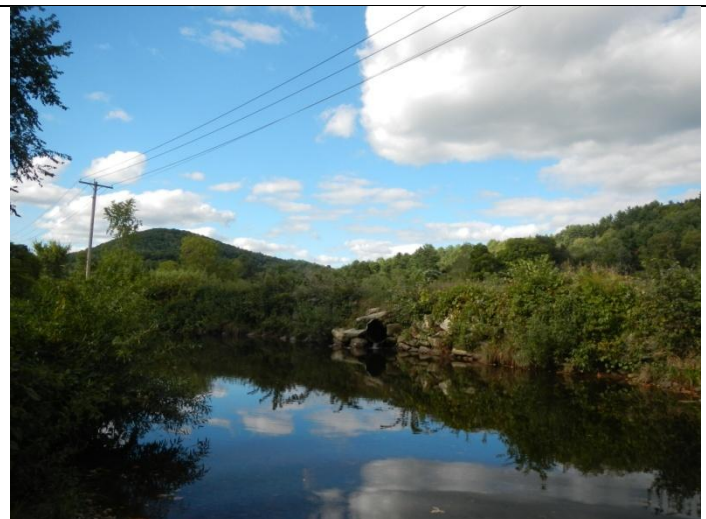
Reach Highlights: The incision and entrenchment in this reach results from historic armoring and straightening. Currently the channel is narrower than curve width and does not have access to the adjacent floodplain. Only a few areas of planform adjustment or widening were observed, the reach is mostly stable. This reach was assessed as a stage II and is expected it to remain there for a long time, due to the incision and entrenchment observed, and the extensive armoring and encroachment.

Armoring results in loss of floodplain due to incision.

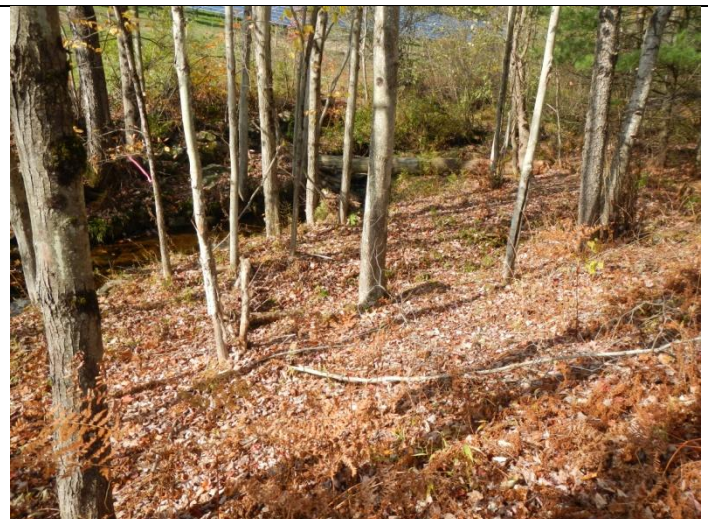
Forested B-type channel with floodplain benches

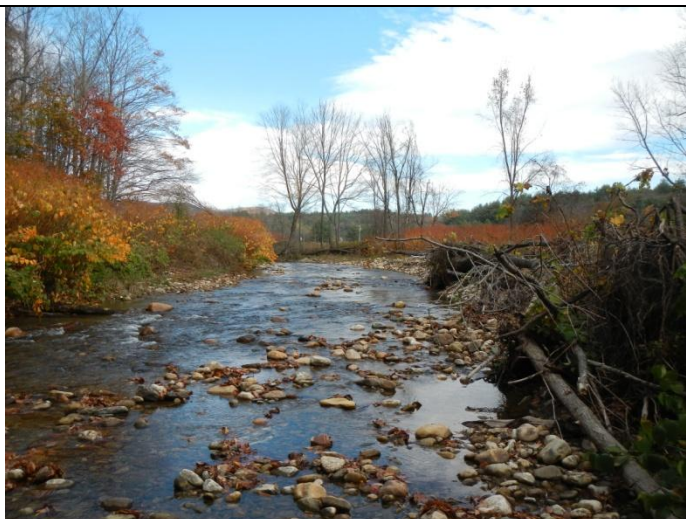
Channel aggrading and floodplain benches remain

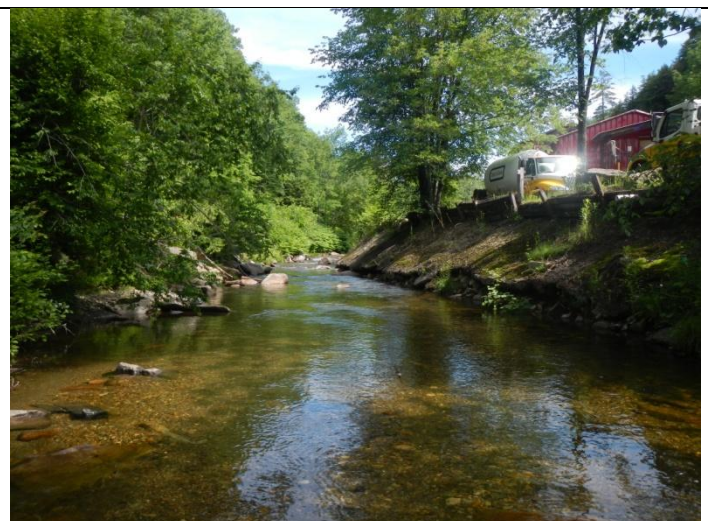
Paved left bank represented in alternate cross section

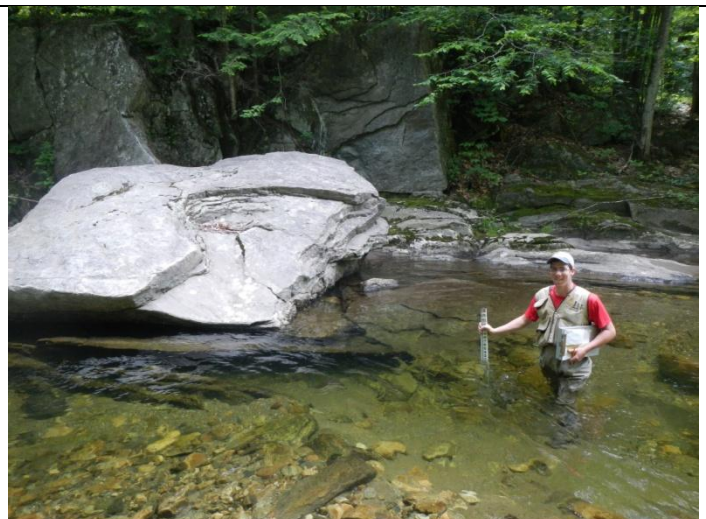
Many large pools now filled in with fines from T.S. Irene

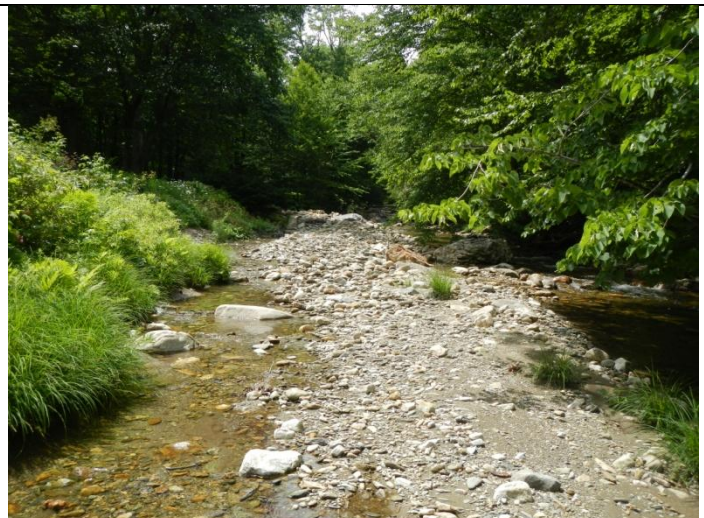
Many depositional features form as the channel widens

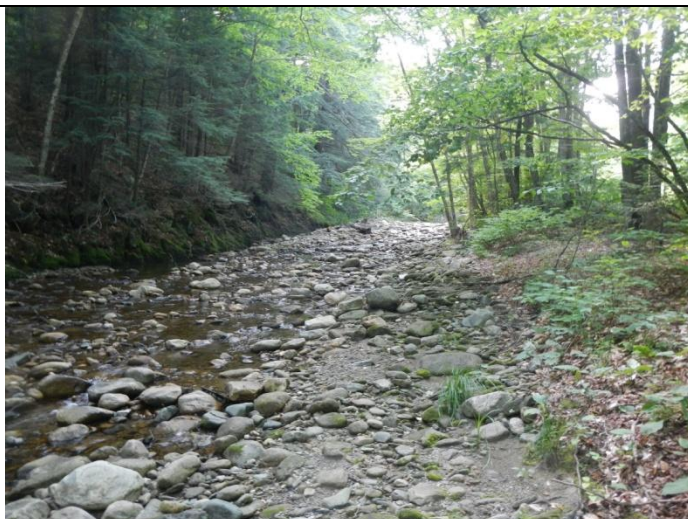
Floodplain is greater than 2x Wbkf

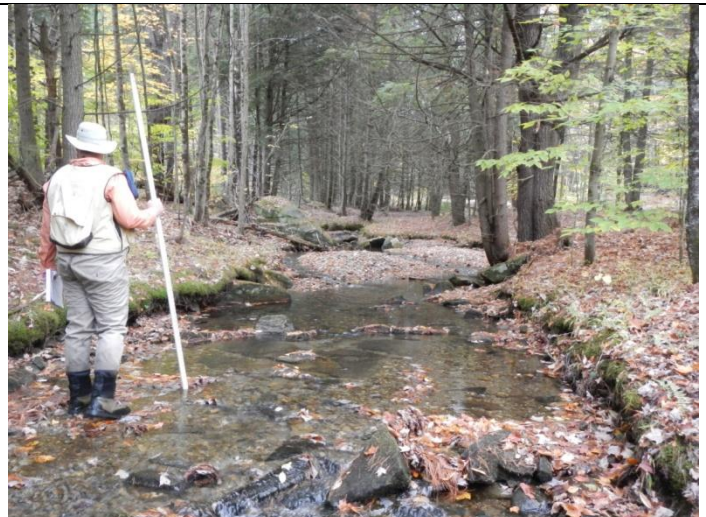
Upper reach easily accessible floodplain

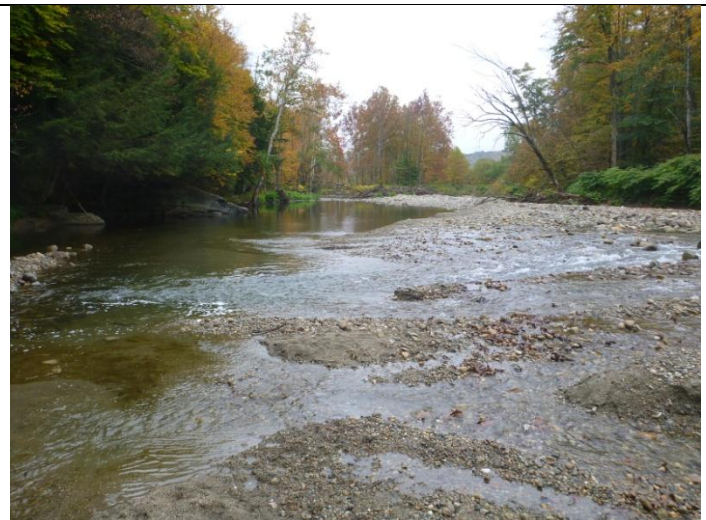
Planform adjustment displayed by diagonal riffles

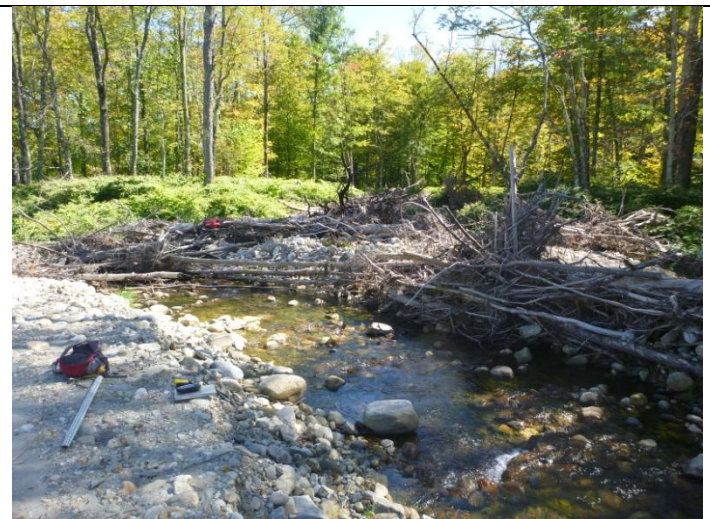
Many debris jams present throughout braided segment

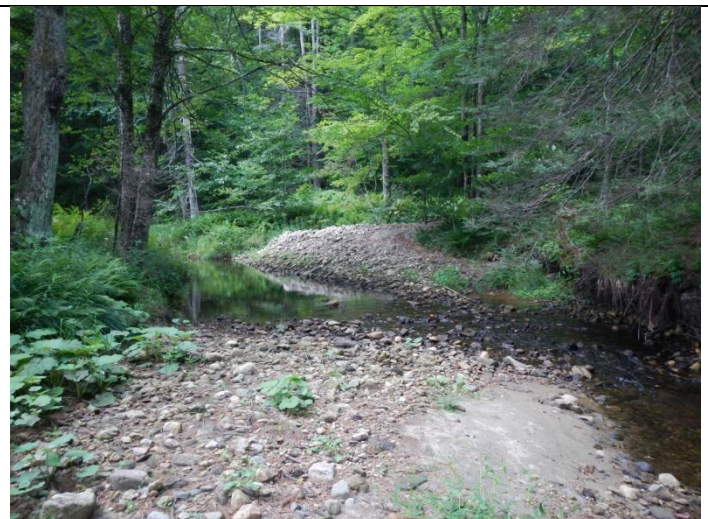
Planform adjustments present throughout segment

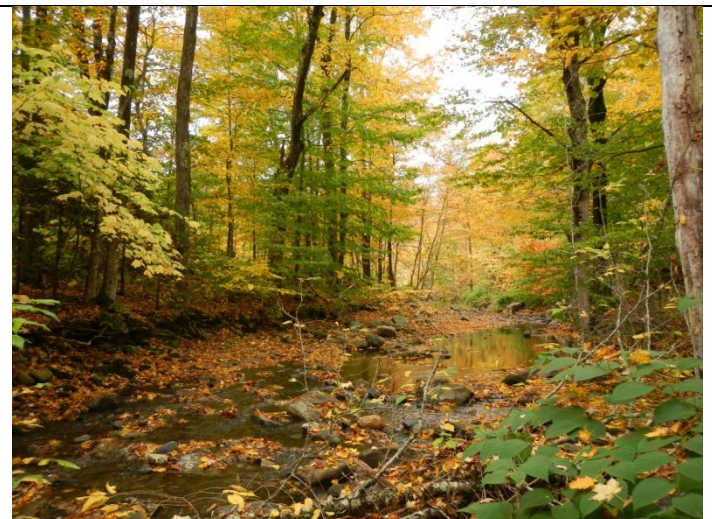
Reference C, now aggrading to regain floodplain access

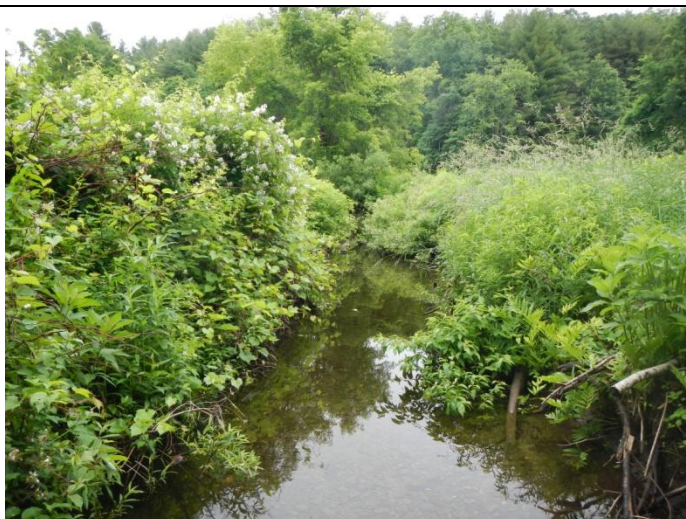
E-type channel geometry with dense bank growth

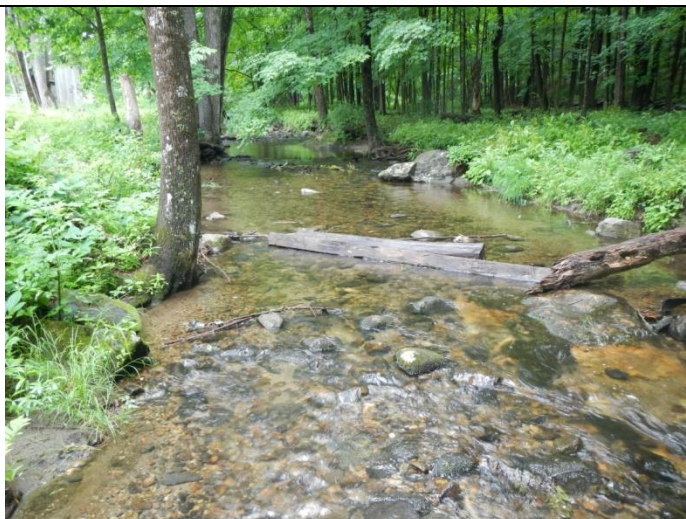
Floodplain becomes more accessible from aggradation

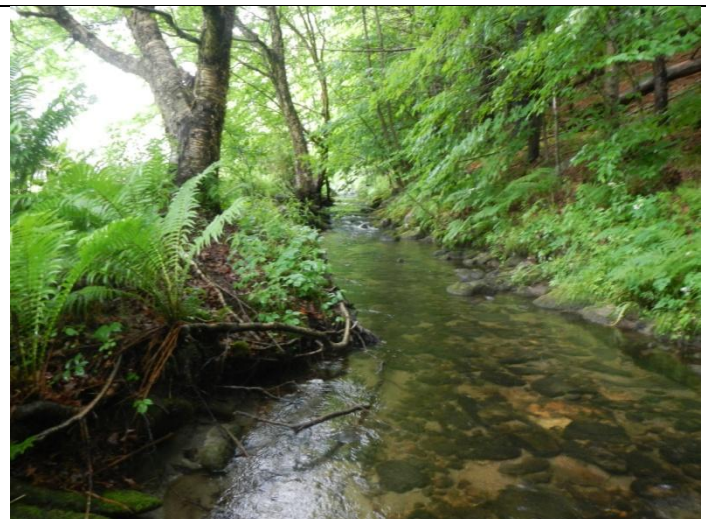
Stream pinched against valley wall

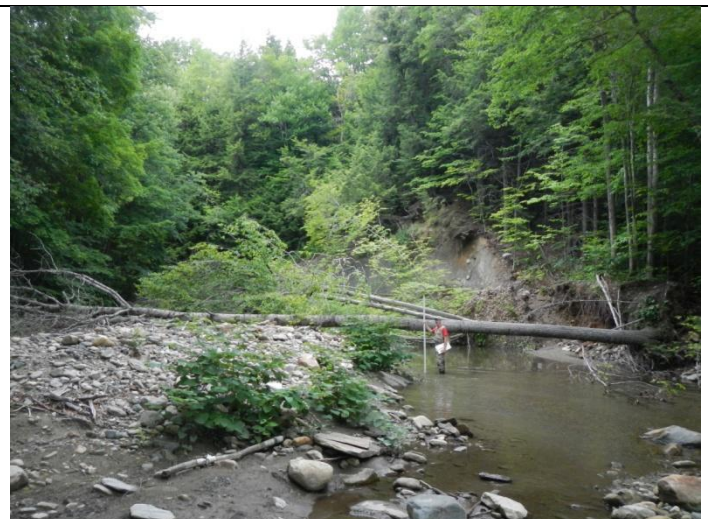
Large depositional features in highly active reach

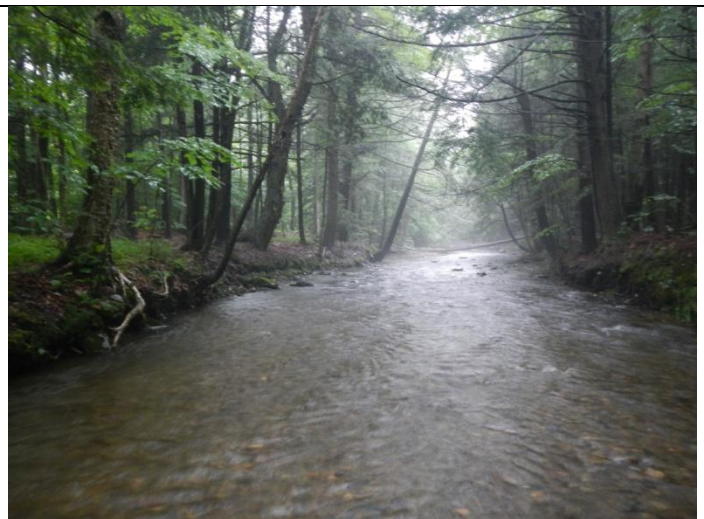
Widened channel, but still F-type channel geometry
